Pipes Inspected, Massillon Levee					
Size (Inches)	Material	Length (Feet)	Location					
18	RCP	103	West of RR with Flap Gate					
12	RCP?	175	Could not locate/unknown/does not exist					
42	RCP	95	Culvert through West Bank Levee opposite of Croose Avenue, 1000 ft					
			upstream of Cherry Rd.					
66	RCP	93	Culvert through East Bank Levee near control weir					
42	RCP	360	At inlet to siphon control weir					
			James Avenue Pump Station Gravity Outlet					
			Discharge from James Avenue Pump Station					
		100	Discharge from James Avenue Pump Station					
30	CIP	100	Discharge from James Avenue Pump Station					
			Federal Avenue Pump Station Outlet					
			Federal Avenue Pump Station Outlet					
			Discharge from Federal Avenue Pump Station					
		141	Discharge from Federal Avenue Pump Station					
30	CIP	141	Discharge from Federal Avenue Pump Station					
		120	Sippo Creek Pump Station					
			Discharge from Sippo Creek Pump Station

Army Corp of Engineers Rating Guidelines for Levee Inspection

HUNTINGTON DISTRICT

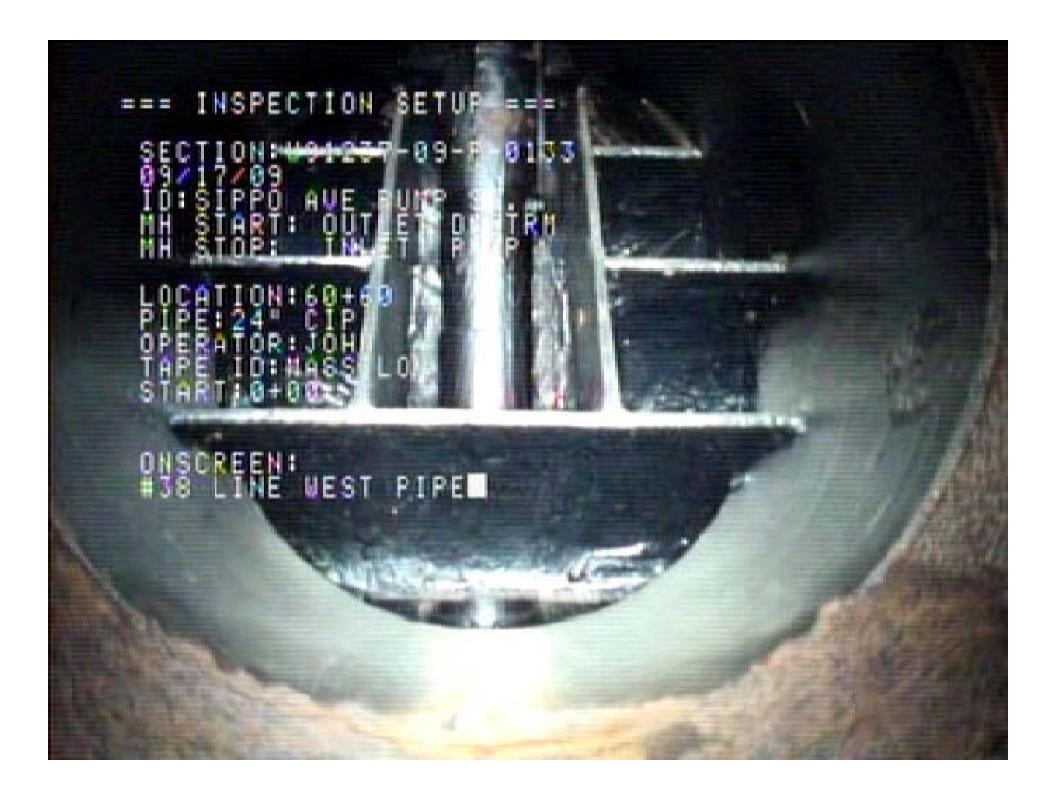
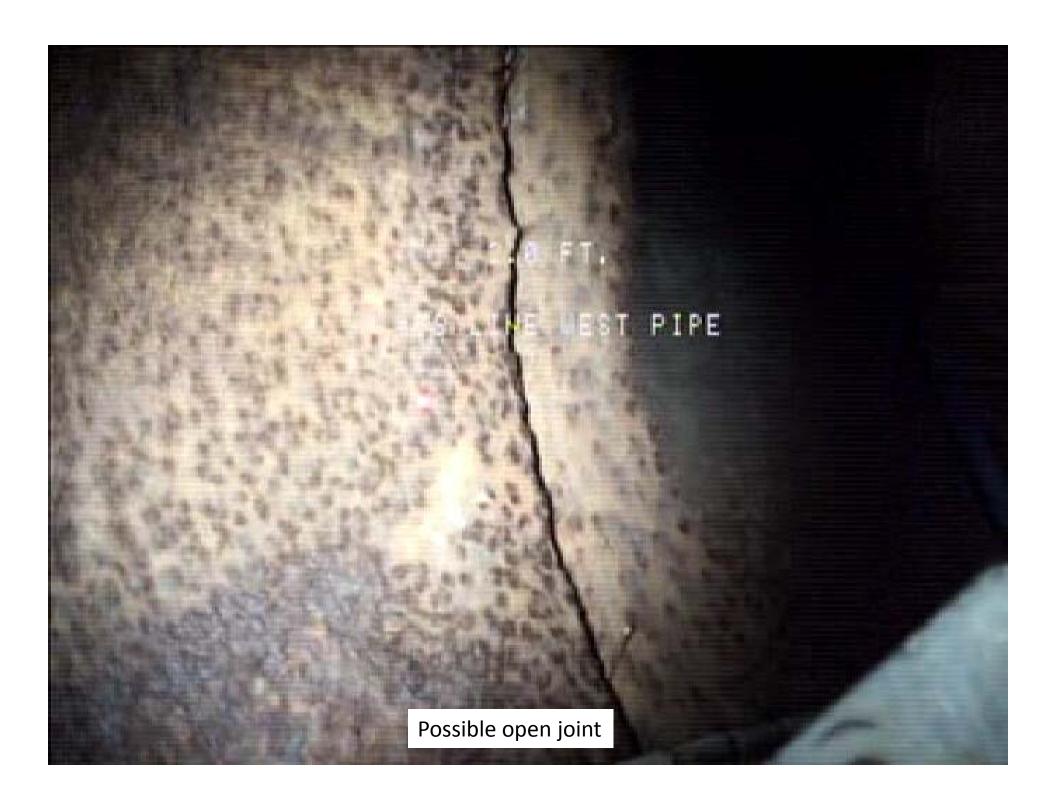
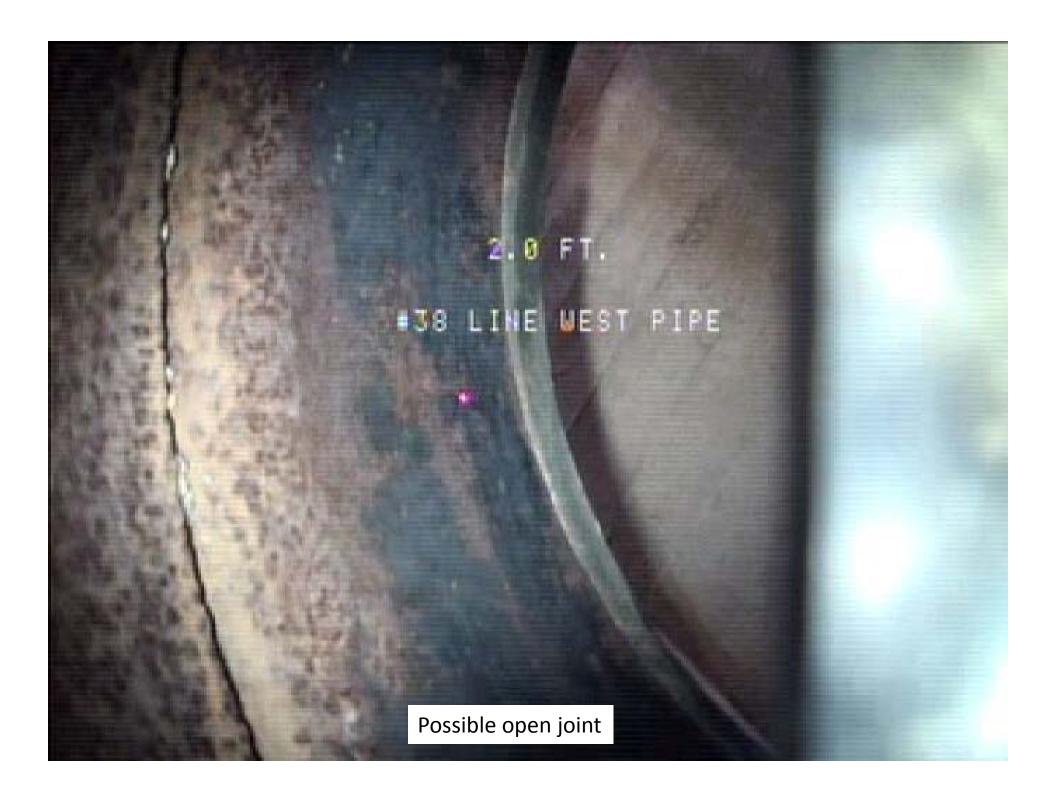
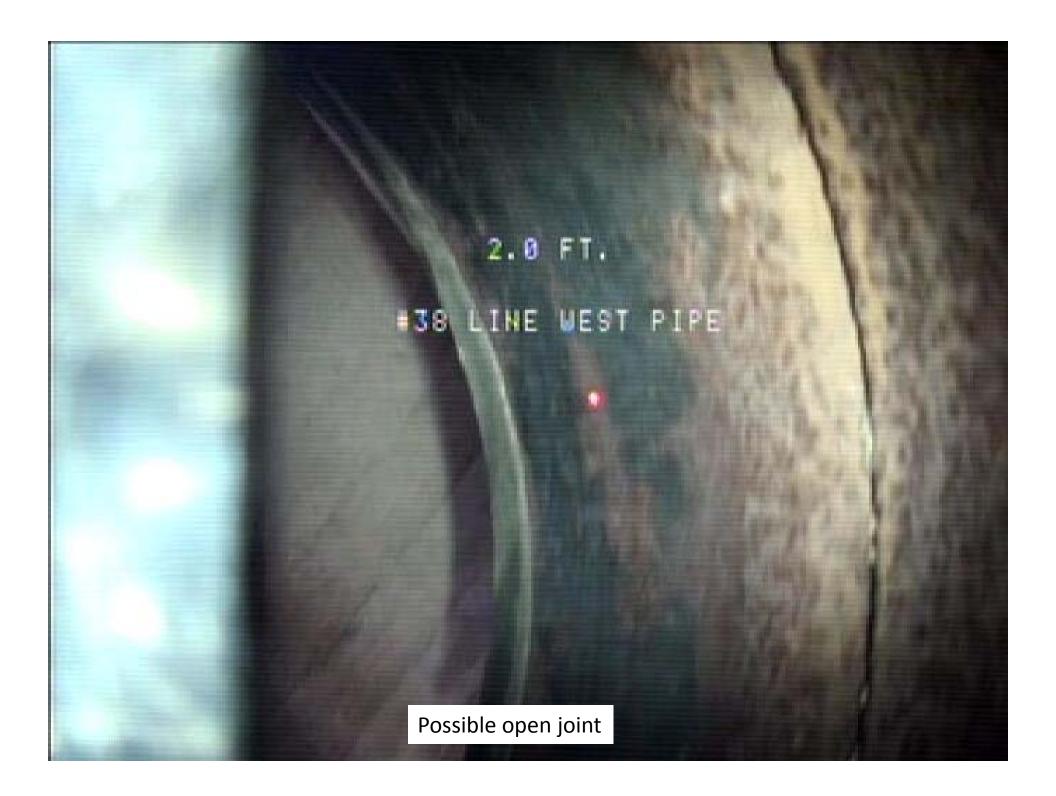
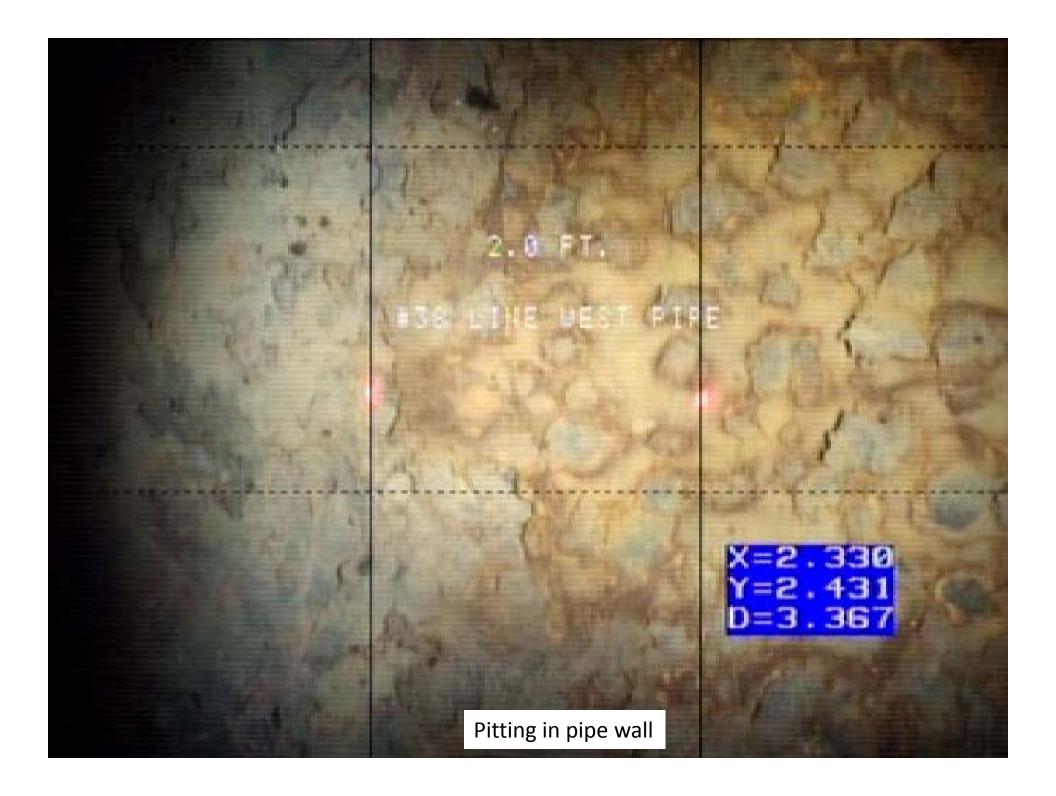
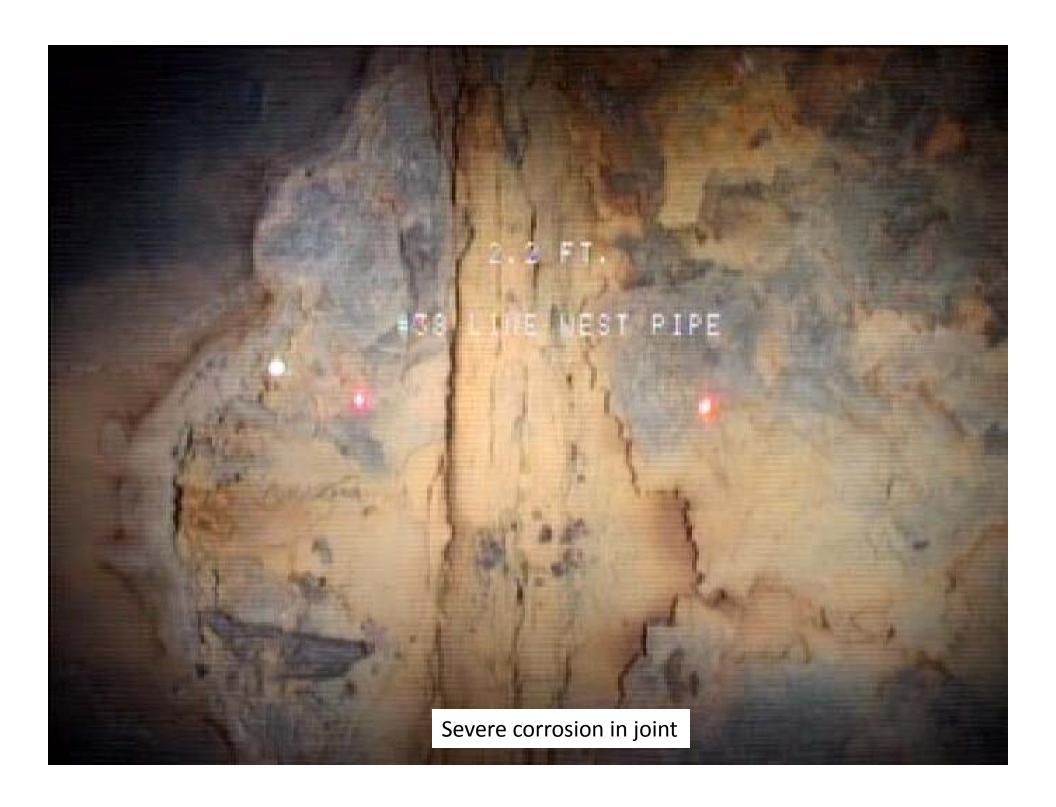
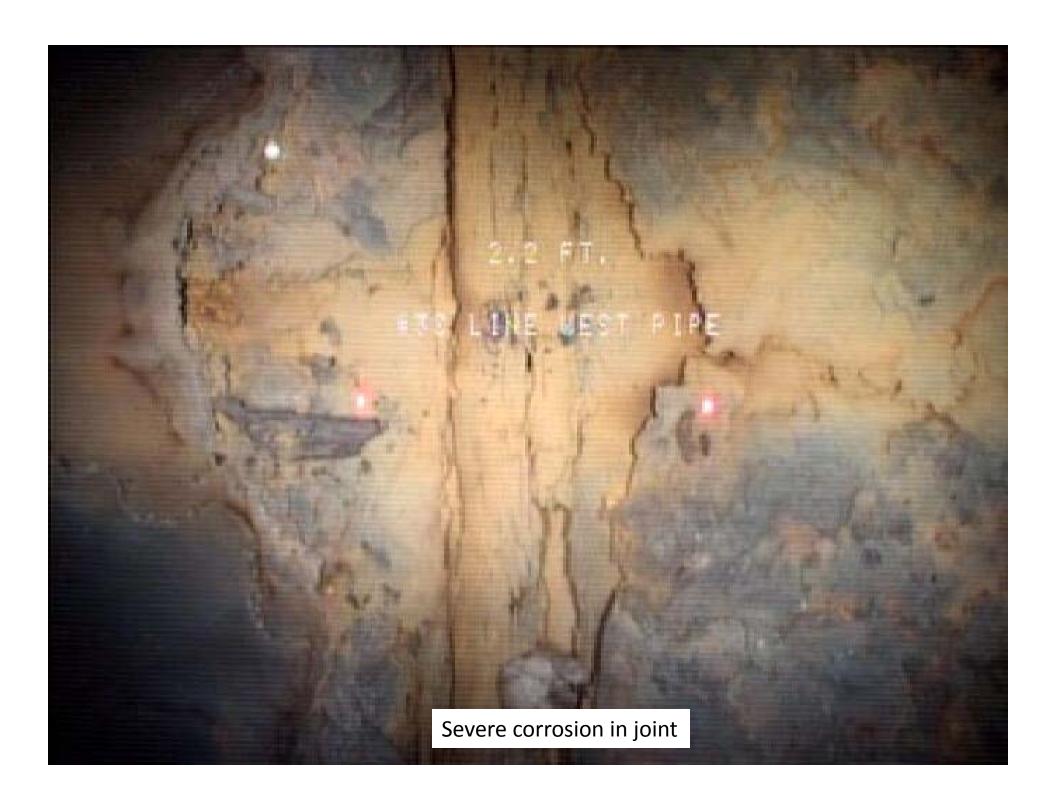
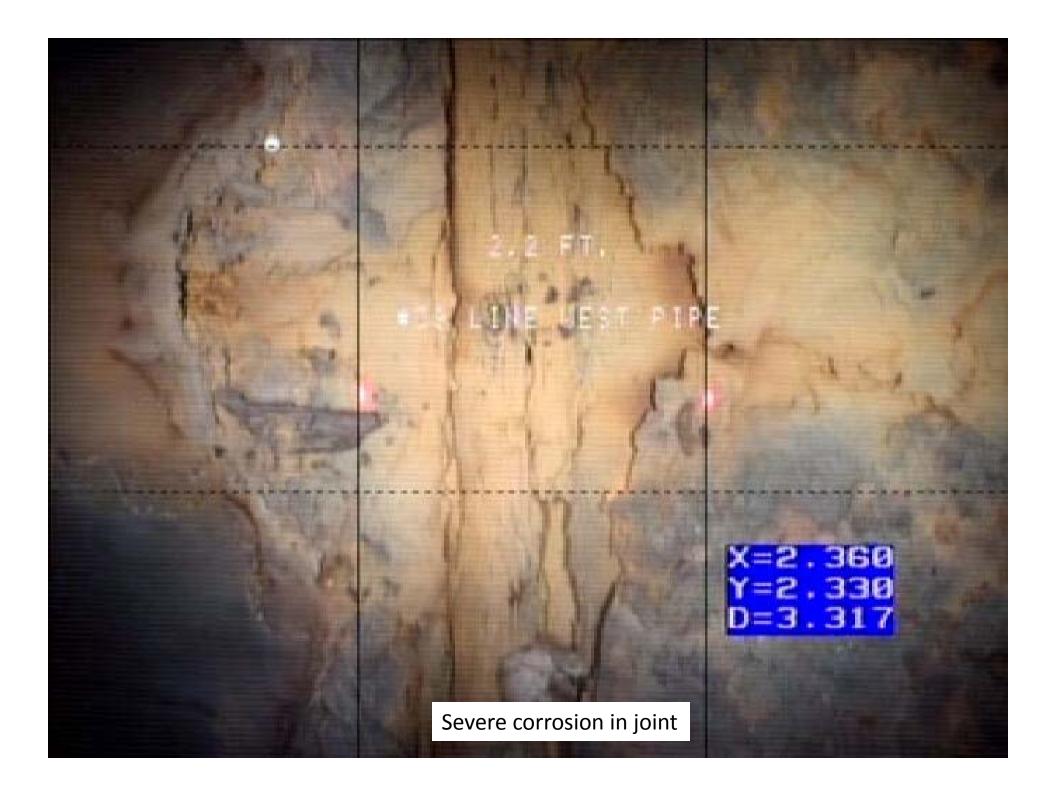
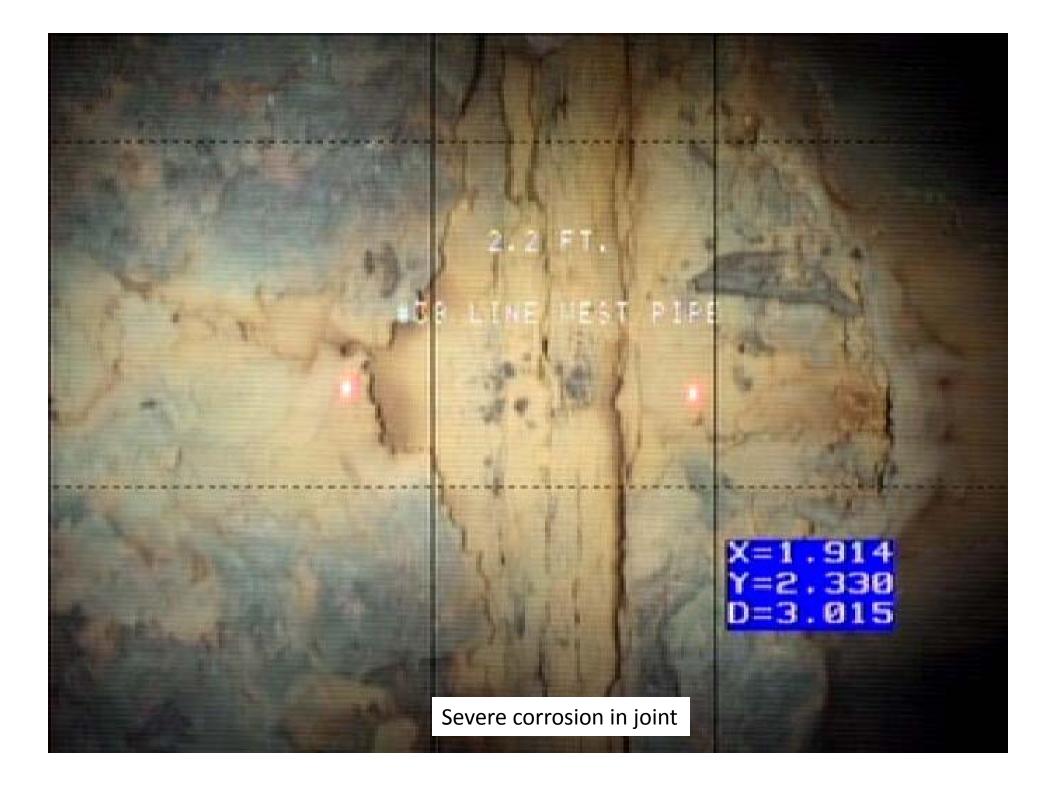
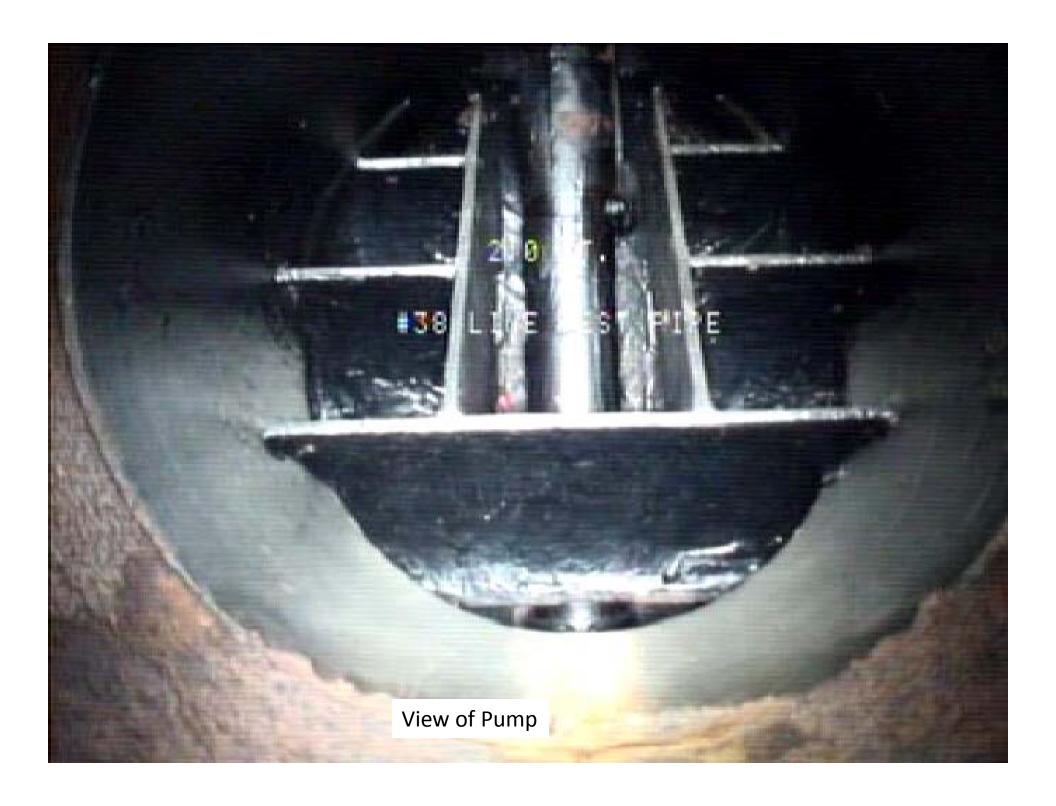
Massillon, Ohio Sippo Creek Pump Station Outlet Pipe #38 (West Pipe)

GENERAL INPECTION FINDINGS: All three pipes have moderate to severe corrosion and rust at the joints and pipe walls. Missing protective coating was predominately around the haunches and inverts of the pipe. Recommend air pressure testing to verify integrity of the joints.

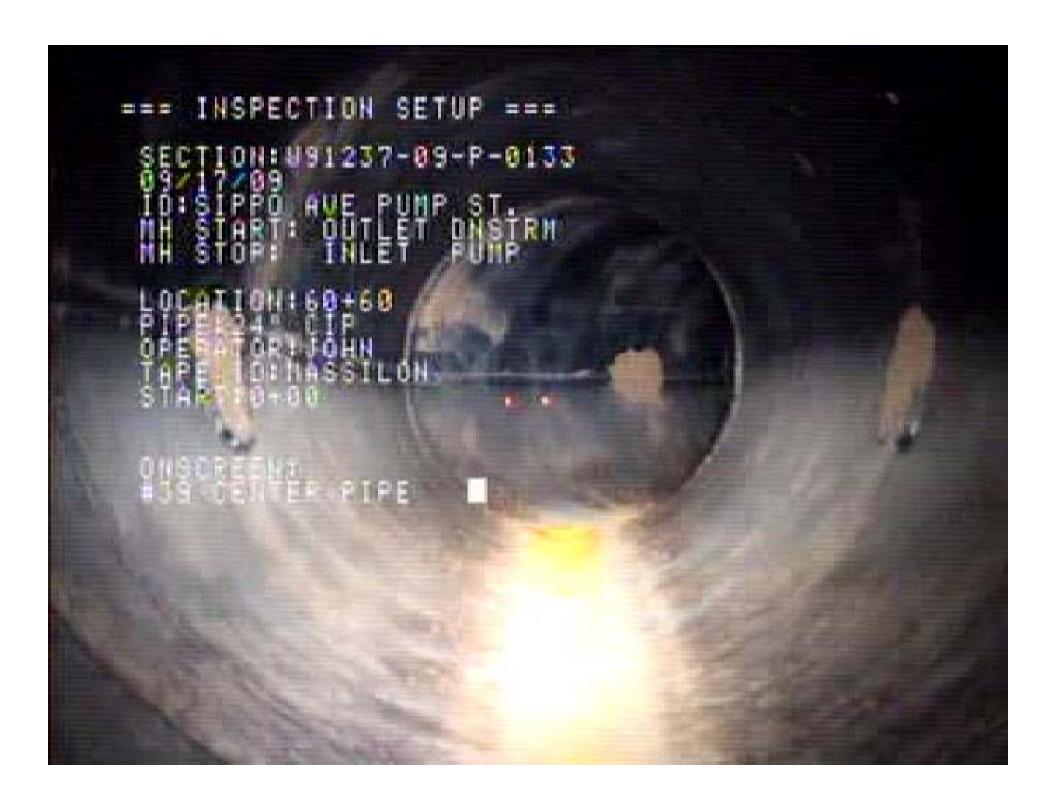
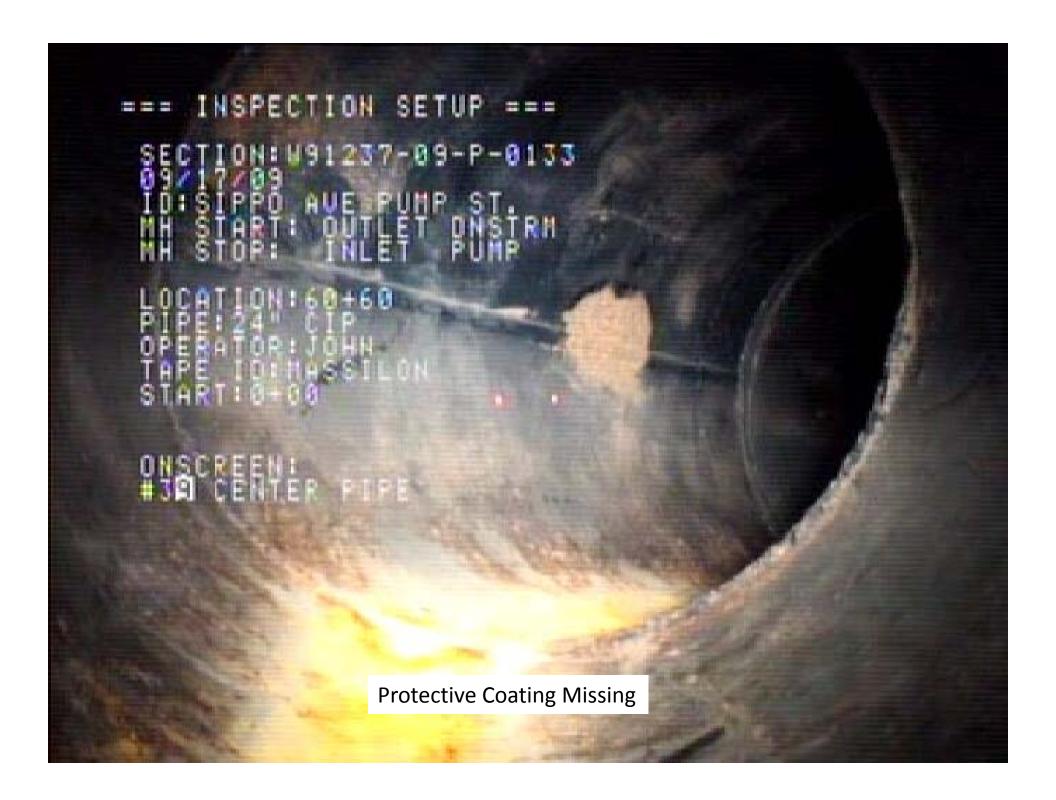
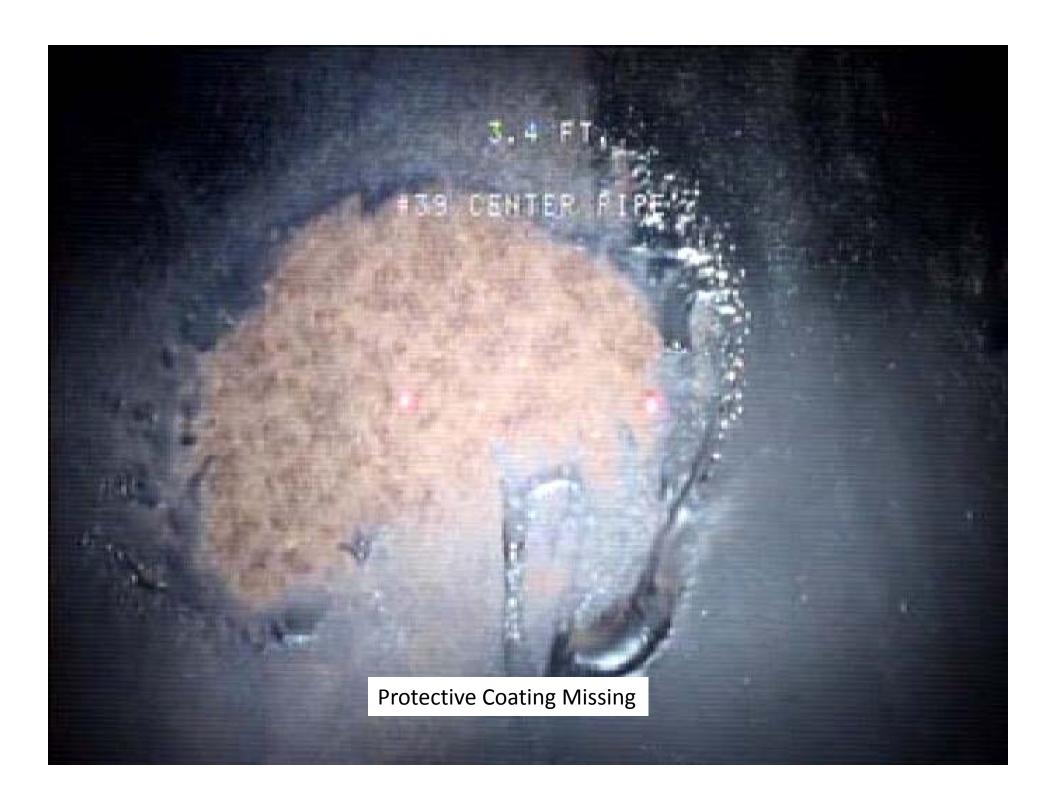
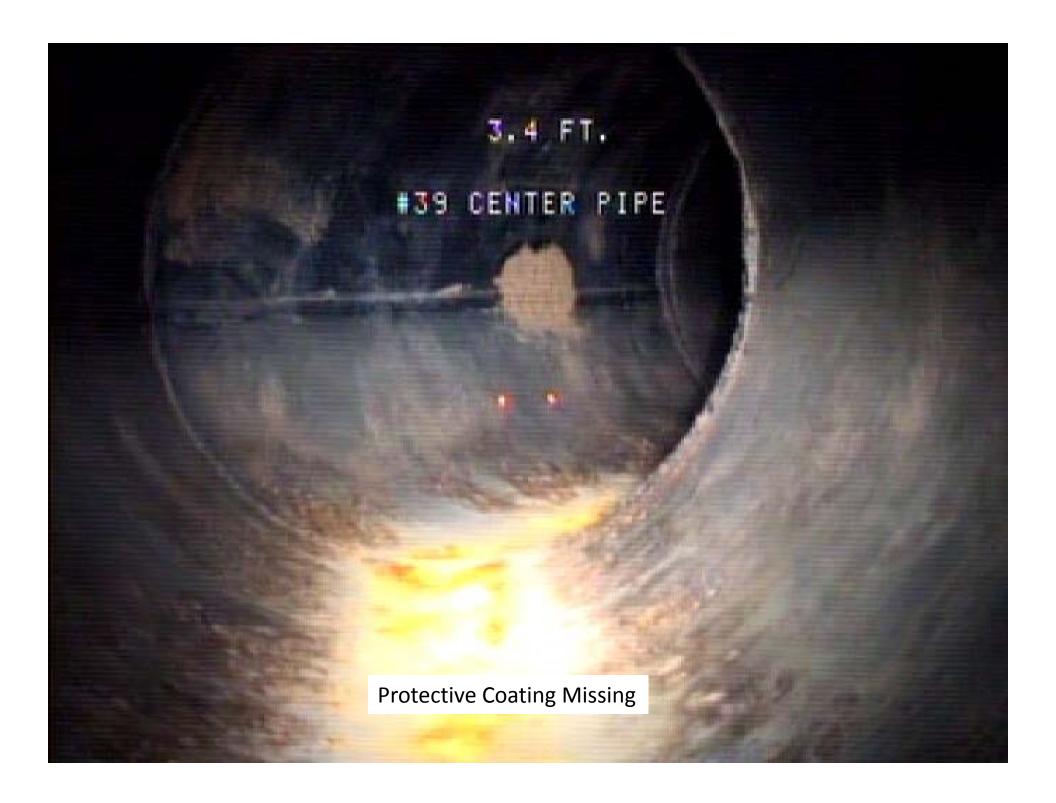
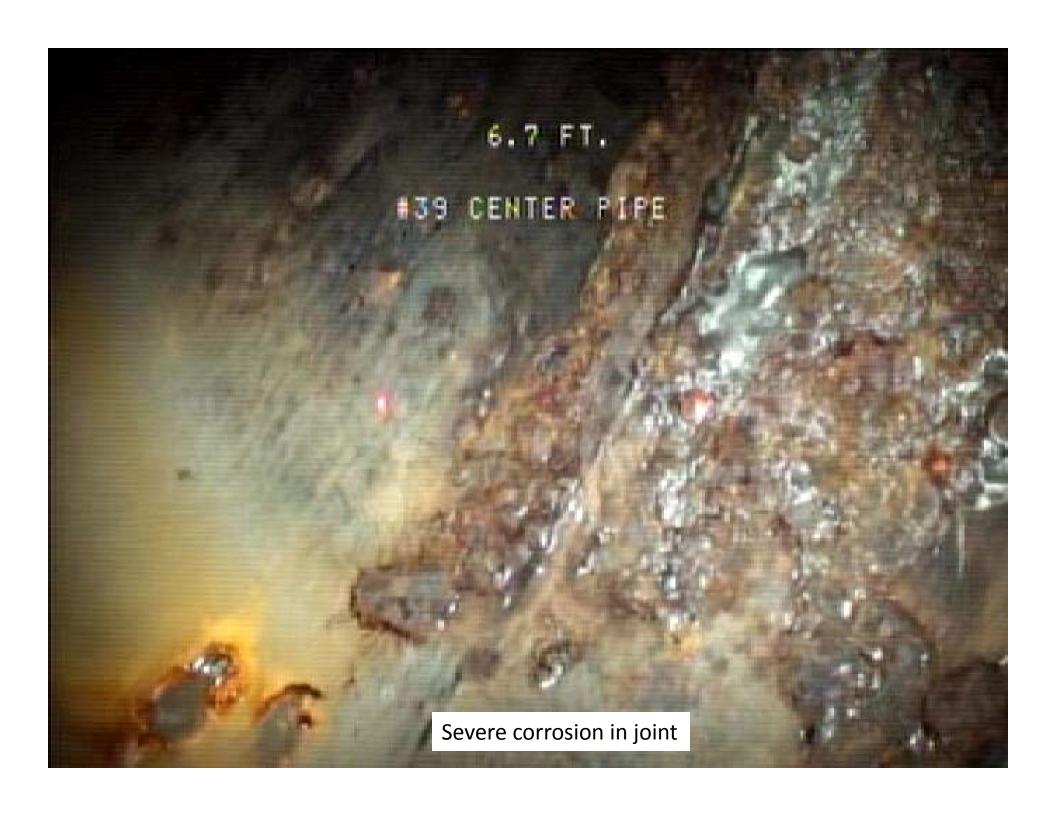
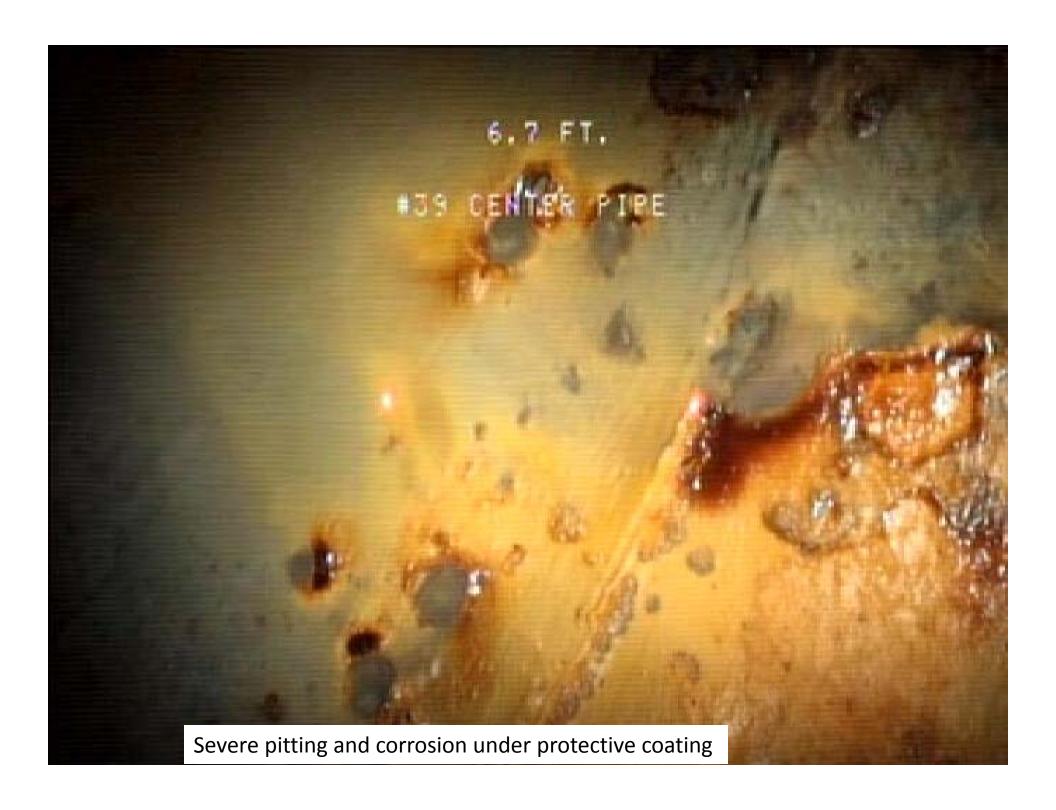
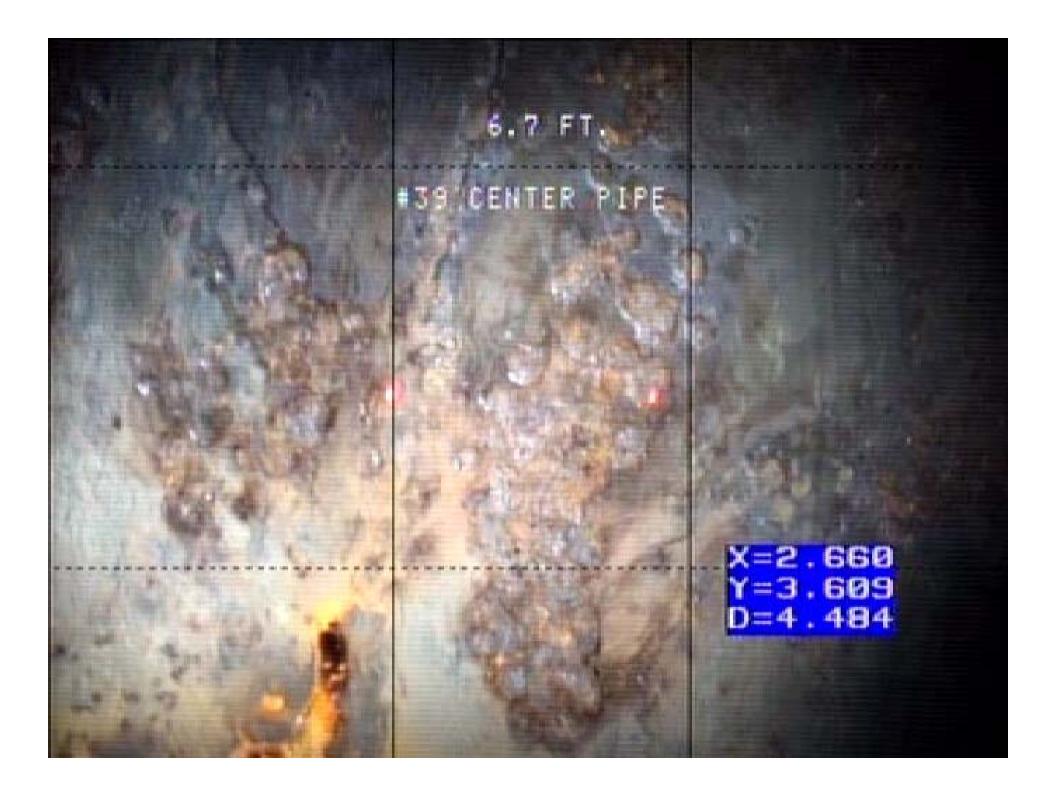
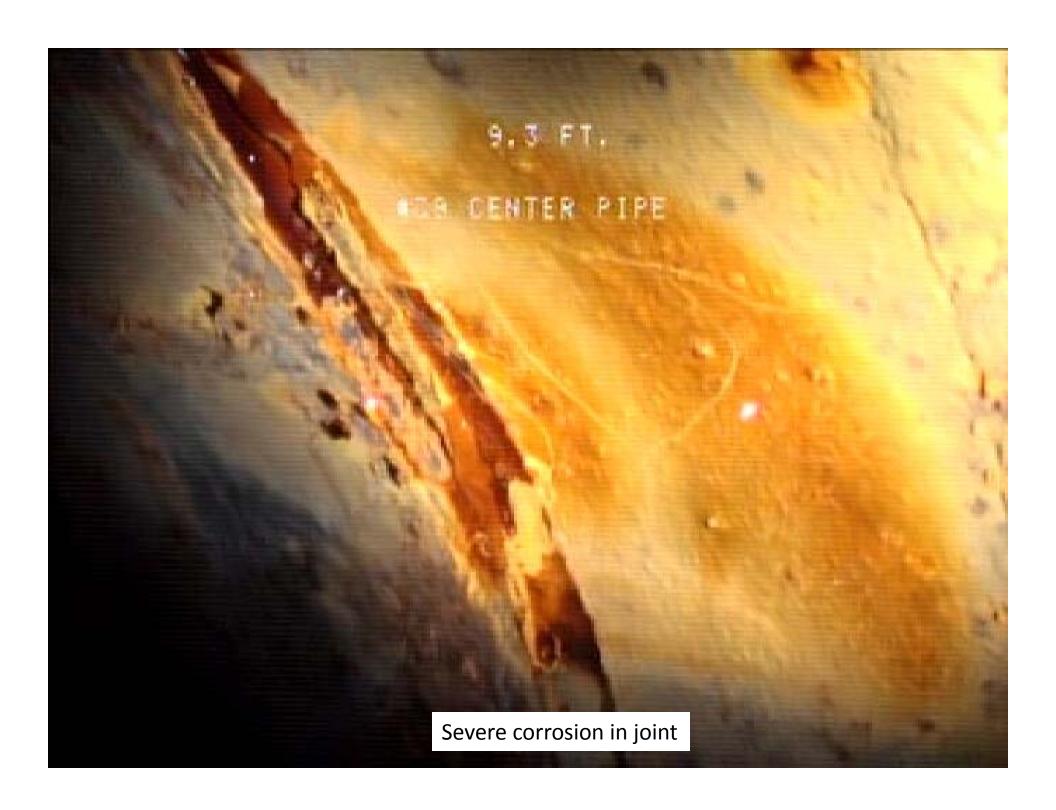
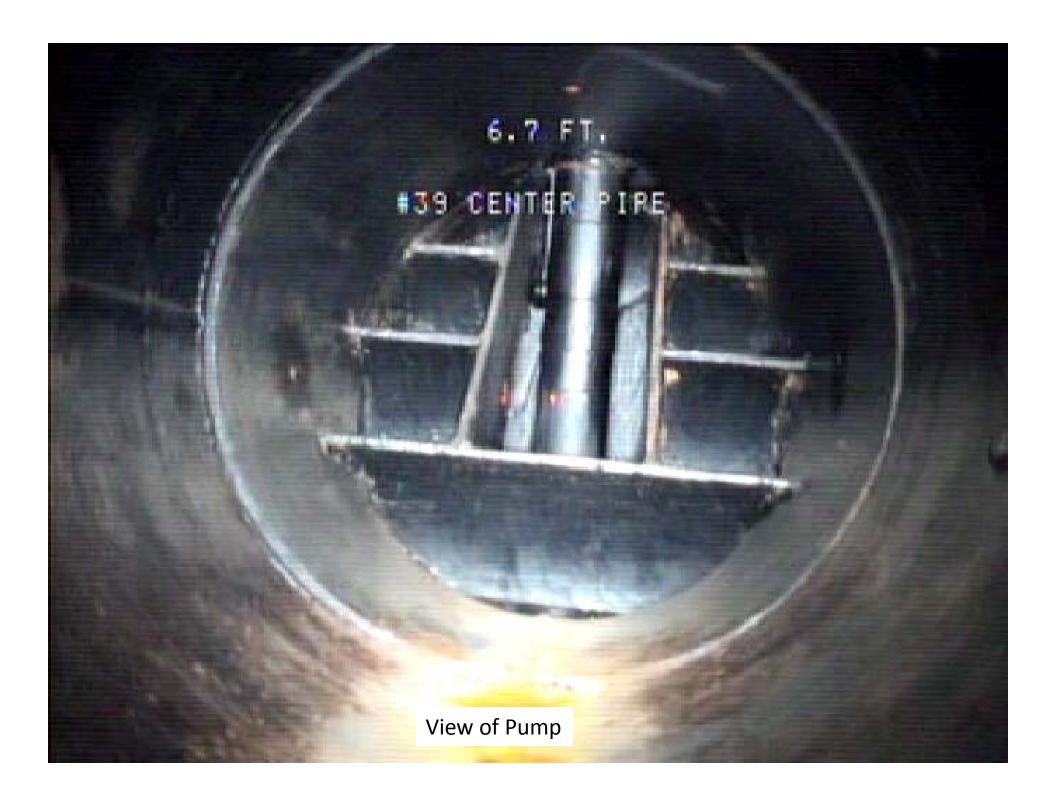
Massillon, Ohio Sippo Creek Pump Station Outlet Pipe #39 (Center Pipe)

*Note: Pipe #39 (center) at 9.3ft has a severe offset/separated joint with potential leakage.

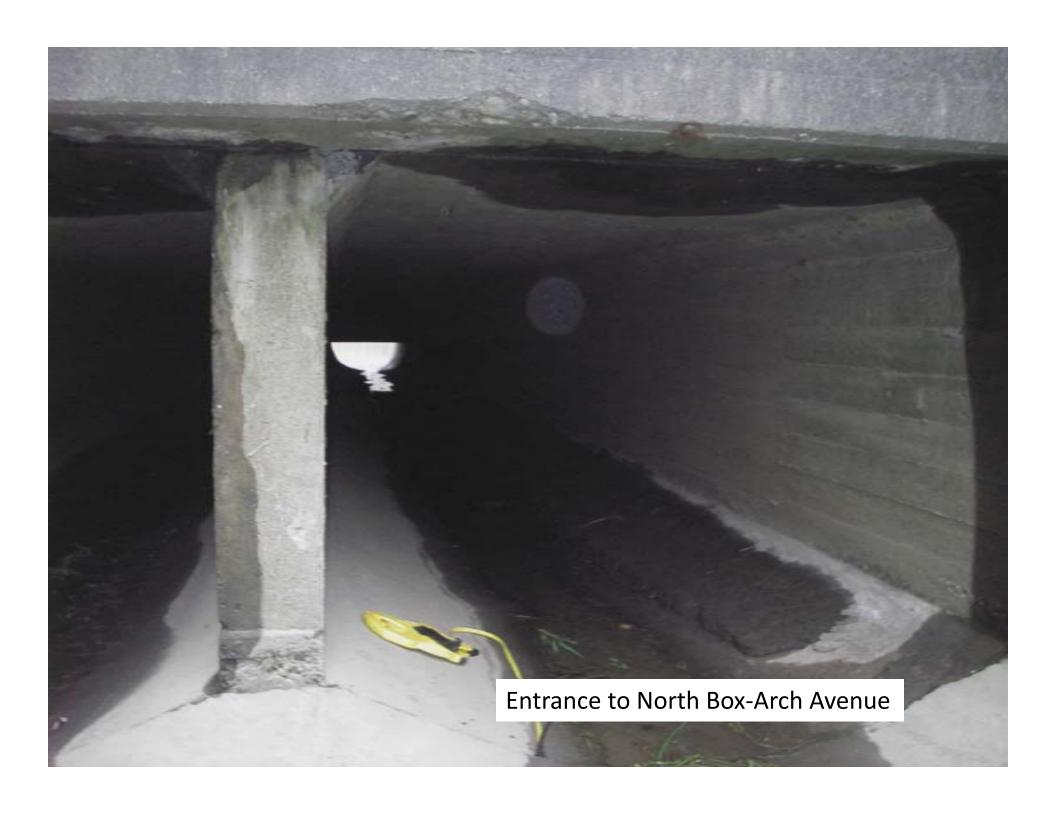
Massillon, Ohio Arch Avenue 6'x6'RCB Pipe #41 (North Box)

OVERALL CONDITION: NASSCO Rating 3: Moderate defects that will continue to deteriorate.

Arch Avenue Box #41				
Feet	Defect			
5 ft	Rebar/nails visible in crown			
23ft	Slight spalling/ offset joint in crown			
32ft	Hairline cracking			
46ft	Open joint between North and South barrel			
68ft	Scouring/Staining in crown			
80ft	Right haunch, offset joint approx. 2", possible soil penetration			
85ft	Spalling/ cracking at headwall

*First part of the structure from the inlet to gatewell is RCB, gatewell to outlet is RCP

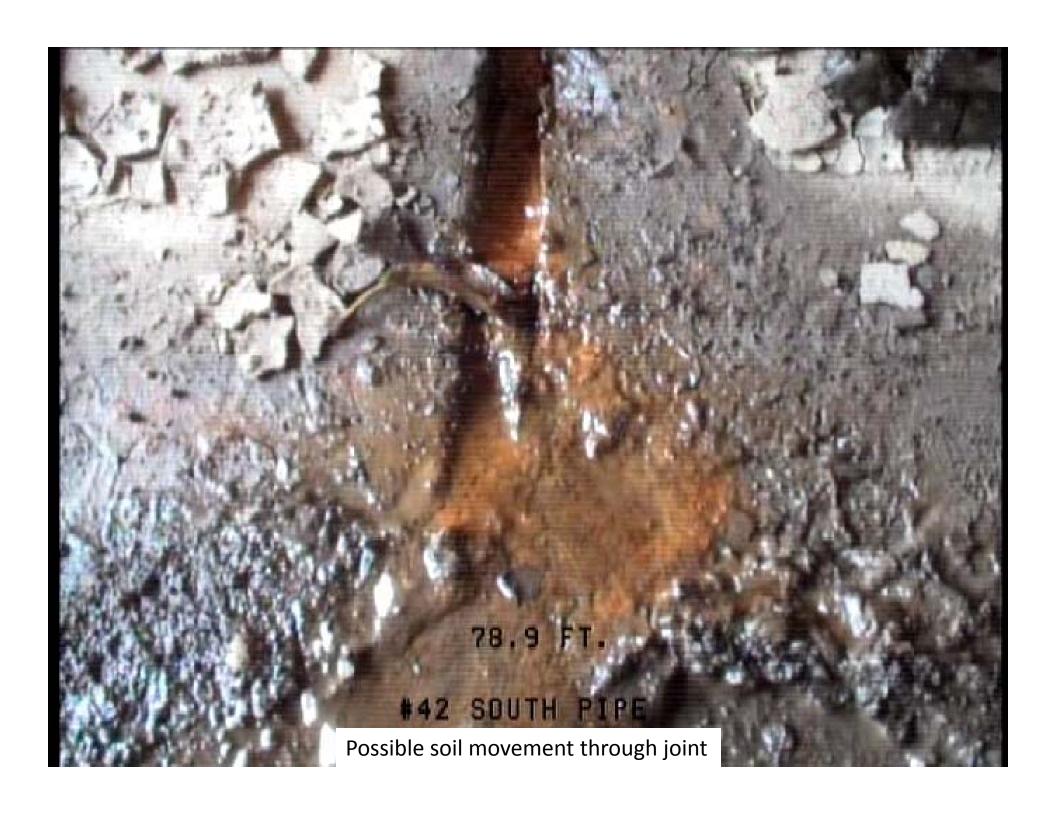
Scouring at joint in left haunch/soil or rust seeping in through joint- 79ft
