Pipes Inspected, Massillon Levee					
Size (Inches)	Material	Length (Feet)	Location					
18	RCP	103	West of RR with Flap Gate					
12	RCP?	175	Could not locate/unknown/does not exist					
42	RCP	95	Culvert through West Bank Levee opposite of Croose Avenue, 1000 ft					
			upstream of Cherry Rd.					
66	RCP	93	Culvert through East Bank Levee near control weir					
42	RCP	360	At inlet to siphon control weir					
			James Avenue Pump Station Gravity Outlet					
			Discharge from James Avenue Pump Station					
		100	Discharge from James Avenue Pump Station					
30	CIP	100	Discharge from James Avenue Pump Station					
			Federal Avenue Pump Station Outlet					
			Federal Avenue Pump Station Outlet					
			Discharge from Federal Avenue Pump Station					
		141	Discharge from Federal Avenue Pump Station					
30	CIP	141	Discharge from Federal Avenue Pump Station					
		120	Sippo Creek Pump Station					
			Discharge from Sippo Creek Pump Station

Army Corp of Engineers Rating Guidelines for Levee Inspection

HUNTINGTON DISTRICT

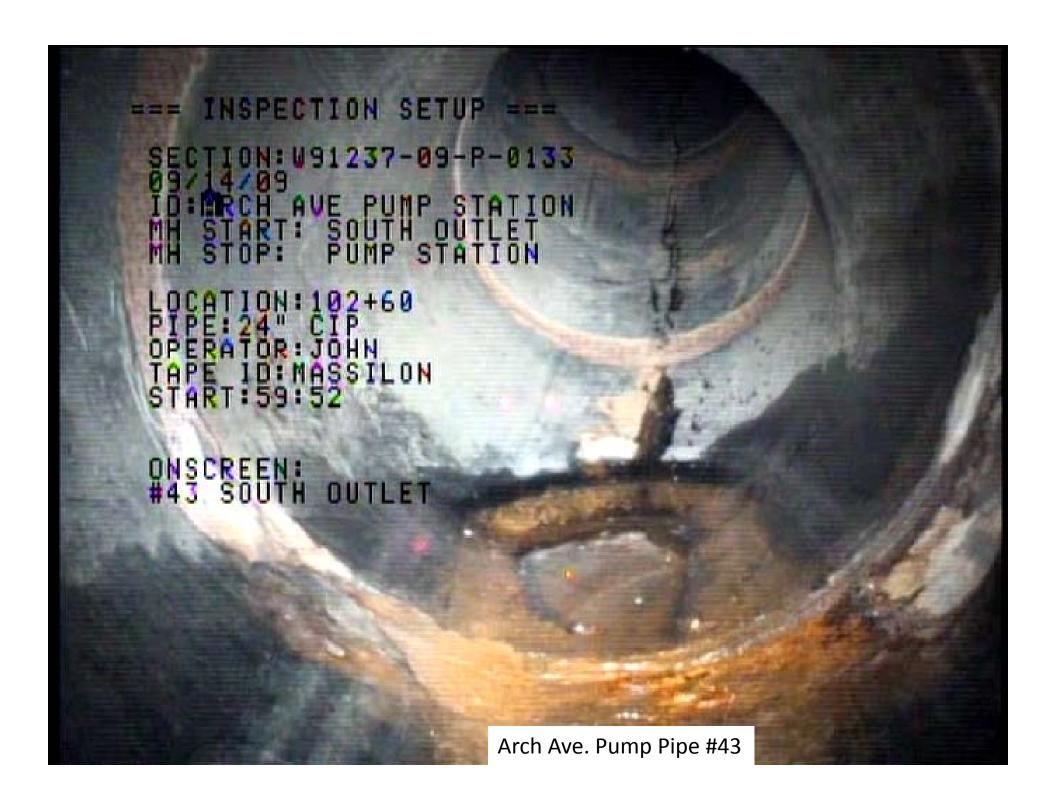
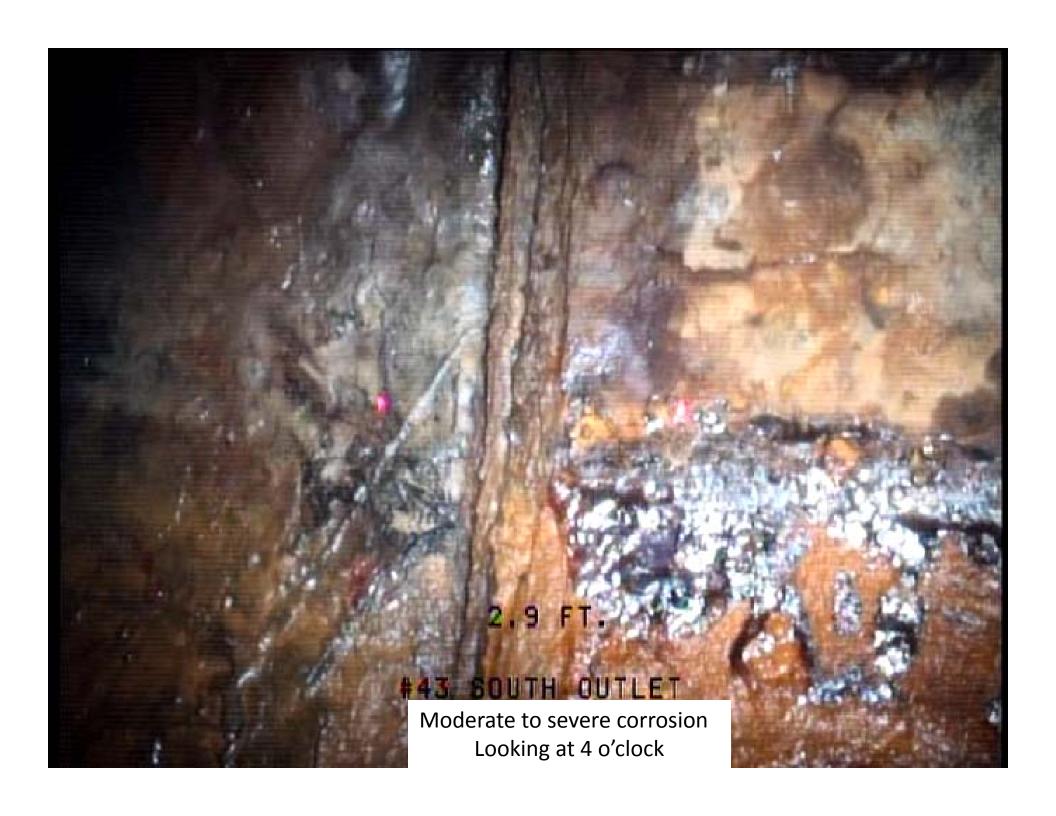
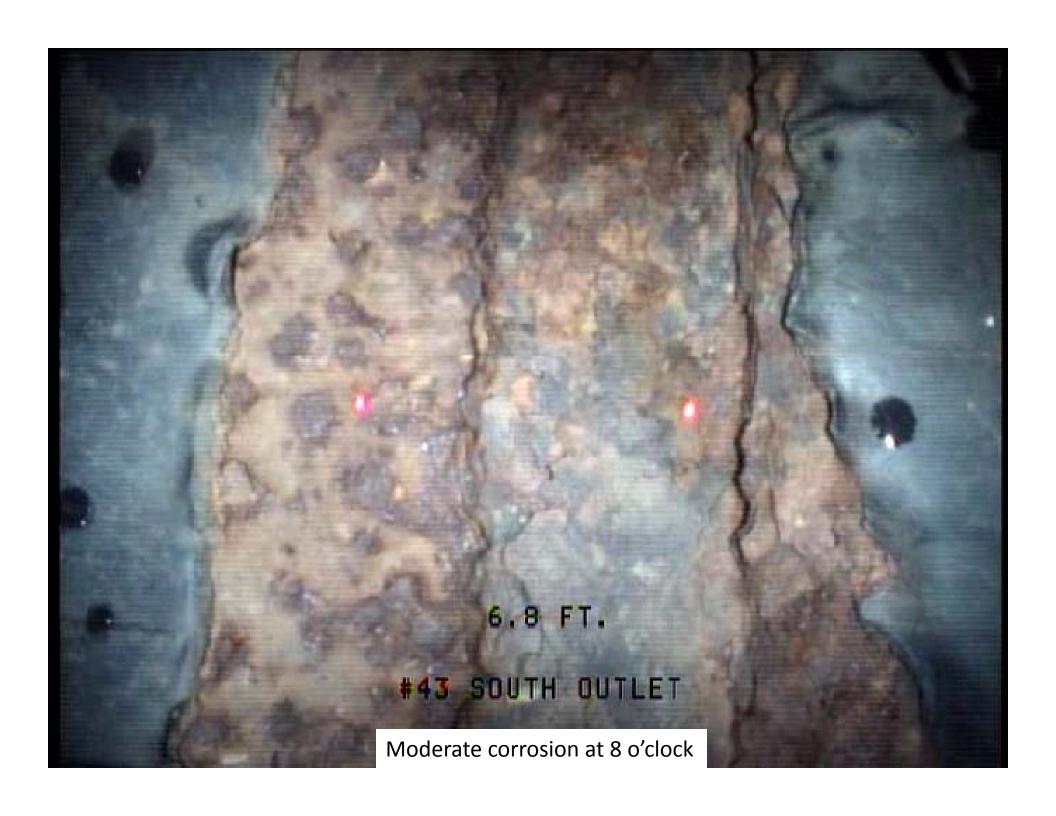
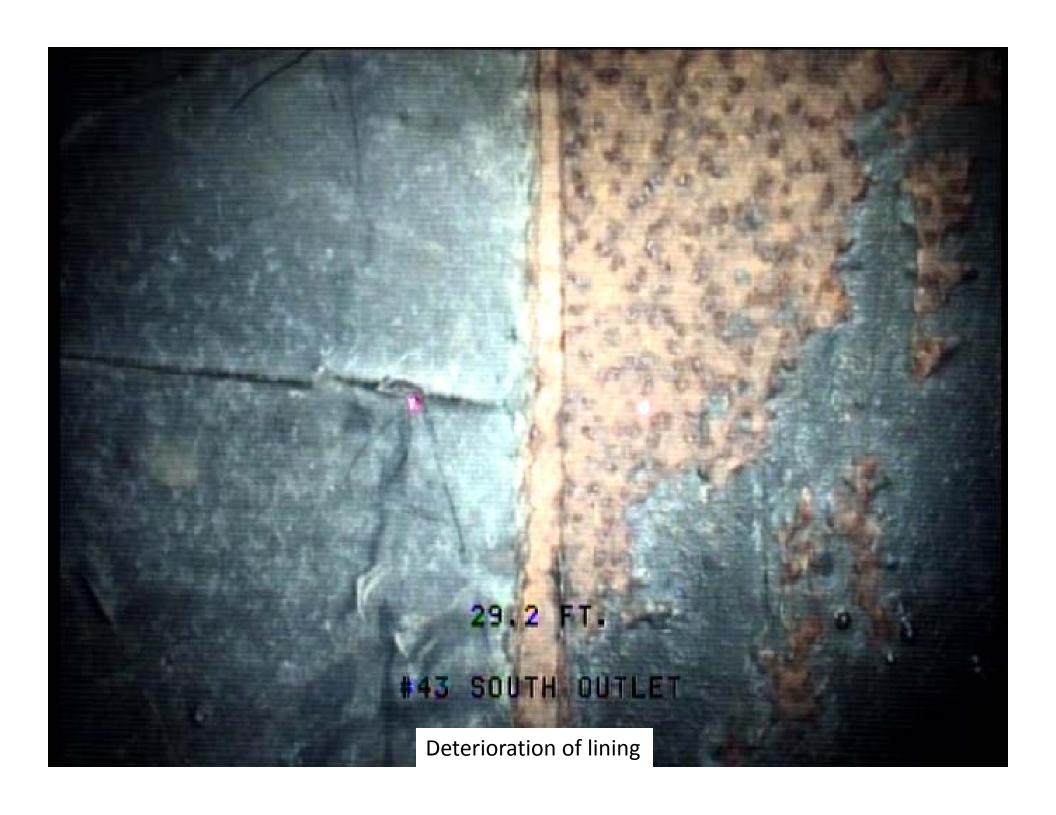
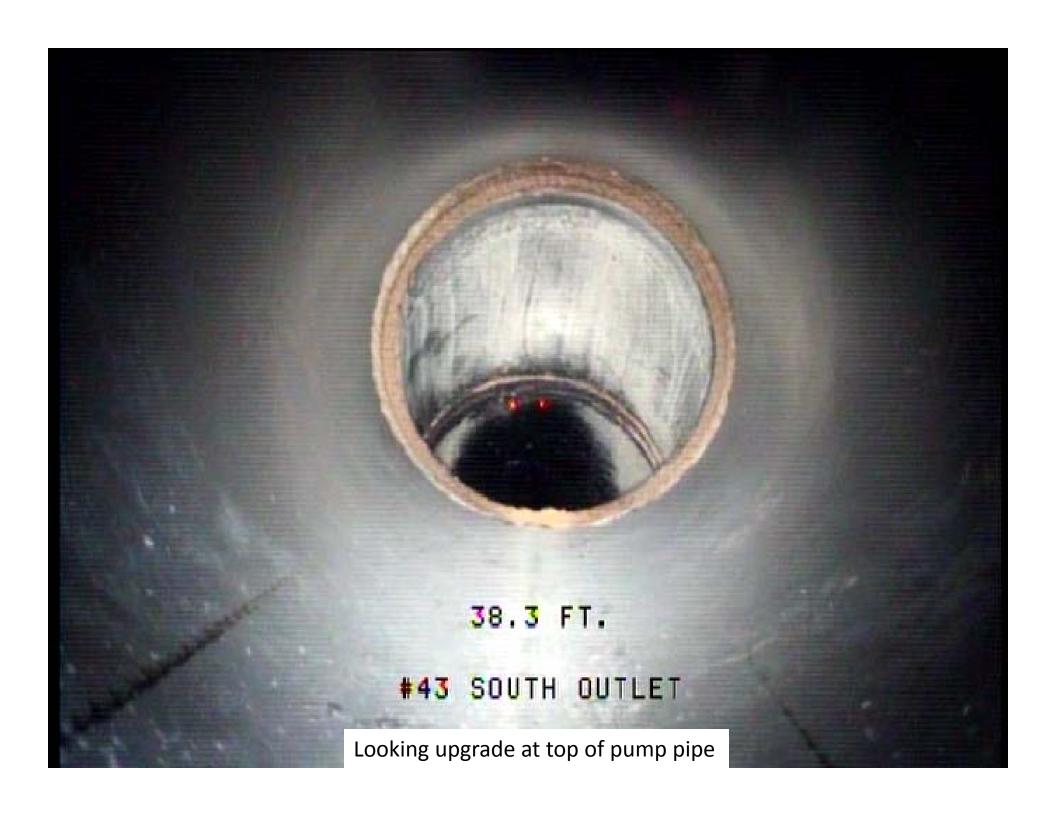
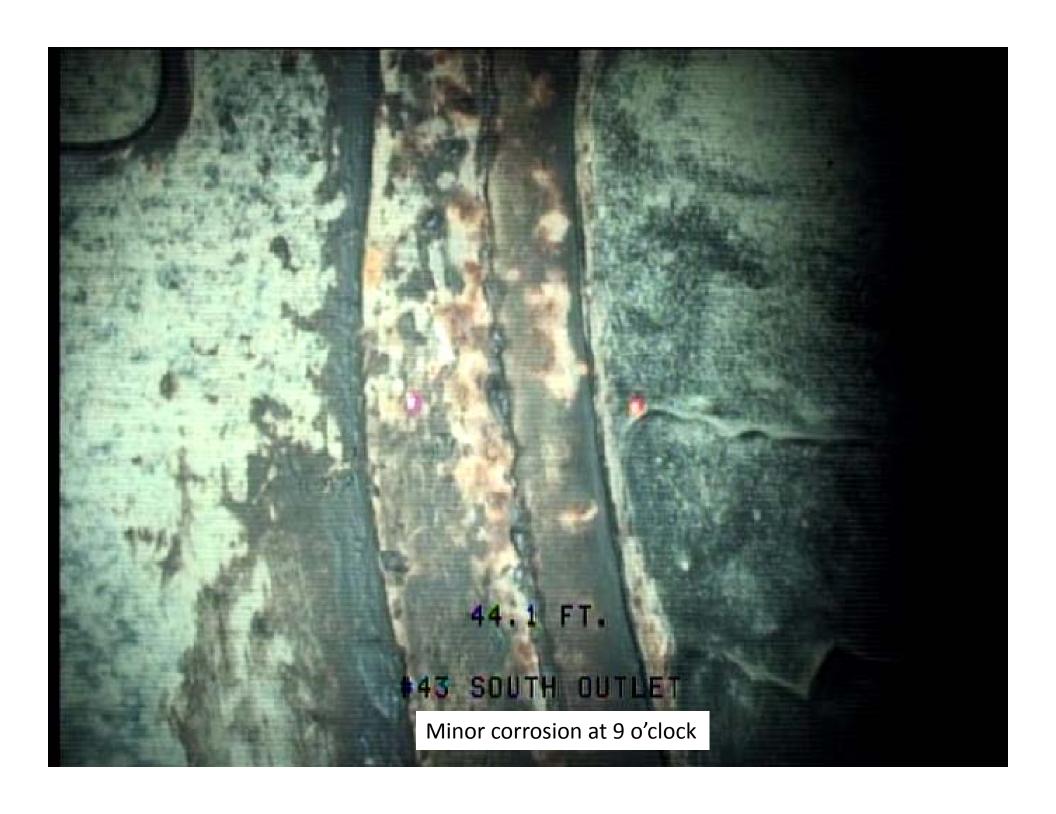
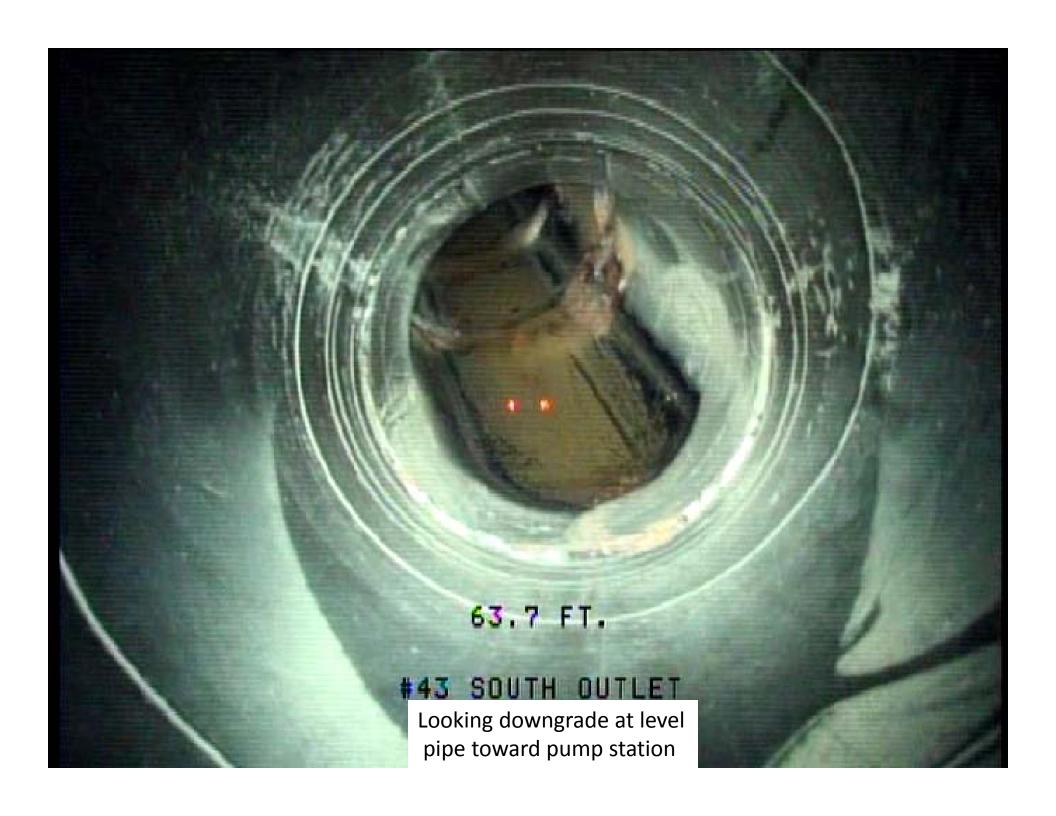
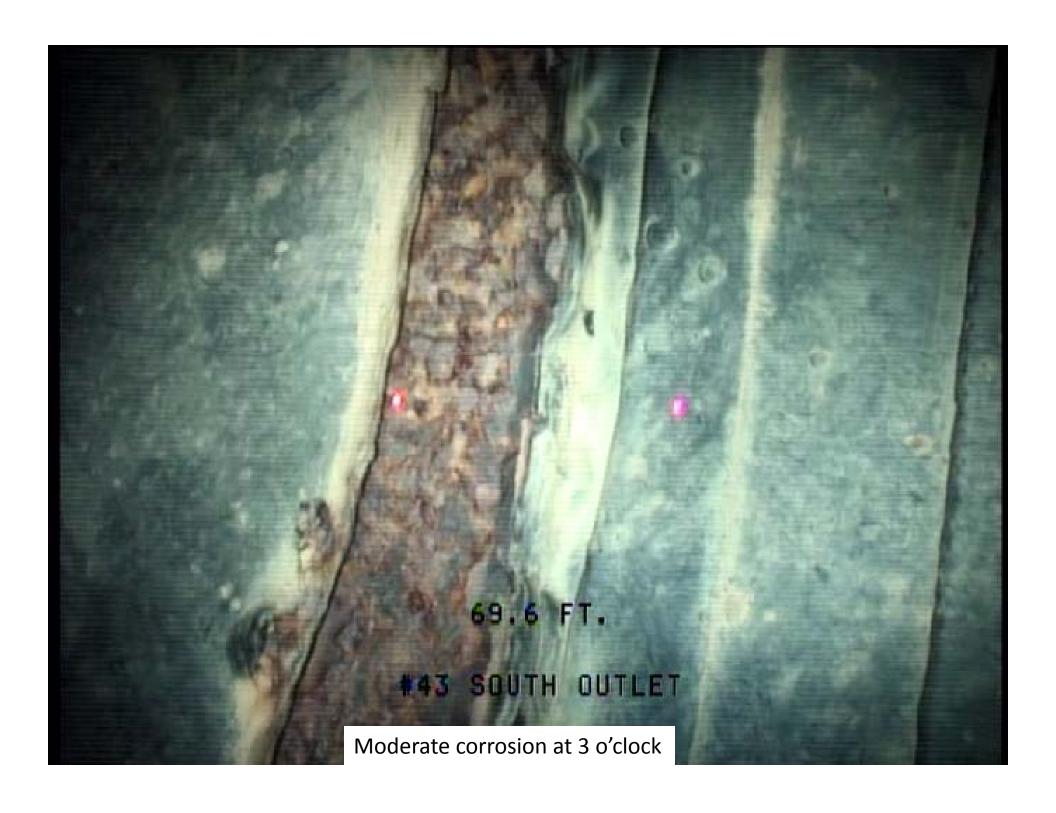
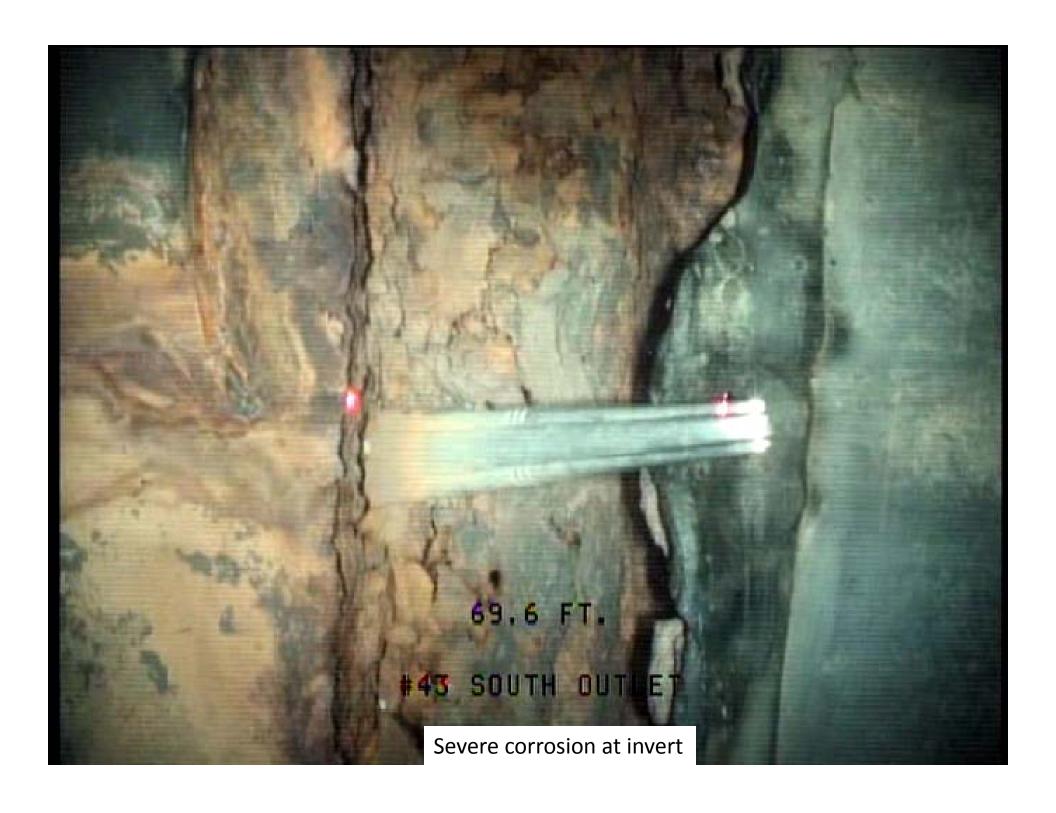
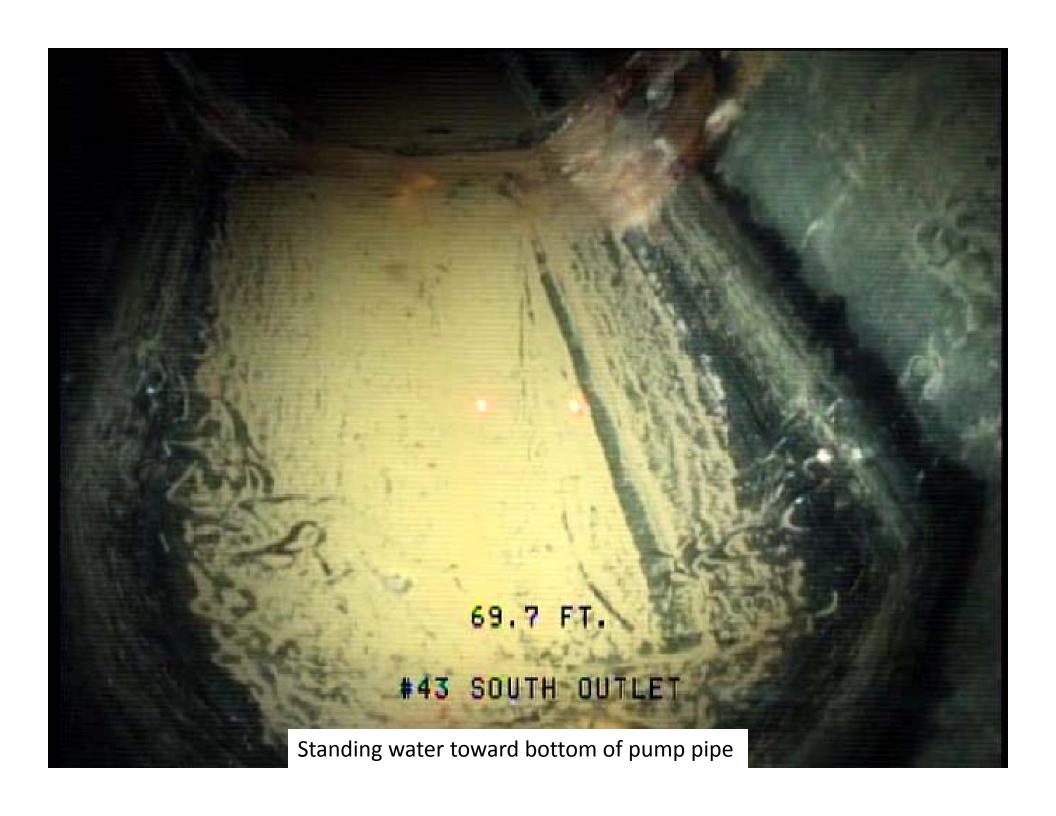
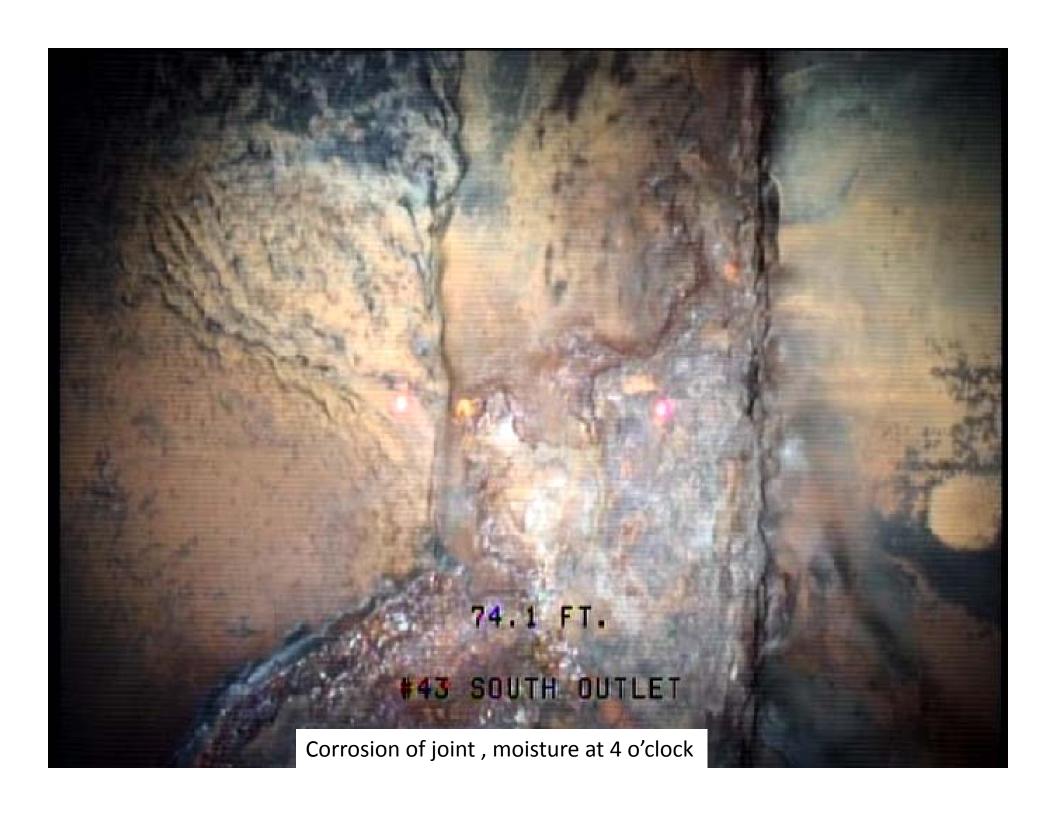
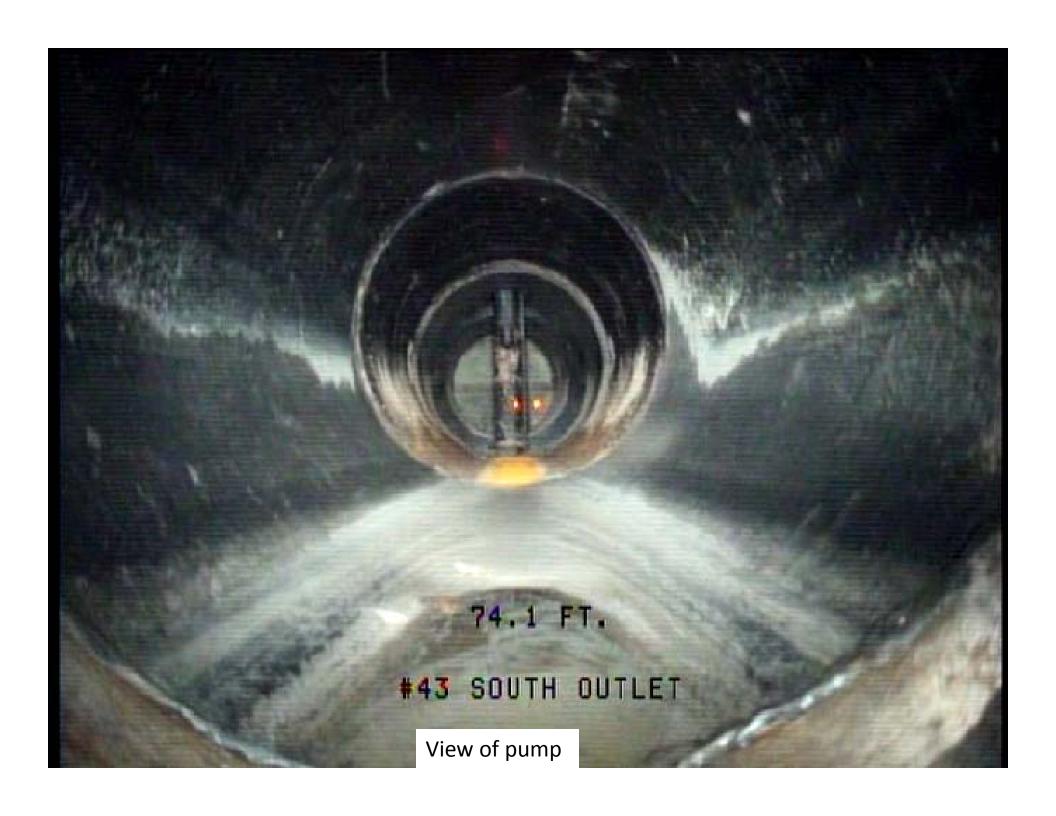
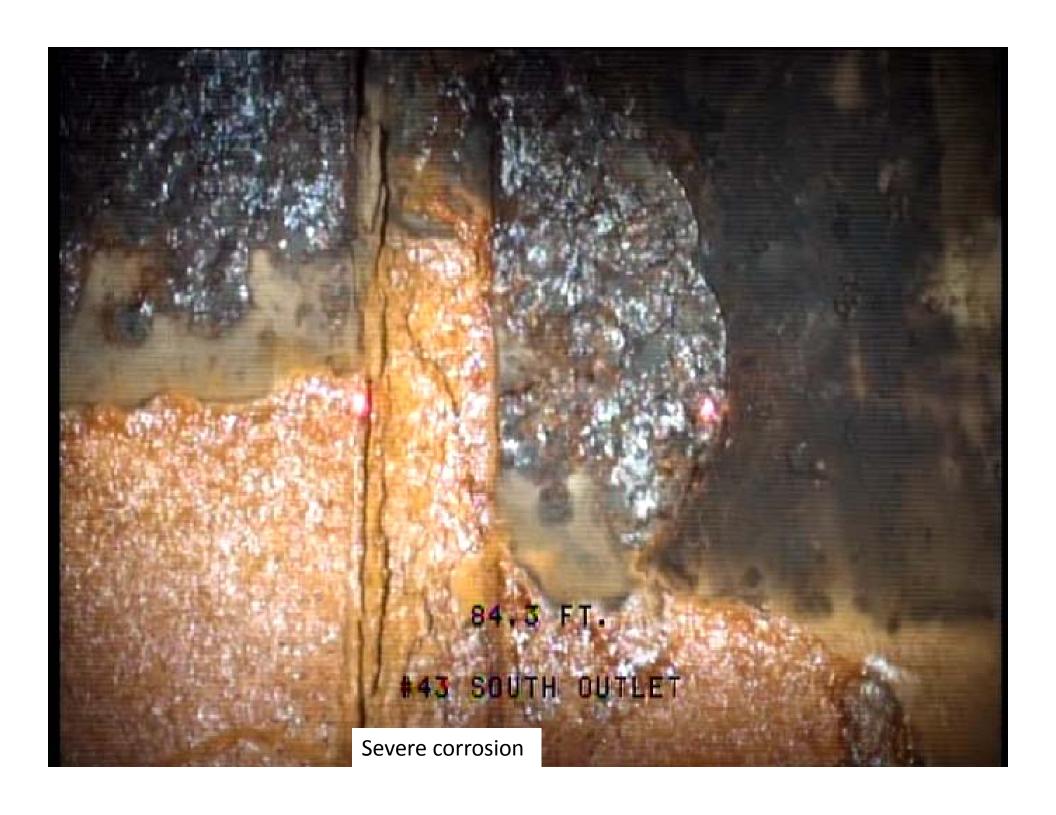
Massillon, Ohio Arch Avenue Pump Station Pipe #43 (South Pipe)

OVERALL CONDITION: NASSCO Grade 4: Pipe will probably fail in 5 to 10 years. Pipe rated at a more serious condition due to that it is a pump line going through a levee.

GENERAL INSPECTION FINDINGS: All three pipes have moderate to severe corrosion at the joints. Missing protective coating and corrosion was also noted in flat areas and sharp bends. It appears in some sections that point repairs have been made on the protective coating. Recommend air pressure testing to verify integrity of the joints.

Feet	Defect
0-85 ft	All three pipes have moderate to severe corrosion at the joints. Missing protective coating and corrosion was also noted in flat areas and sharp bends. It appears in some sections that point repairs have been made on the protective coating. Recommend air pressure testing to verify integrity of the joints.

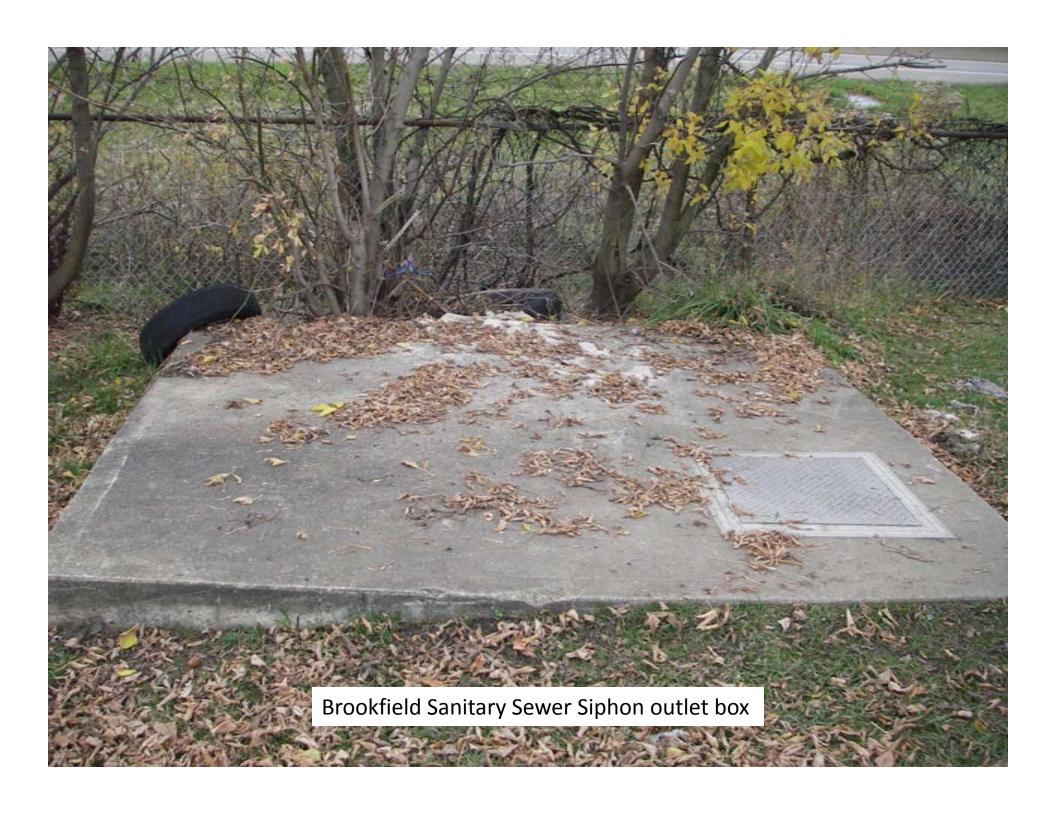
Massillon, Ohio Brookfield Sanitary Sewer Siphon Pipe #47, 24-inch DIP

OVERALL CONDITION: NASSCO Grade 3: Moderate defects that will continue to deteriorate

GENERAL INSPECTION FINDING: Sheets of the liner coming off in several areas. Some corrosion noted in areas where coating was missing. No gate valves on inlet or outlet. Pipe slopes up on constant grade from inlet to outlet.

Brookfield Siphon 24"- Outlet			
Feet Observation/Defect			
10ft	Corroded joint at crown		
28ft	Approx. 1" joint separation at 7 o'clock, Corroded joint in crown		
45.6ft	Tear in lining at approx. 4o'clock		
78.7ft	Lining peeling away from pipe walls at haunches		
99ft	Rust coming from joint at crown		
134.7ft	Rusting of joint at crown		
146.8ft	Large piece of lining detached from pipe wall		
170.5ft	Minor joint corrosion at crown		
200.7ft	Lining peeling away from pipe wall along joint		
241.7ft	Minor joint separation at approx. 4 o'clock		
273.6ft	Lining peeling away from pipe walls at invert		
277.1ft	Corrosion of joint/ small tear in lining		
330.5ft	Minor joint separation >1/2"
