Pipes Inspected, Massillon Levee					
Size (Inches)	Material	Length (Feet)	Location					
18	RCP	103	West of RR with Flap Gate					
12	RCP?	175	Could not locate/unknown/does not exist					
42	RCP	95	Culvert through West Bank Levee opposite of Croose Avenue, 1000 ft					
			upstream of Cherry Rd.					
66	RCP	93	Culvert through East Bank Levee near control weir					
42	RCP	360	At inlet to siphon control weir					
			James Avenue Pump Station Gravity Outlet					
			Discharge from James Avenue Pump Station					
		100	Discharge from James Avenue Pump Station					
30	CIP	100	Discharge from James Avenue Pump Station					
			Federal Avenue Pump Station Outlet					
			Federal Avenue Pump Station Outlet					
			Discharge from Federal Avenue Pump Station					
		141	Discharge from Federal Avenue Pump Station					
30	CIP	141	Discharge from Federal Avenue Pump Station					
		120	Sippo Creek Pump Station					
			Discharge from Sippo Creek Pump Station

Army Corp of Engineers Rating Guidelines for Levee Inspection

HUNTINGTON DISTRICT

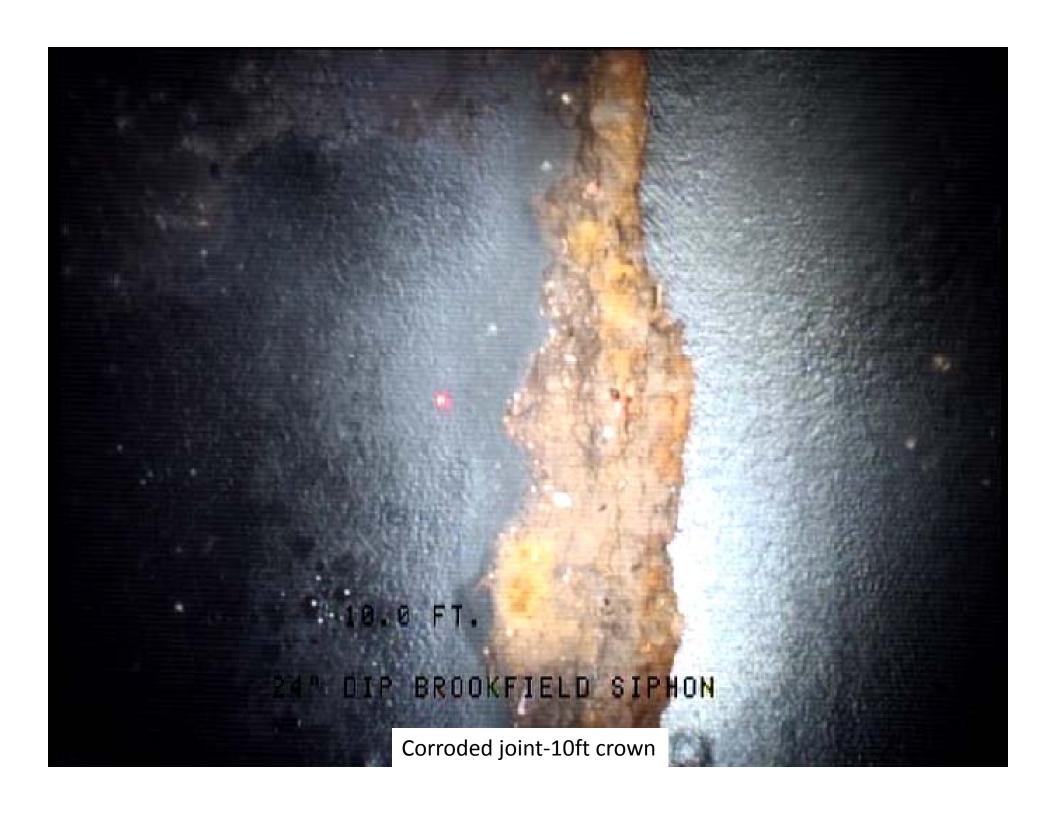
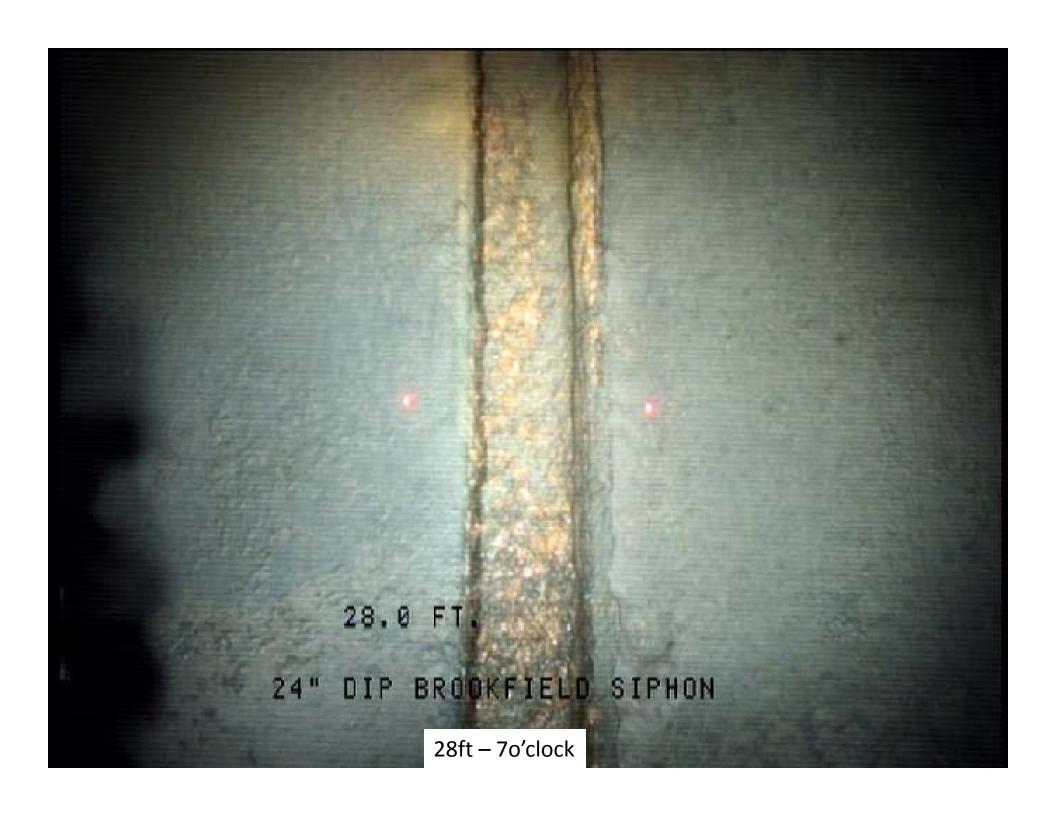
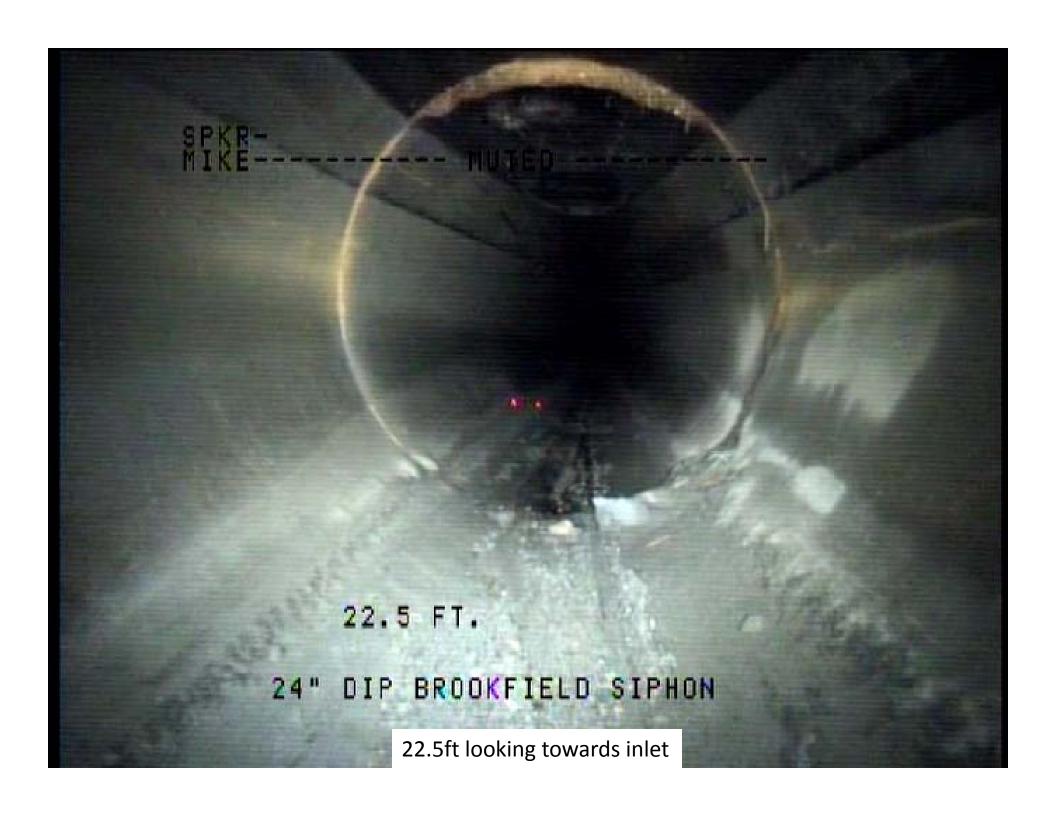
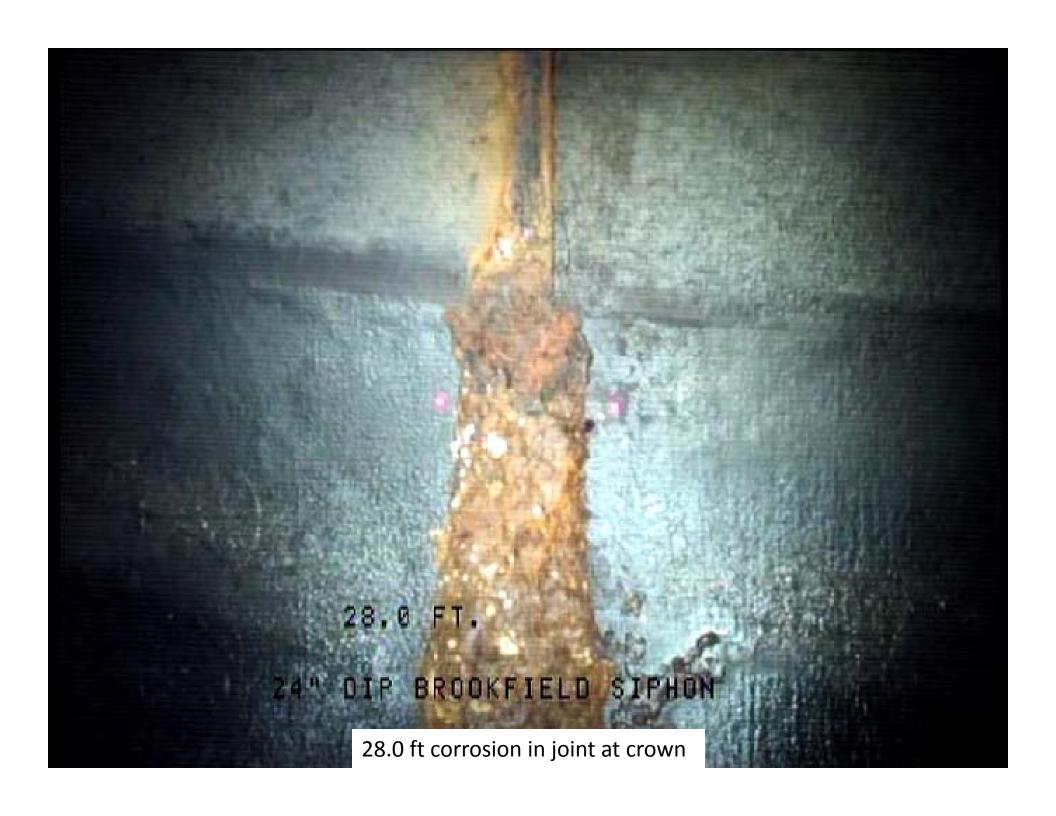
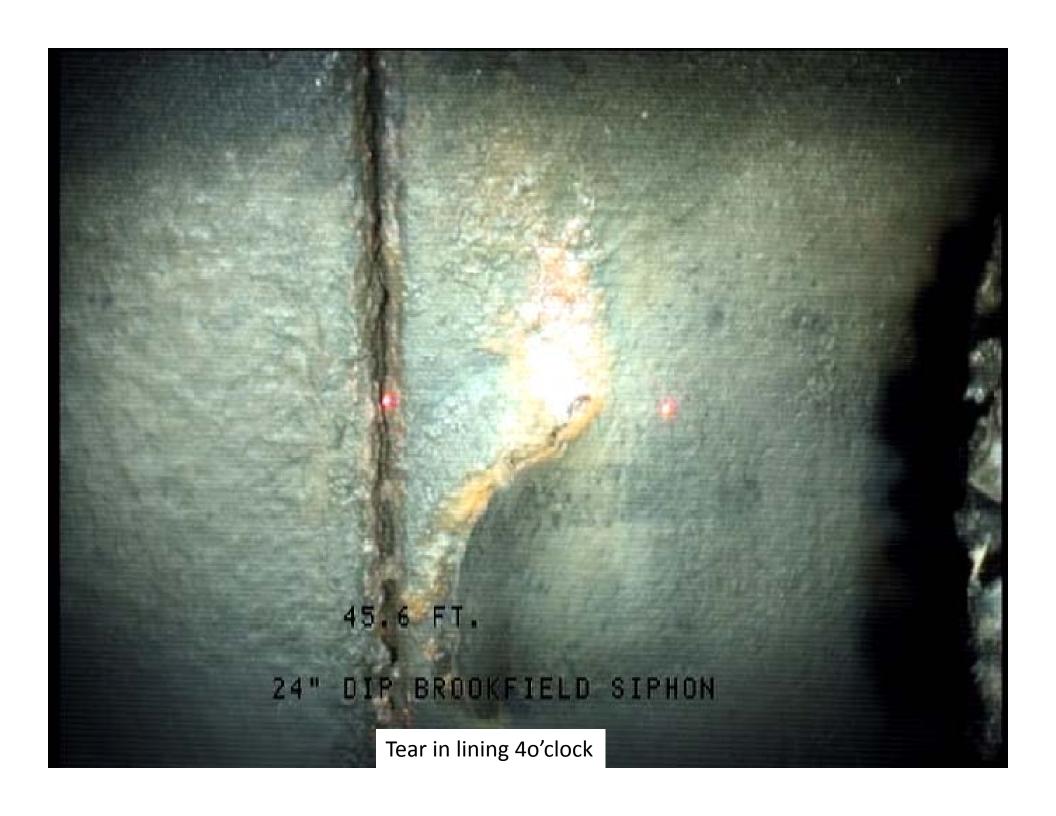
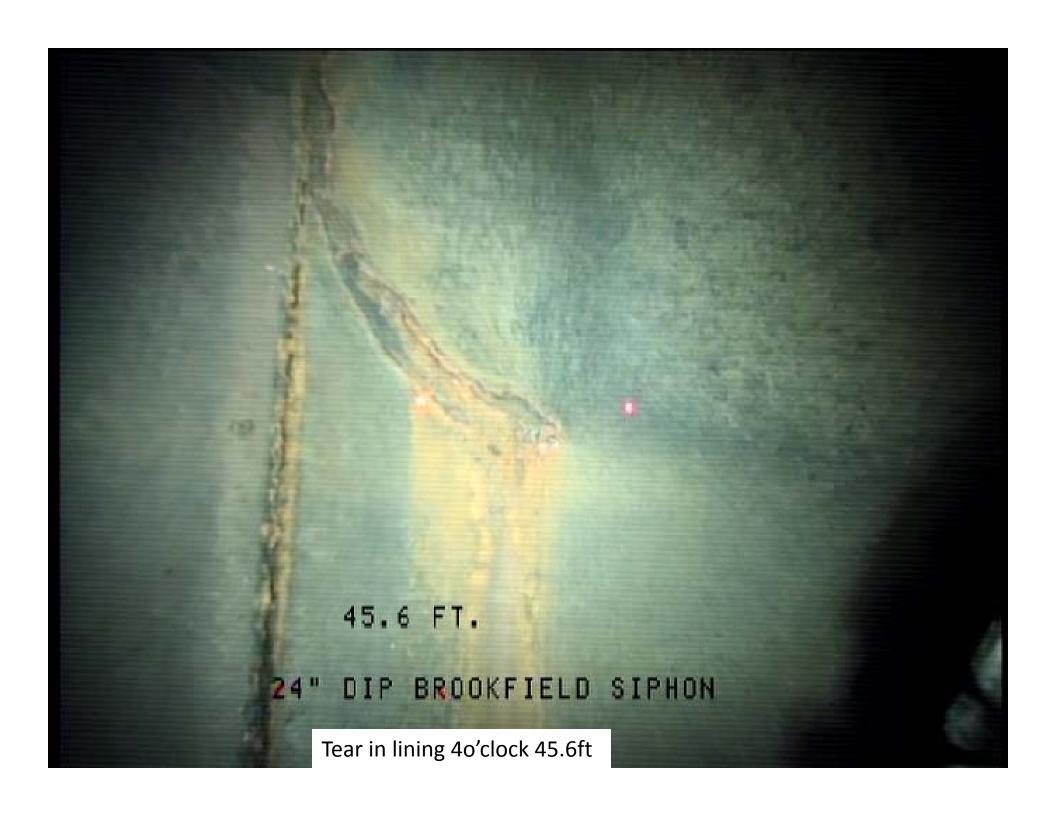
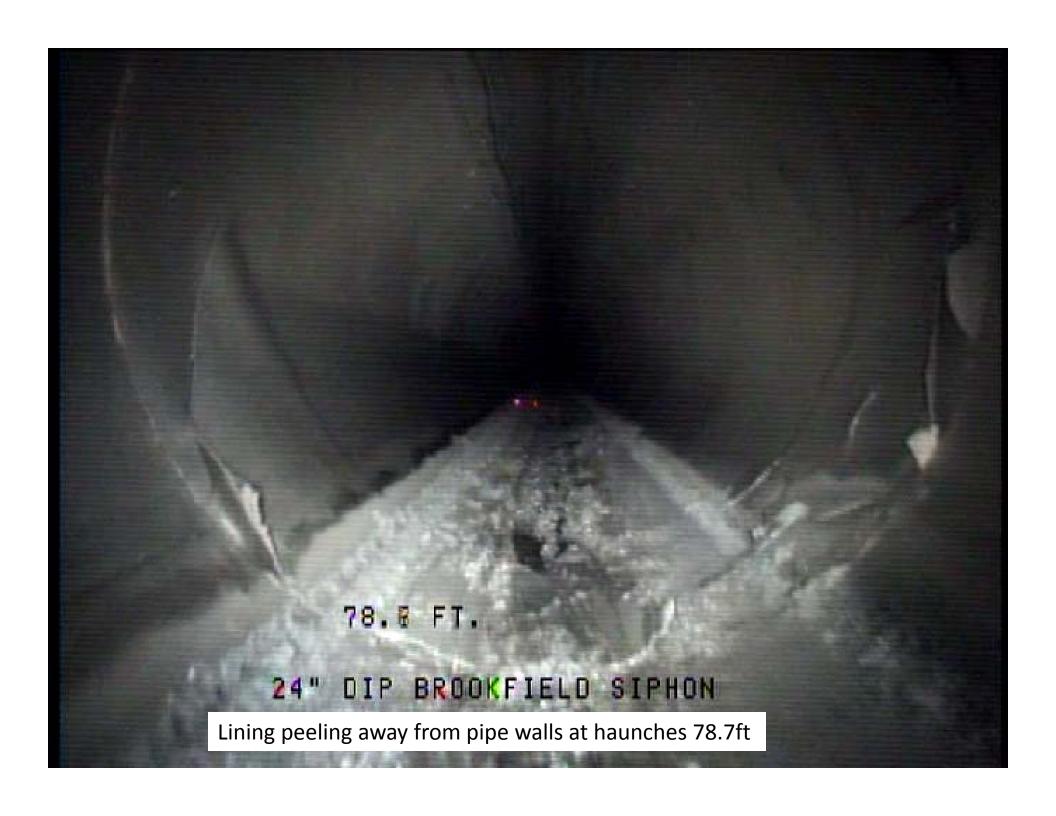
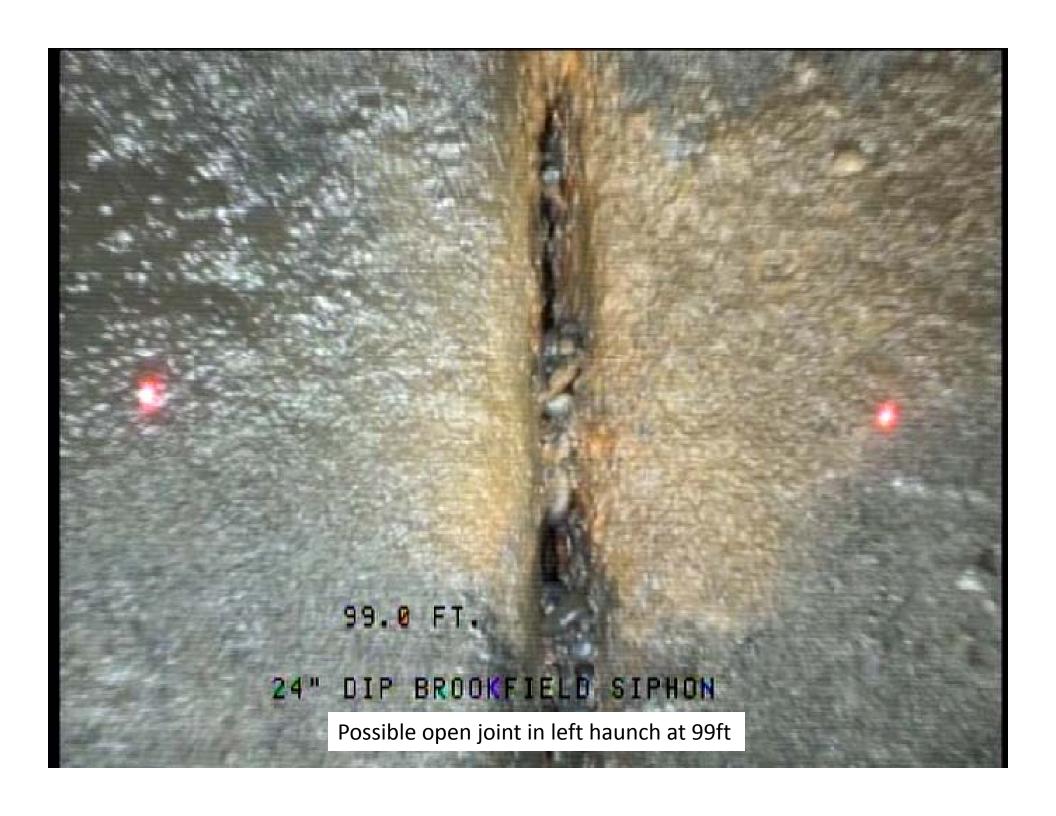
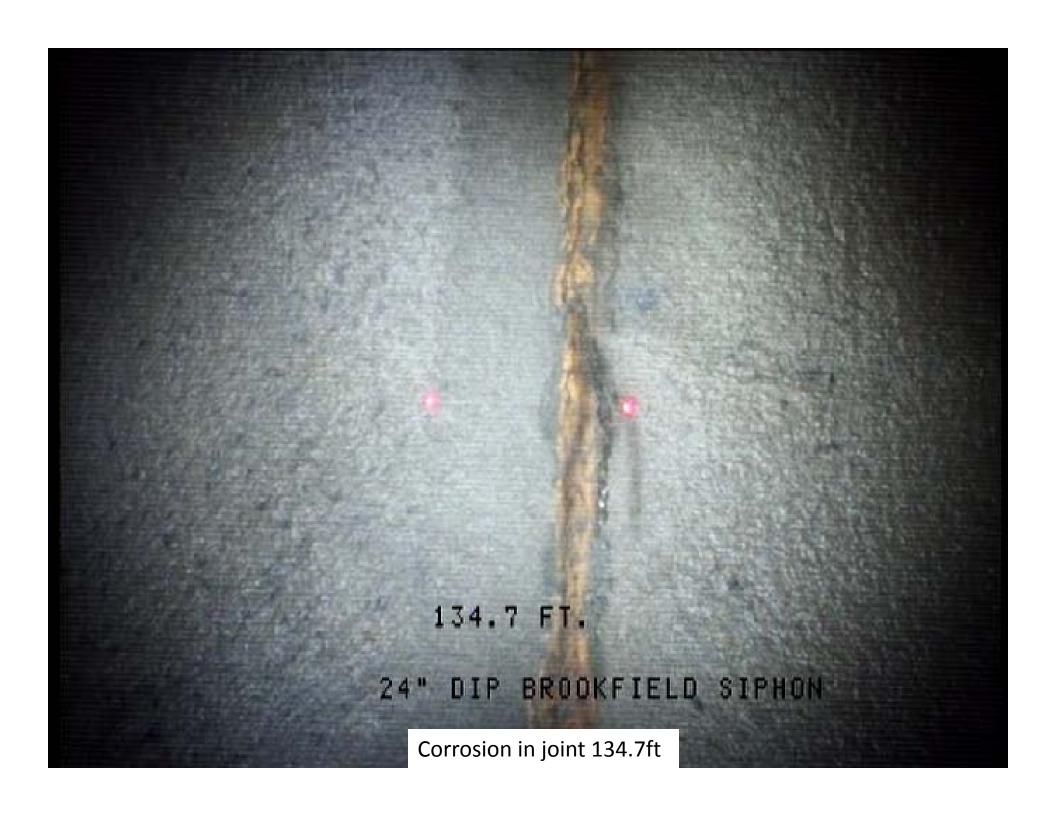
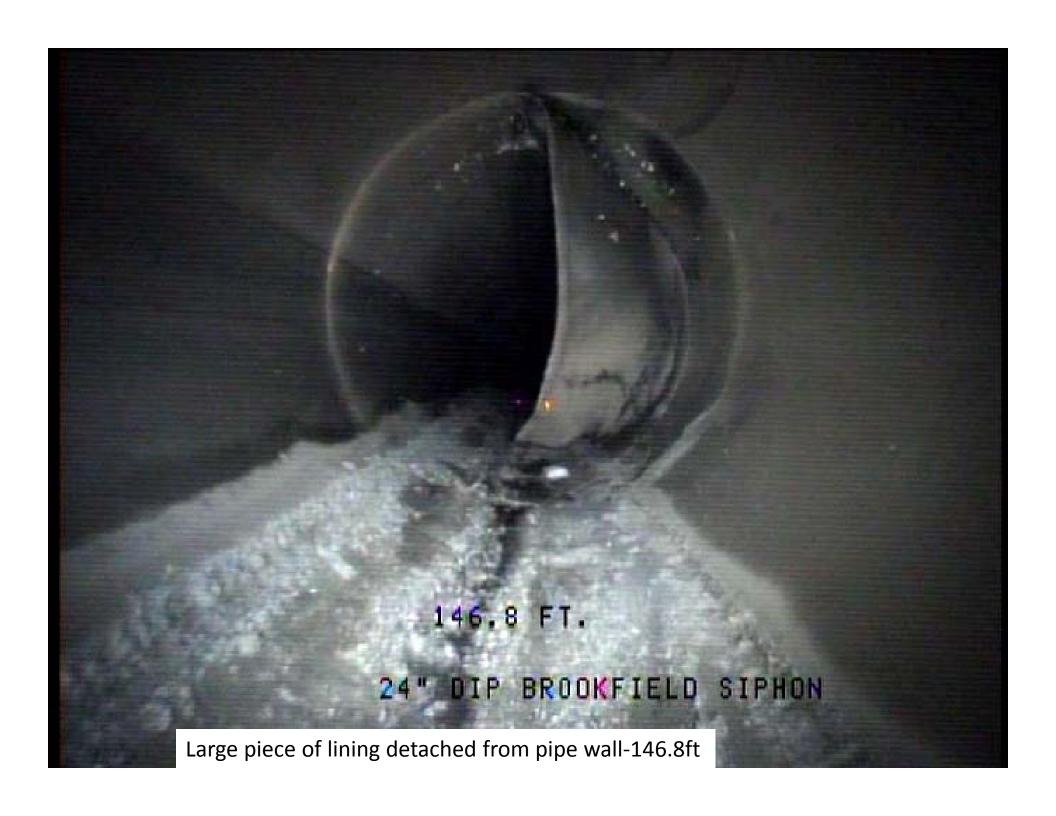
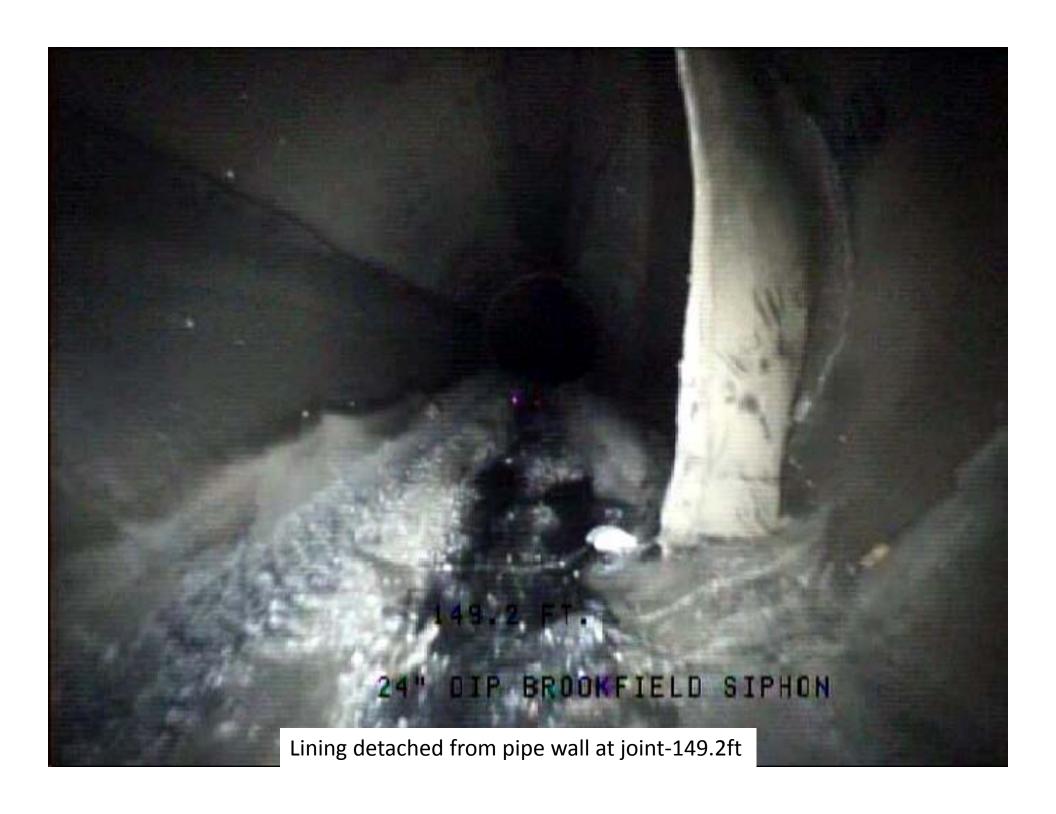
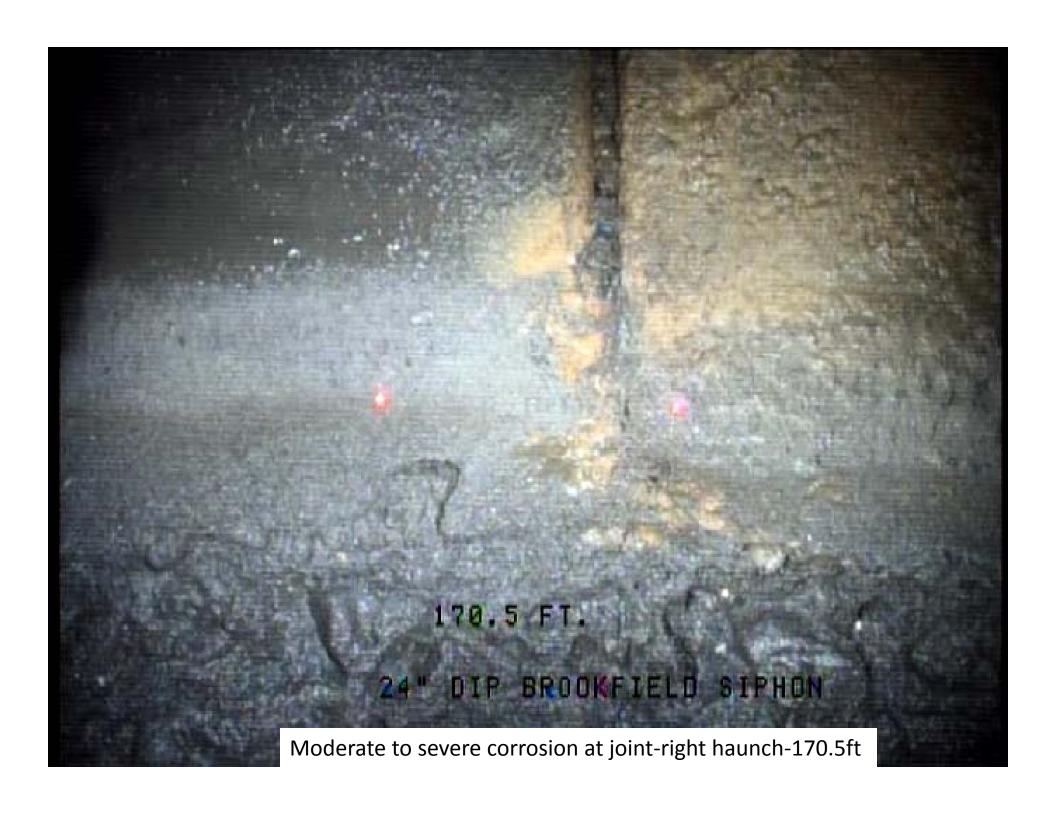
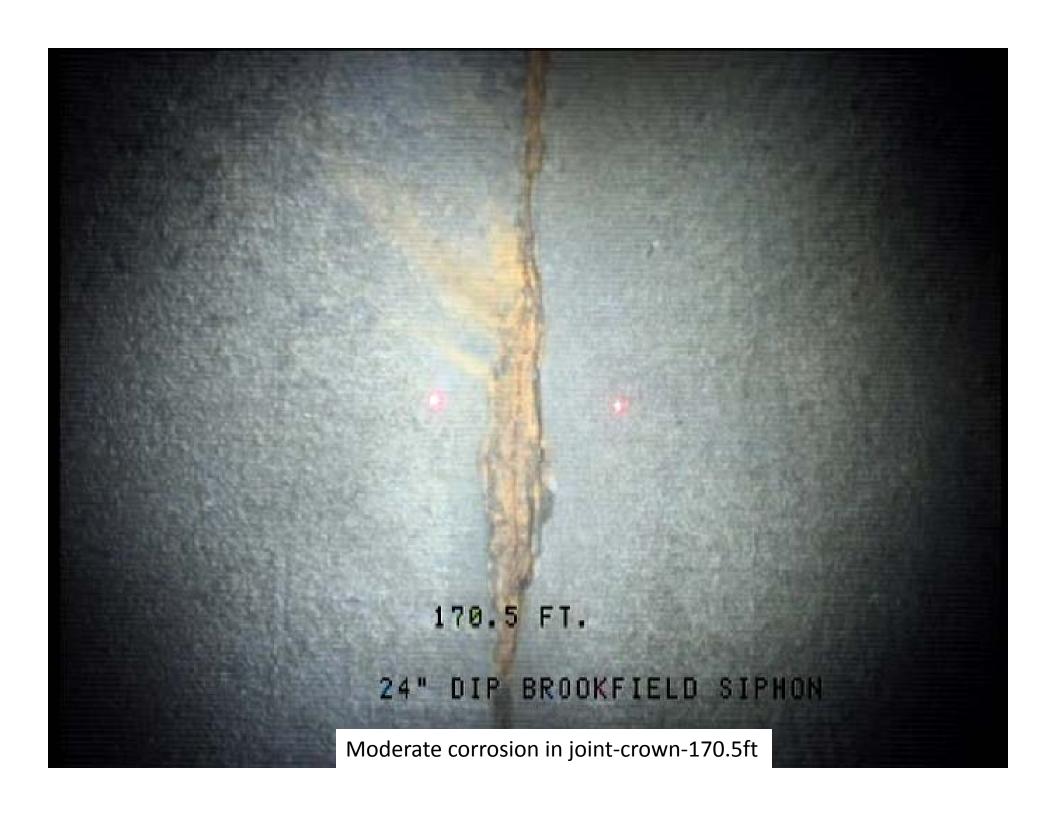
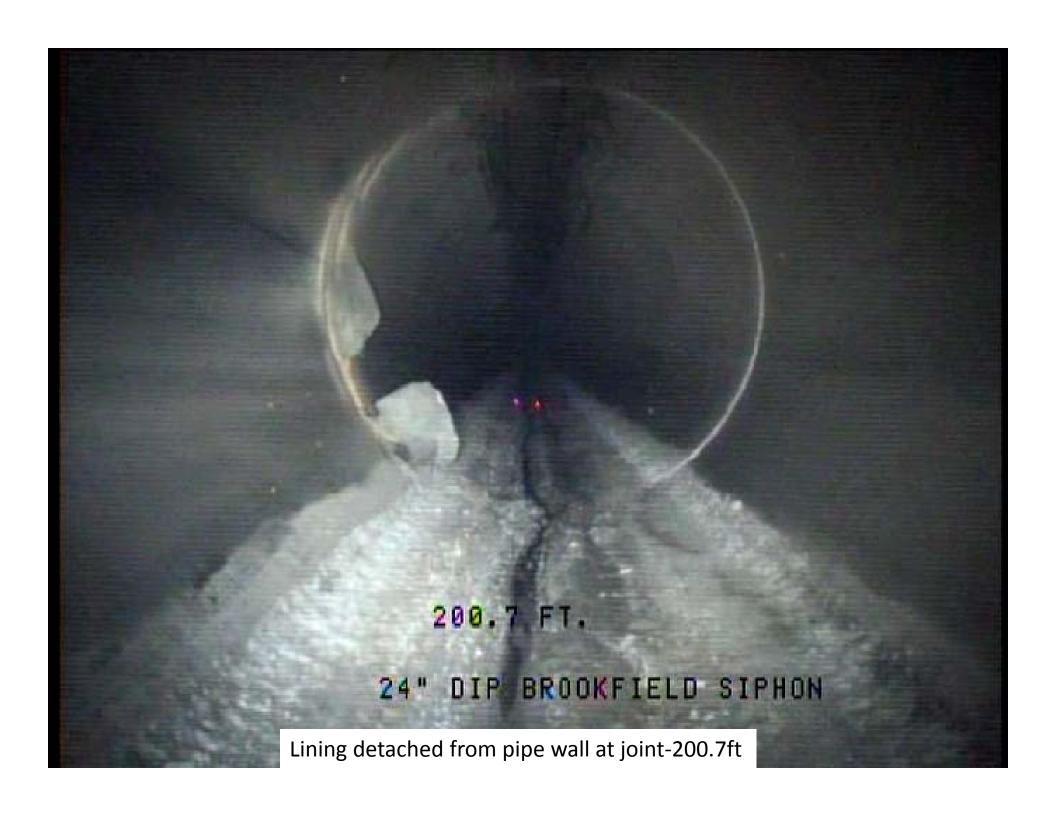
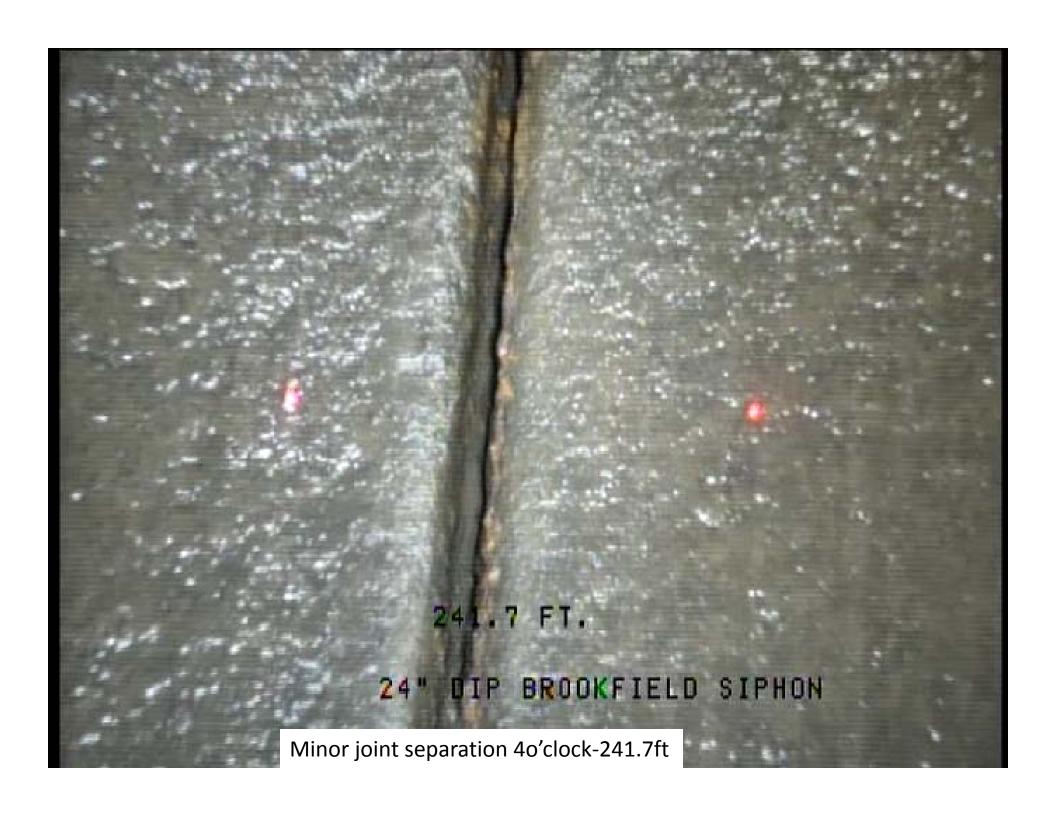
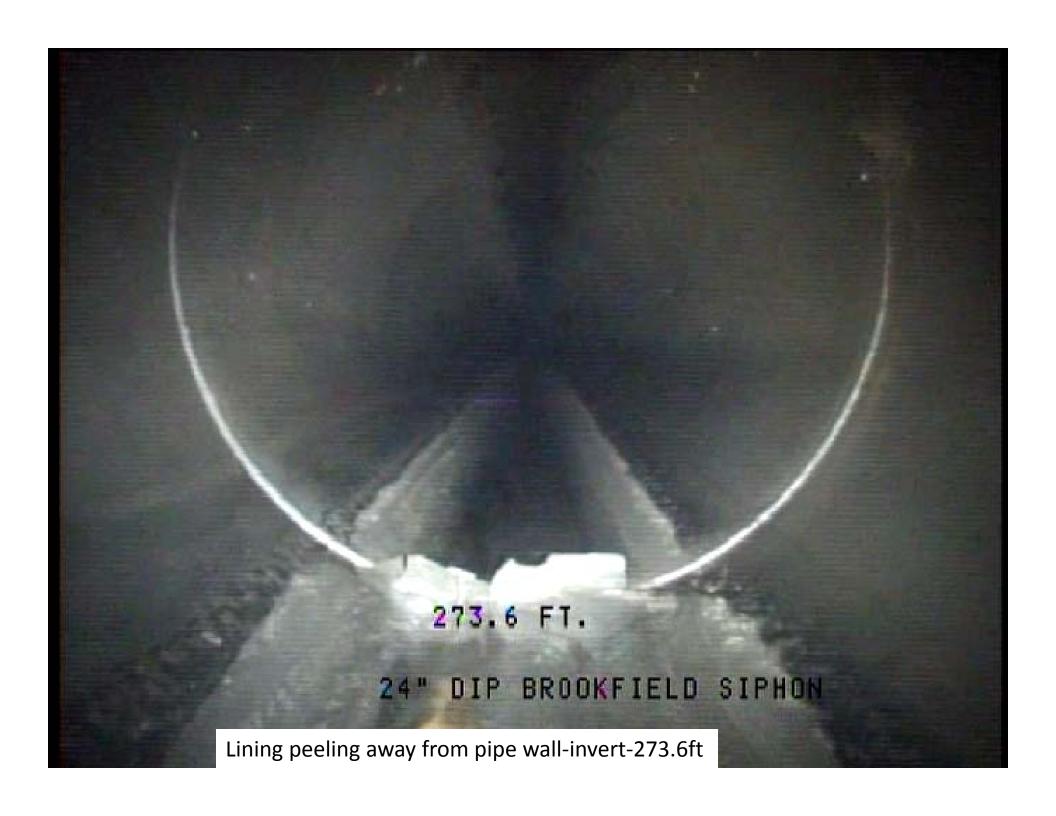
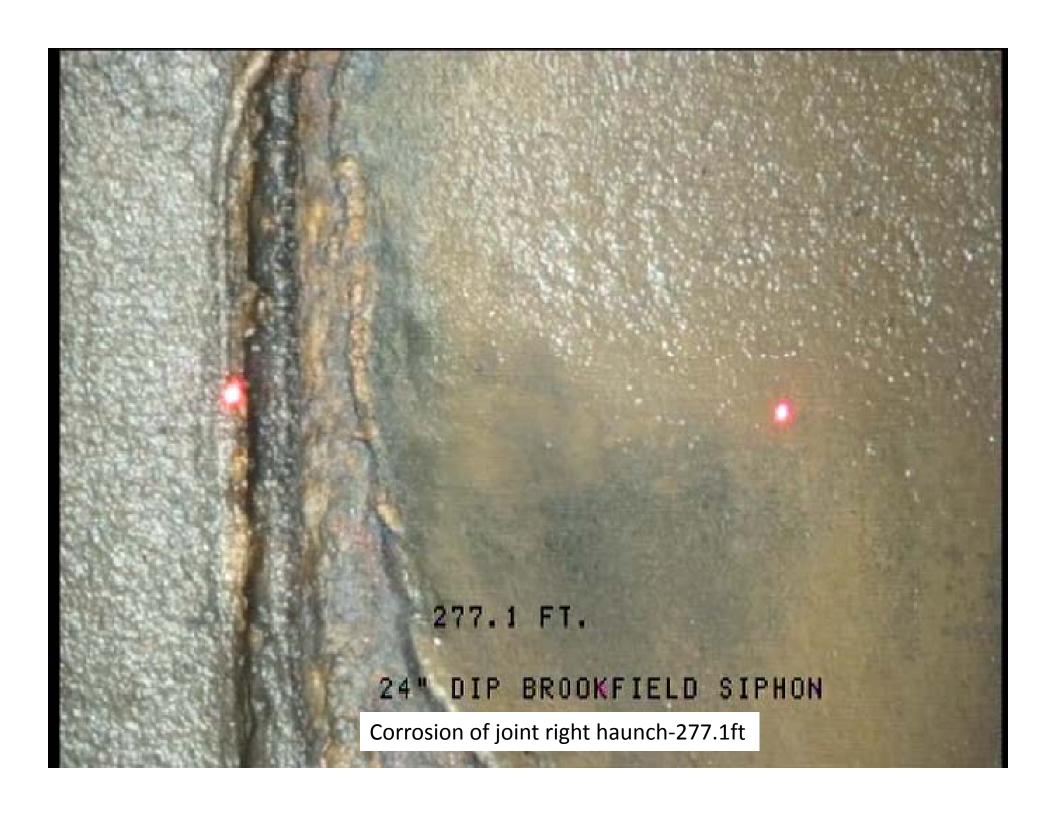
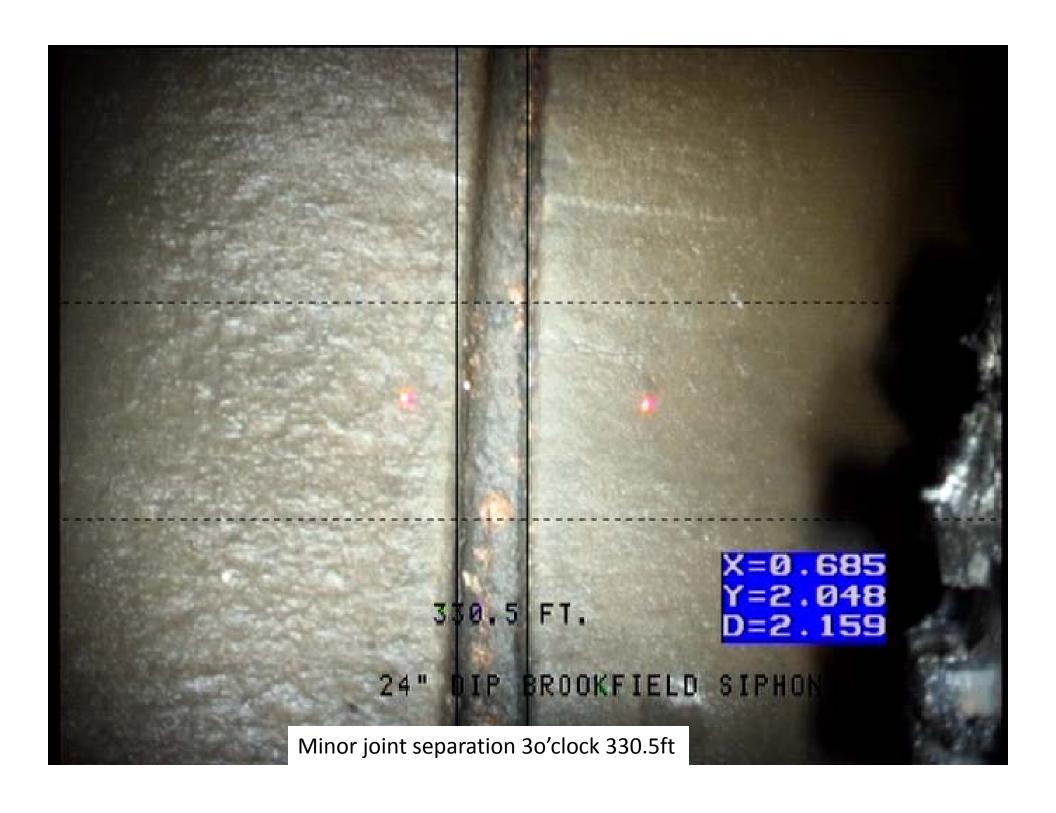
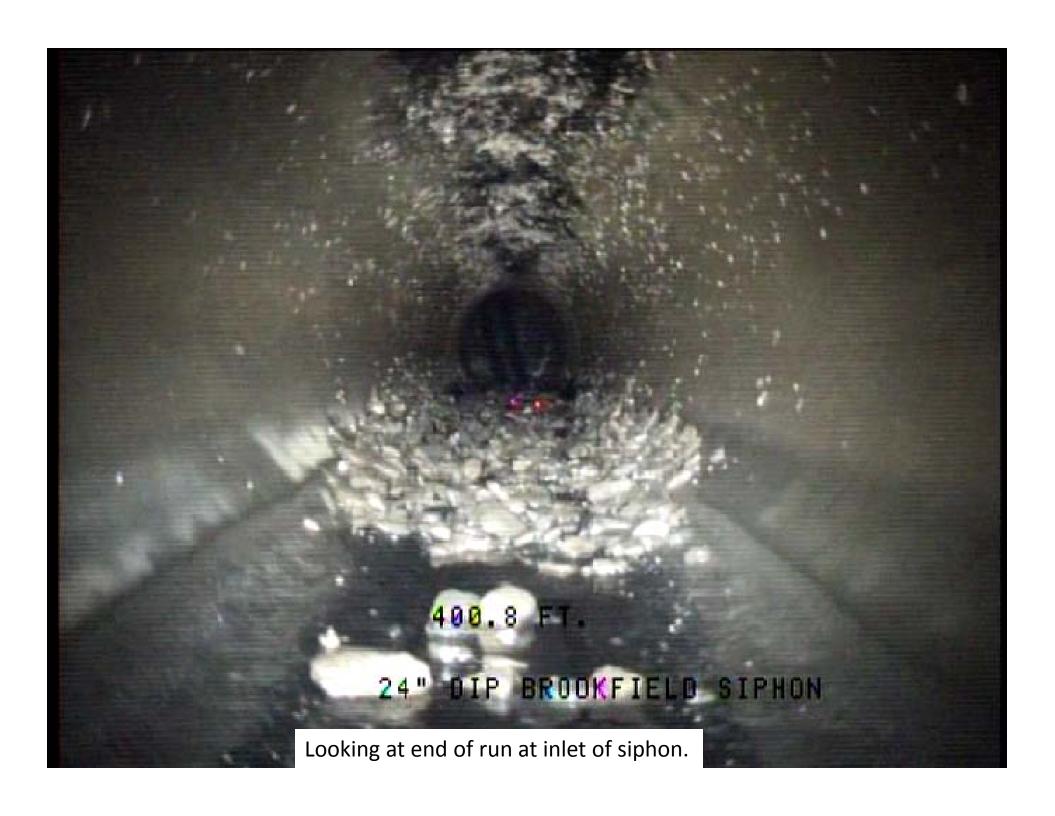
INSPECTION SETUP === N: PRO NO. W91237-09-P-0133 SIPHON *Pipe video inspected from outlet to inlet Brookfield Siphon-24" outlet

Brookfield Siphon 24"- Outlet			
Feet Observation/Defect			
10ft	Corroded joint at crown		
28ft	Approx. 1" joint separation at 7 o'clock, Corroded joint in crown		
45.6ft	Tear in lining at approx. 4o'clock		
78.7ft	Lining peeling away from pipe walls at haunches		
99ft	Rust coming from joint at crown		
134.7ft	Rusting of joint at crown		
146.8ft	Large piece of lining detached from pipe wall		
170.5ft	Minor joint corrosion at crown		
200.7ft	Lining peeling away from pipe wall along joint		
241.7ft	Minor joint separation at approx. 4 o'clock		
273.6ft	Lining peeling away from pipe walls at invert		
277.1ft	Corrosion of joint/ small tear in lining		
330.5ft	Minor joint separation >1/2"

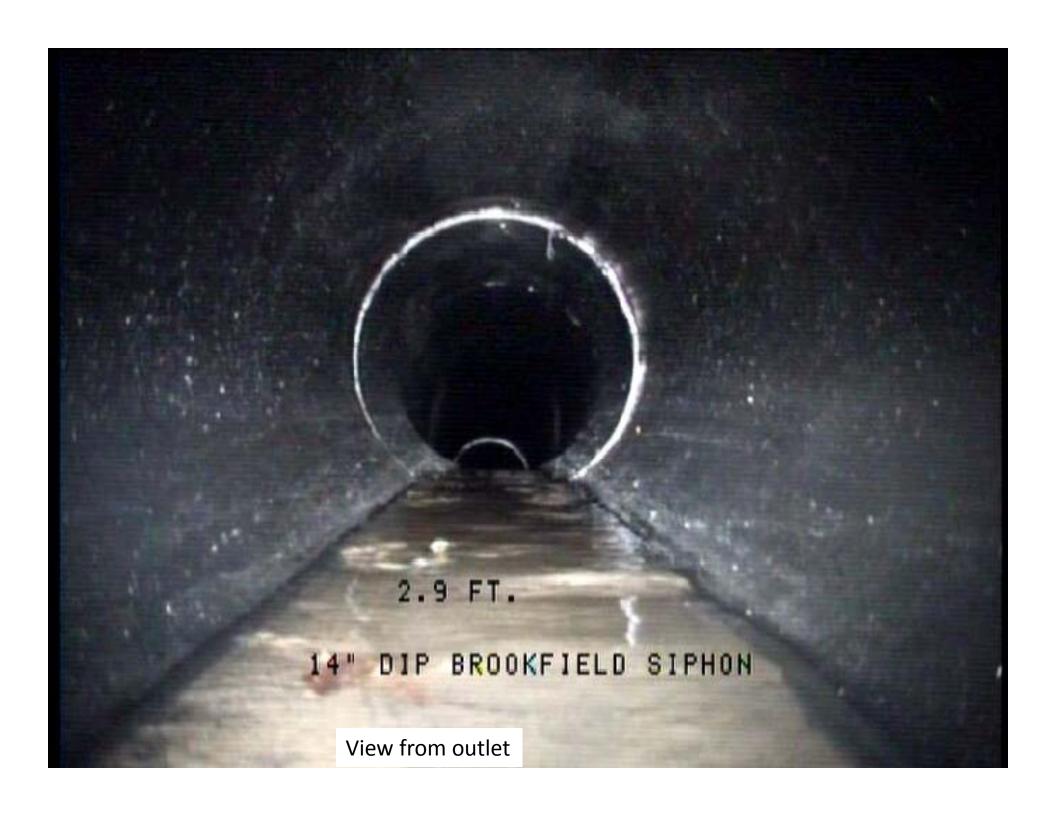
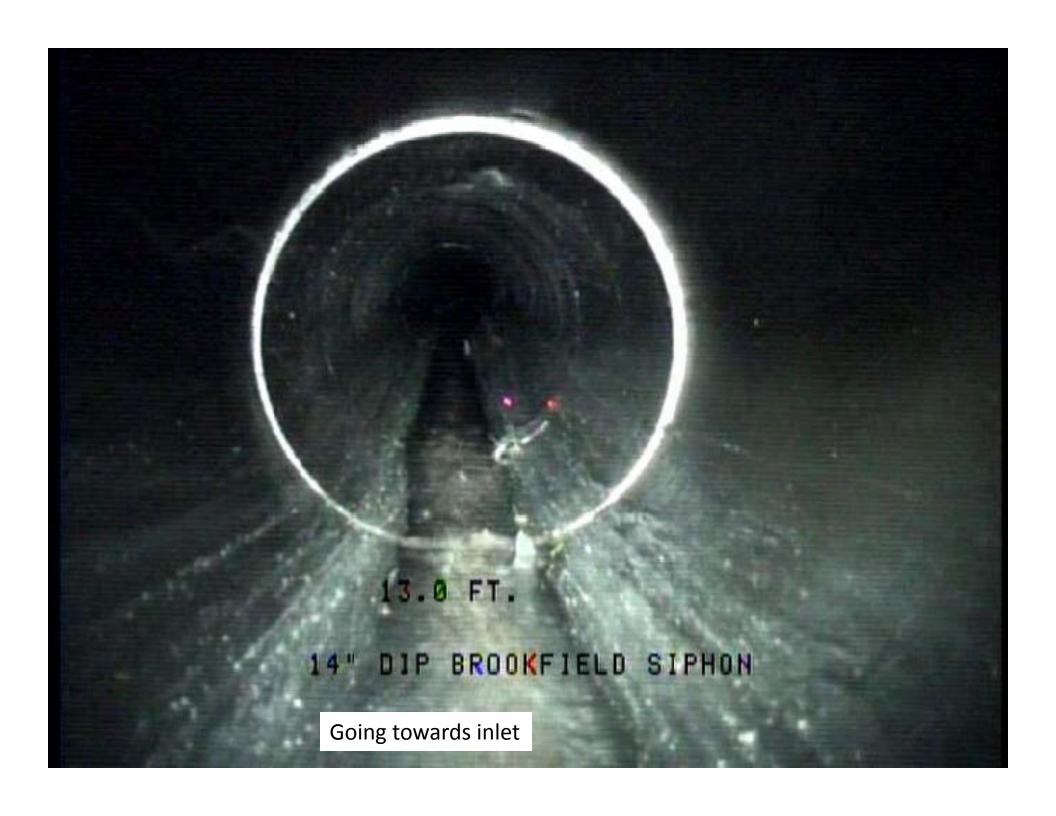
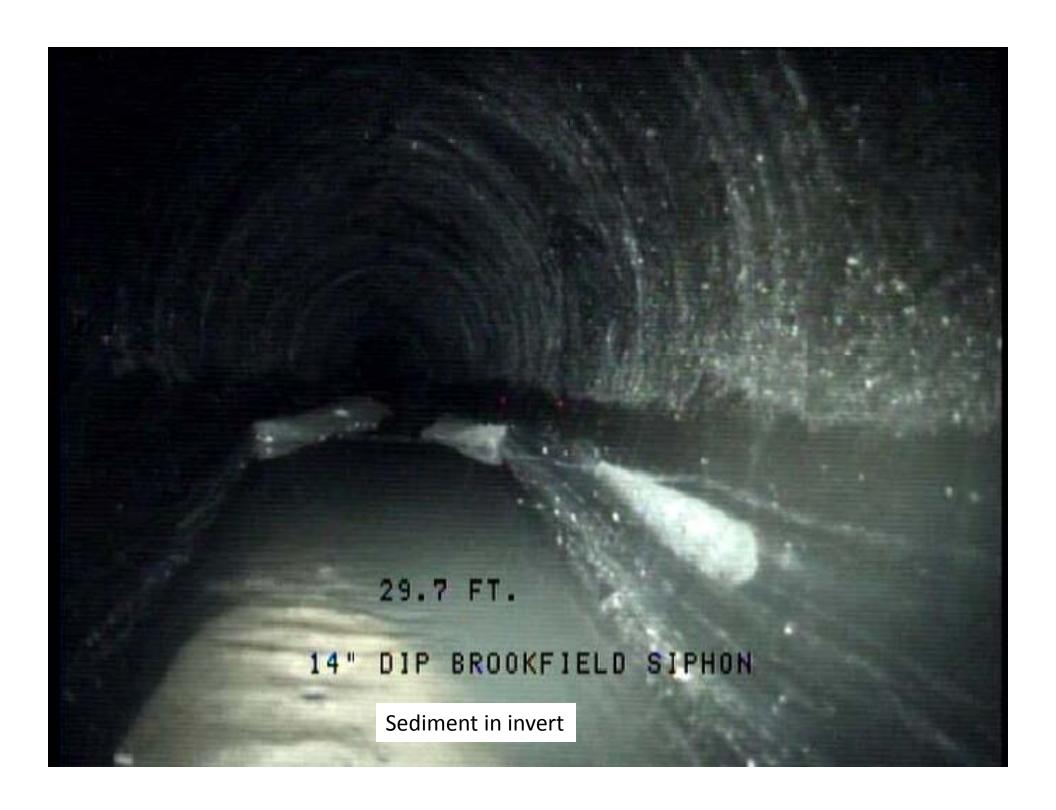
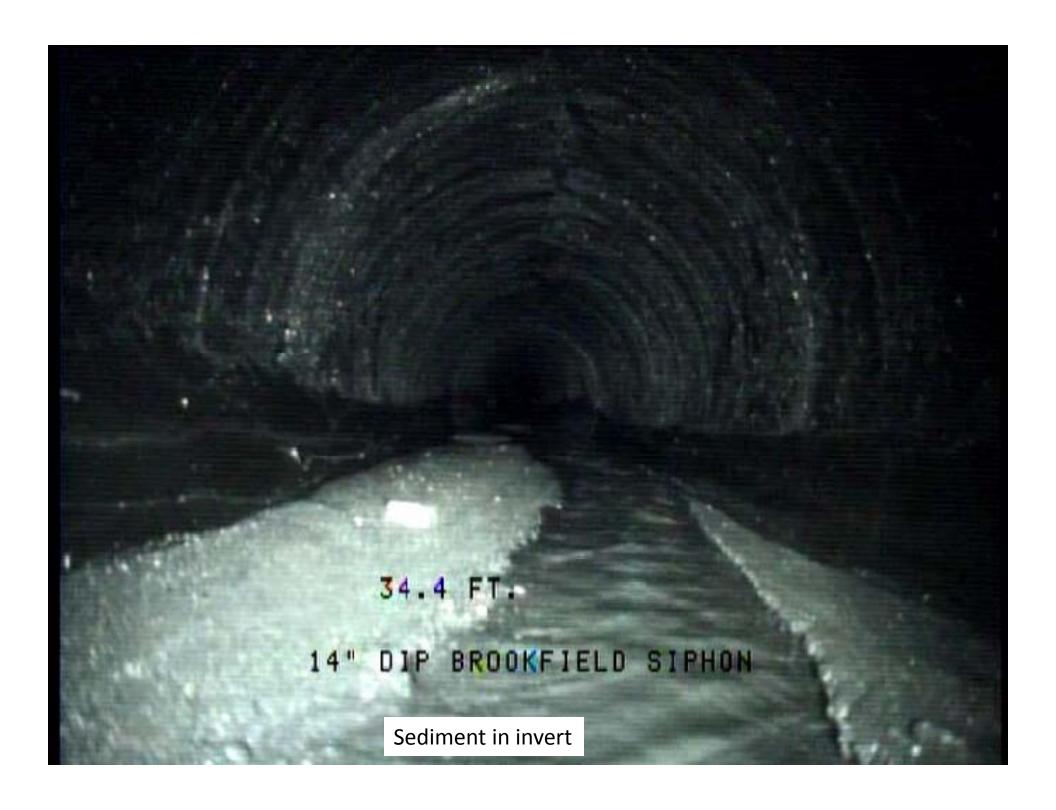
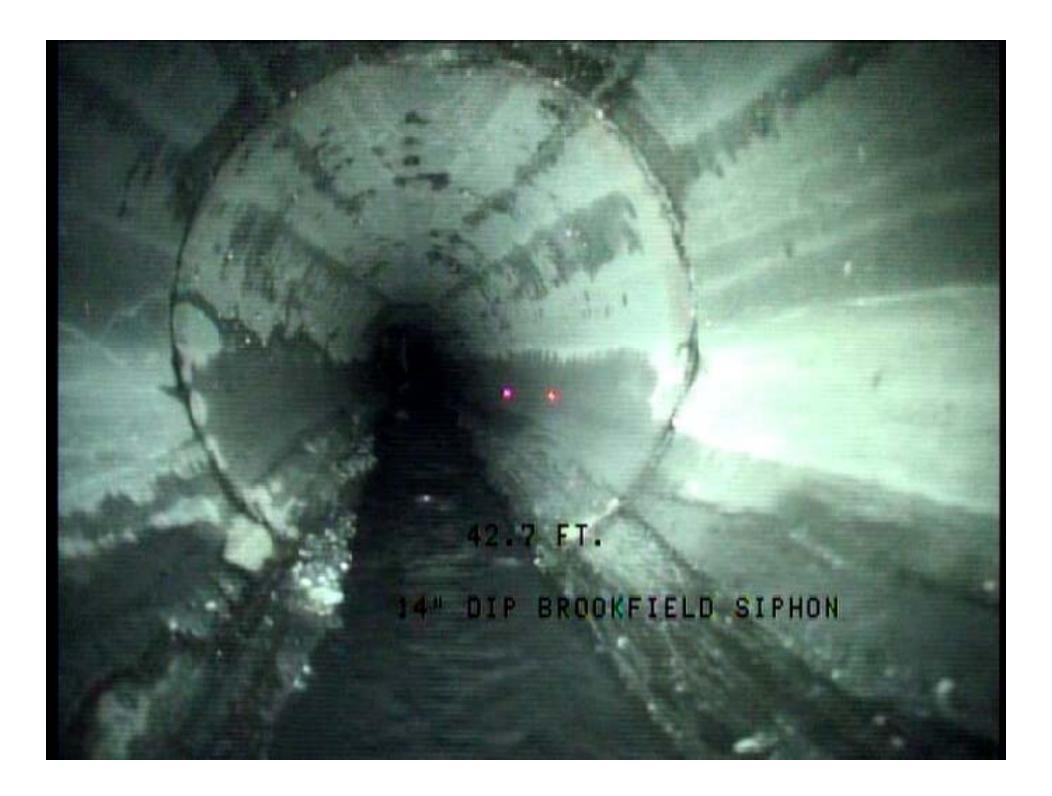
Massillon, Ohio Brookfield Sanitary Sewer Siphon Pipe #48, 14-inch DIP

OVERALL CONDITION: NASSCO Grade 3: Moderate defects that will continue to deteriorate

Brookfield Siphon 14" – Outlet		
Feet	Remarks/Defects	
58ft	Large sections of protective coating coming off	
75ft	Protective coating coming off	
78ft	Protective coating coming off	
93ft	Protective coating coming off	
93ft	Debris level to high to continue, inspection	
	discontinued.
