Pipes Inspected, Massillon Levee					
Size (Inches)	Material	Length (Feet)	Location					
18	RCP	103	West of RR with Flap Gate					
12	RCP?	175	Could not locate/unknown/does not exist					
42	RCP	95	Culvert through West Bank Levee opposite of Croose Avenue, 1000 ft					
			upstream of Cherry Rd.					
66	RCP	93	Culvert through East Bank Levee near control weir					
42	RCP	360	At inlet to siphon control weir					
			James Avenue Pump Station Gravity Outlet					
			Discharge from James Avenue Pump Station					
		100	Discharge from James Avenue Pump Station					
30	CIP	100	Discharge from James Avenue Pump Station					
			Federal Avenue Pump Station Outlet					
			Federal Avenue Pump Station Outlet					
			Discharge from Federal Avenue Pump Station					
		141	Discharge from Federal Avenue Pump Station					
30	CIP	141	Discharge from Federal Avenue Pump Station					
		120	Sippo Creek Pump Station					
			Discharge from Sippo Creek Pump Station

Army Corp of Engineers Rating Guidelines for Levee Inspection

HUNTINGTON DISTRICT

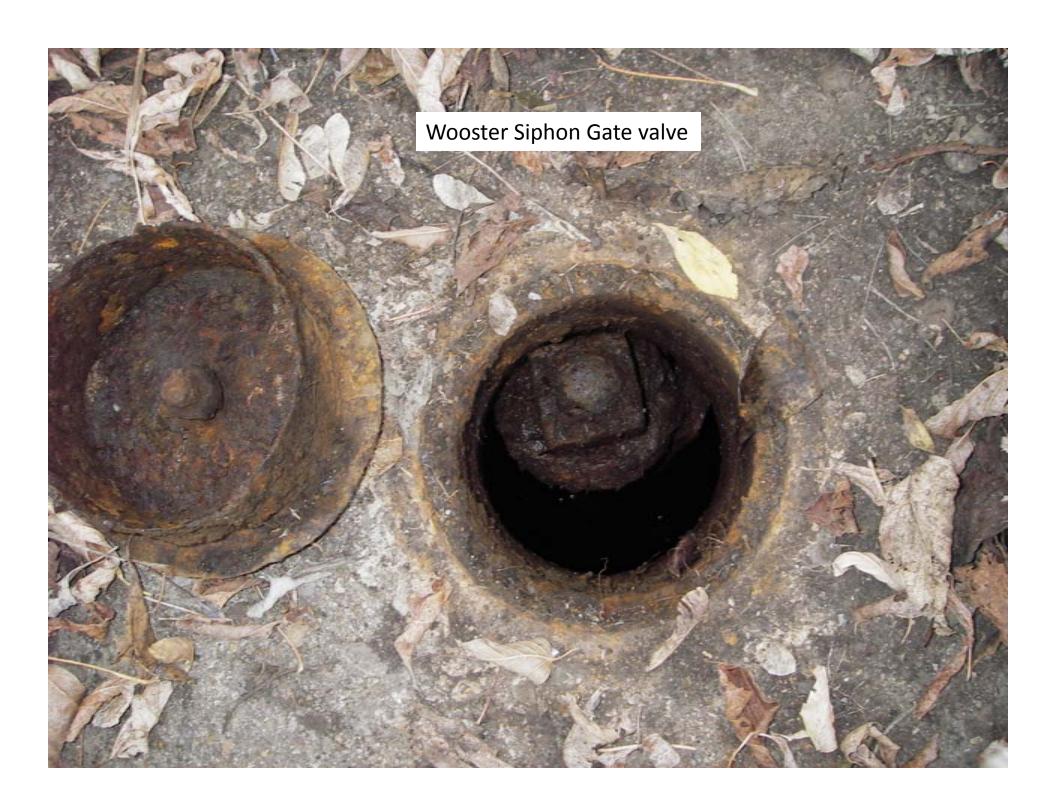
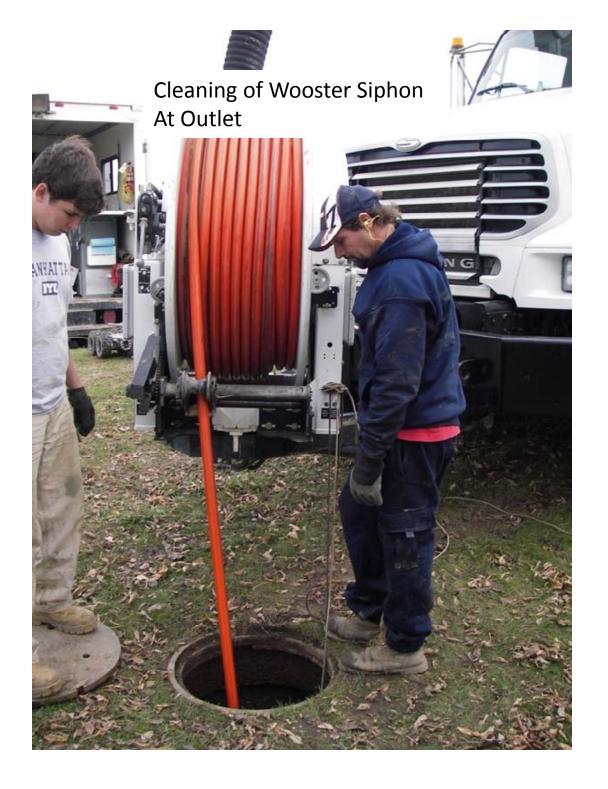
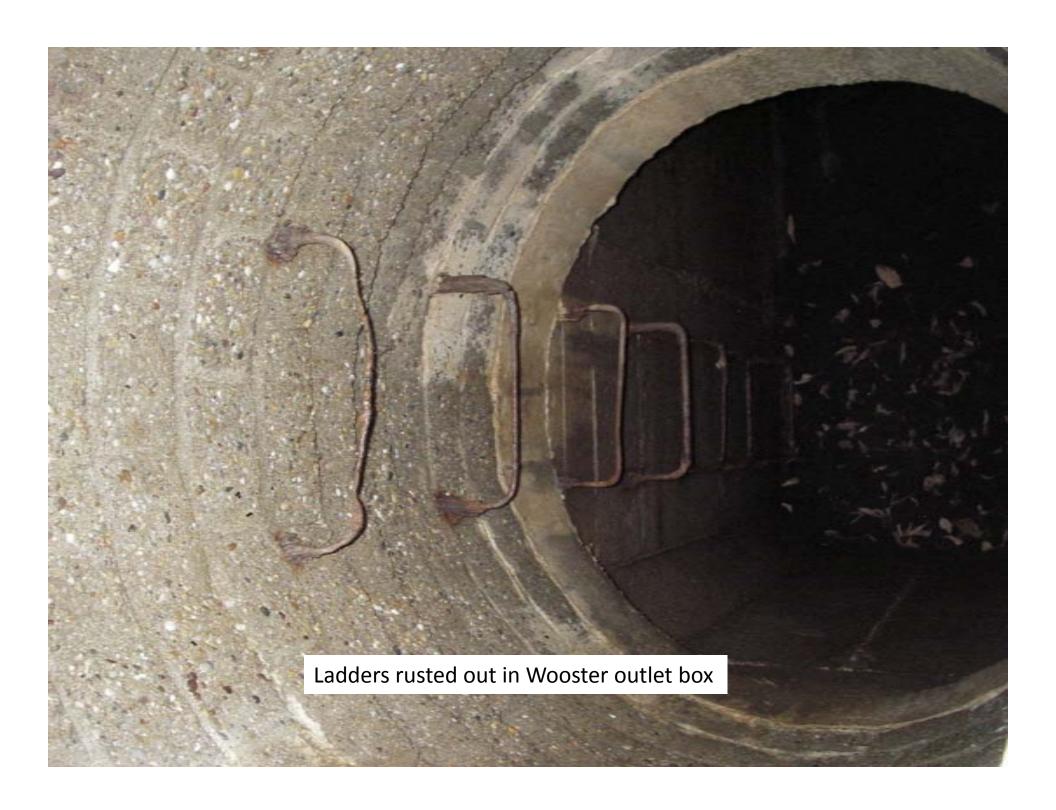
Massillon, Ohio Wooster Sanitary Sewer Siphons Pipe #50, 18" DIP

OVERALL CONDITION: NASSCO Grade 4: Severe defects that will become grade 5 in the near

GENERAL INSPECTION FINDING: Pipe is severely corroded above the waterline. Gate valve severely corroded. Was very difficult to move.

Wooster Siphon 18"- Outlet			
Feet	Observation/Defect		
2.0ft	Broken bell at crown		
3.5ft Severely corroded out gate valve			
3.5ft-108ft	Pipe above water line is severely corroded		
7.5ft Joint separation 1.75-inches			
20.0ft Joint separation approximately 1.75-inches			
108ft	Vertical offset at joint in crown viewable from 108		
	ft.		
108ft	Inspection discontinued

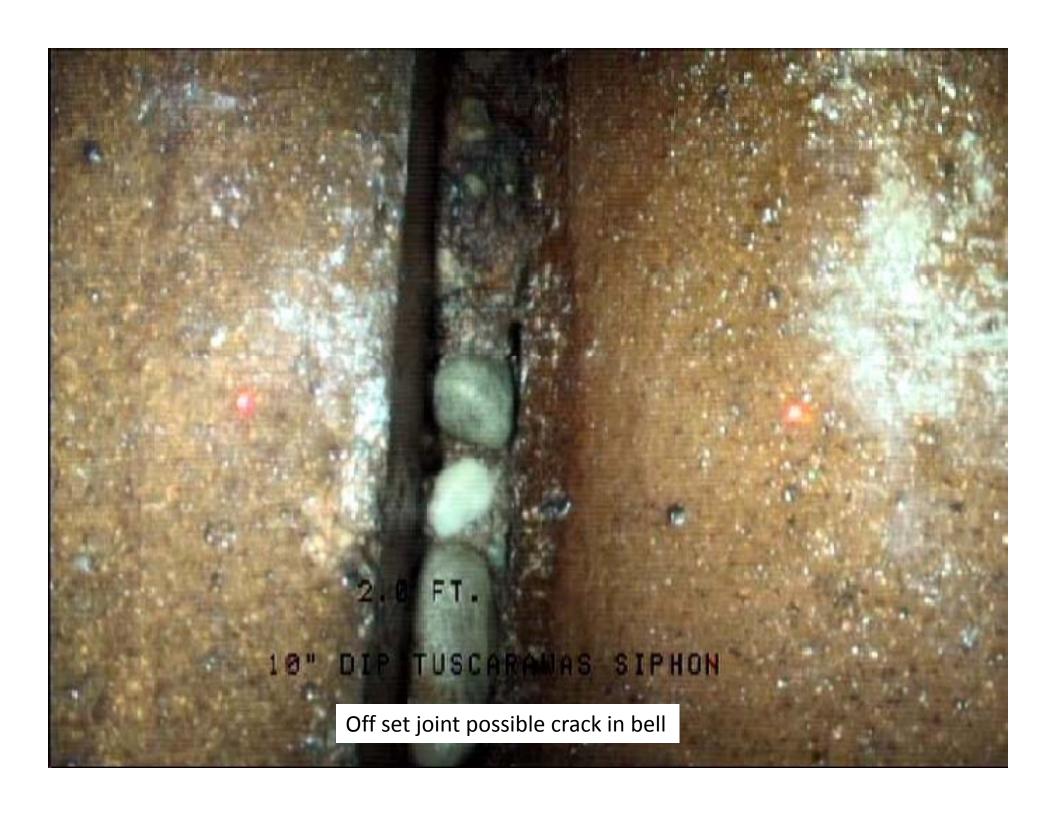
Tuscarawas Siphon Pipe #54 inlet

Siphon Pipe No. 54					
Feet	Observation/Defect				
2.0	Joint offset, possible crack in bell				
13.6	Several offset joints visible down grade				
15.0	Joint separation 0.91-inches				
18.3	Joint separation 1.26-inches				
18.3	Several offset joints visible down grade				
19.7	Offset joint in invert				
24.0	Pipe bends to the left/down river				
32.0	Grade begins to flatten out				
33.1	End inspection due to high water
