**DEPARTMENT OF THE ARMY**  
HUNTINGTON DISTRICT, CORPS OF ENGINEERS  
502 EIGHTH STREET  
HUNTINGTON, WV 25701

A routine continuing eligibility inspection of the Massillon Local Flood Protection Project was conducted on November 2-3, 2016, by Mr. Jon Samsa of your organization and Mr. Charles Barry and Mr. David Humphreys of the Huntington District.

## Flood Damage Reduction Segment / System Inspection Report

**Flood Damage Reduction Segment / System  
Inspection Report  
Massillon, OH, LPP, (East) (MALE)**

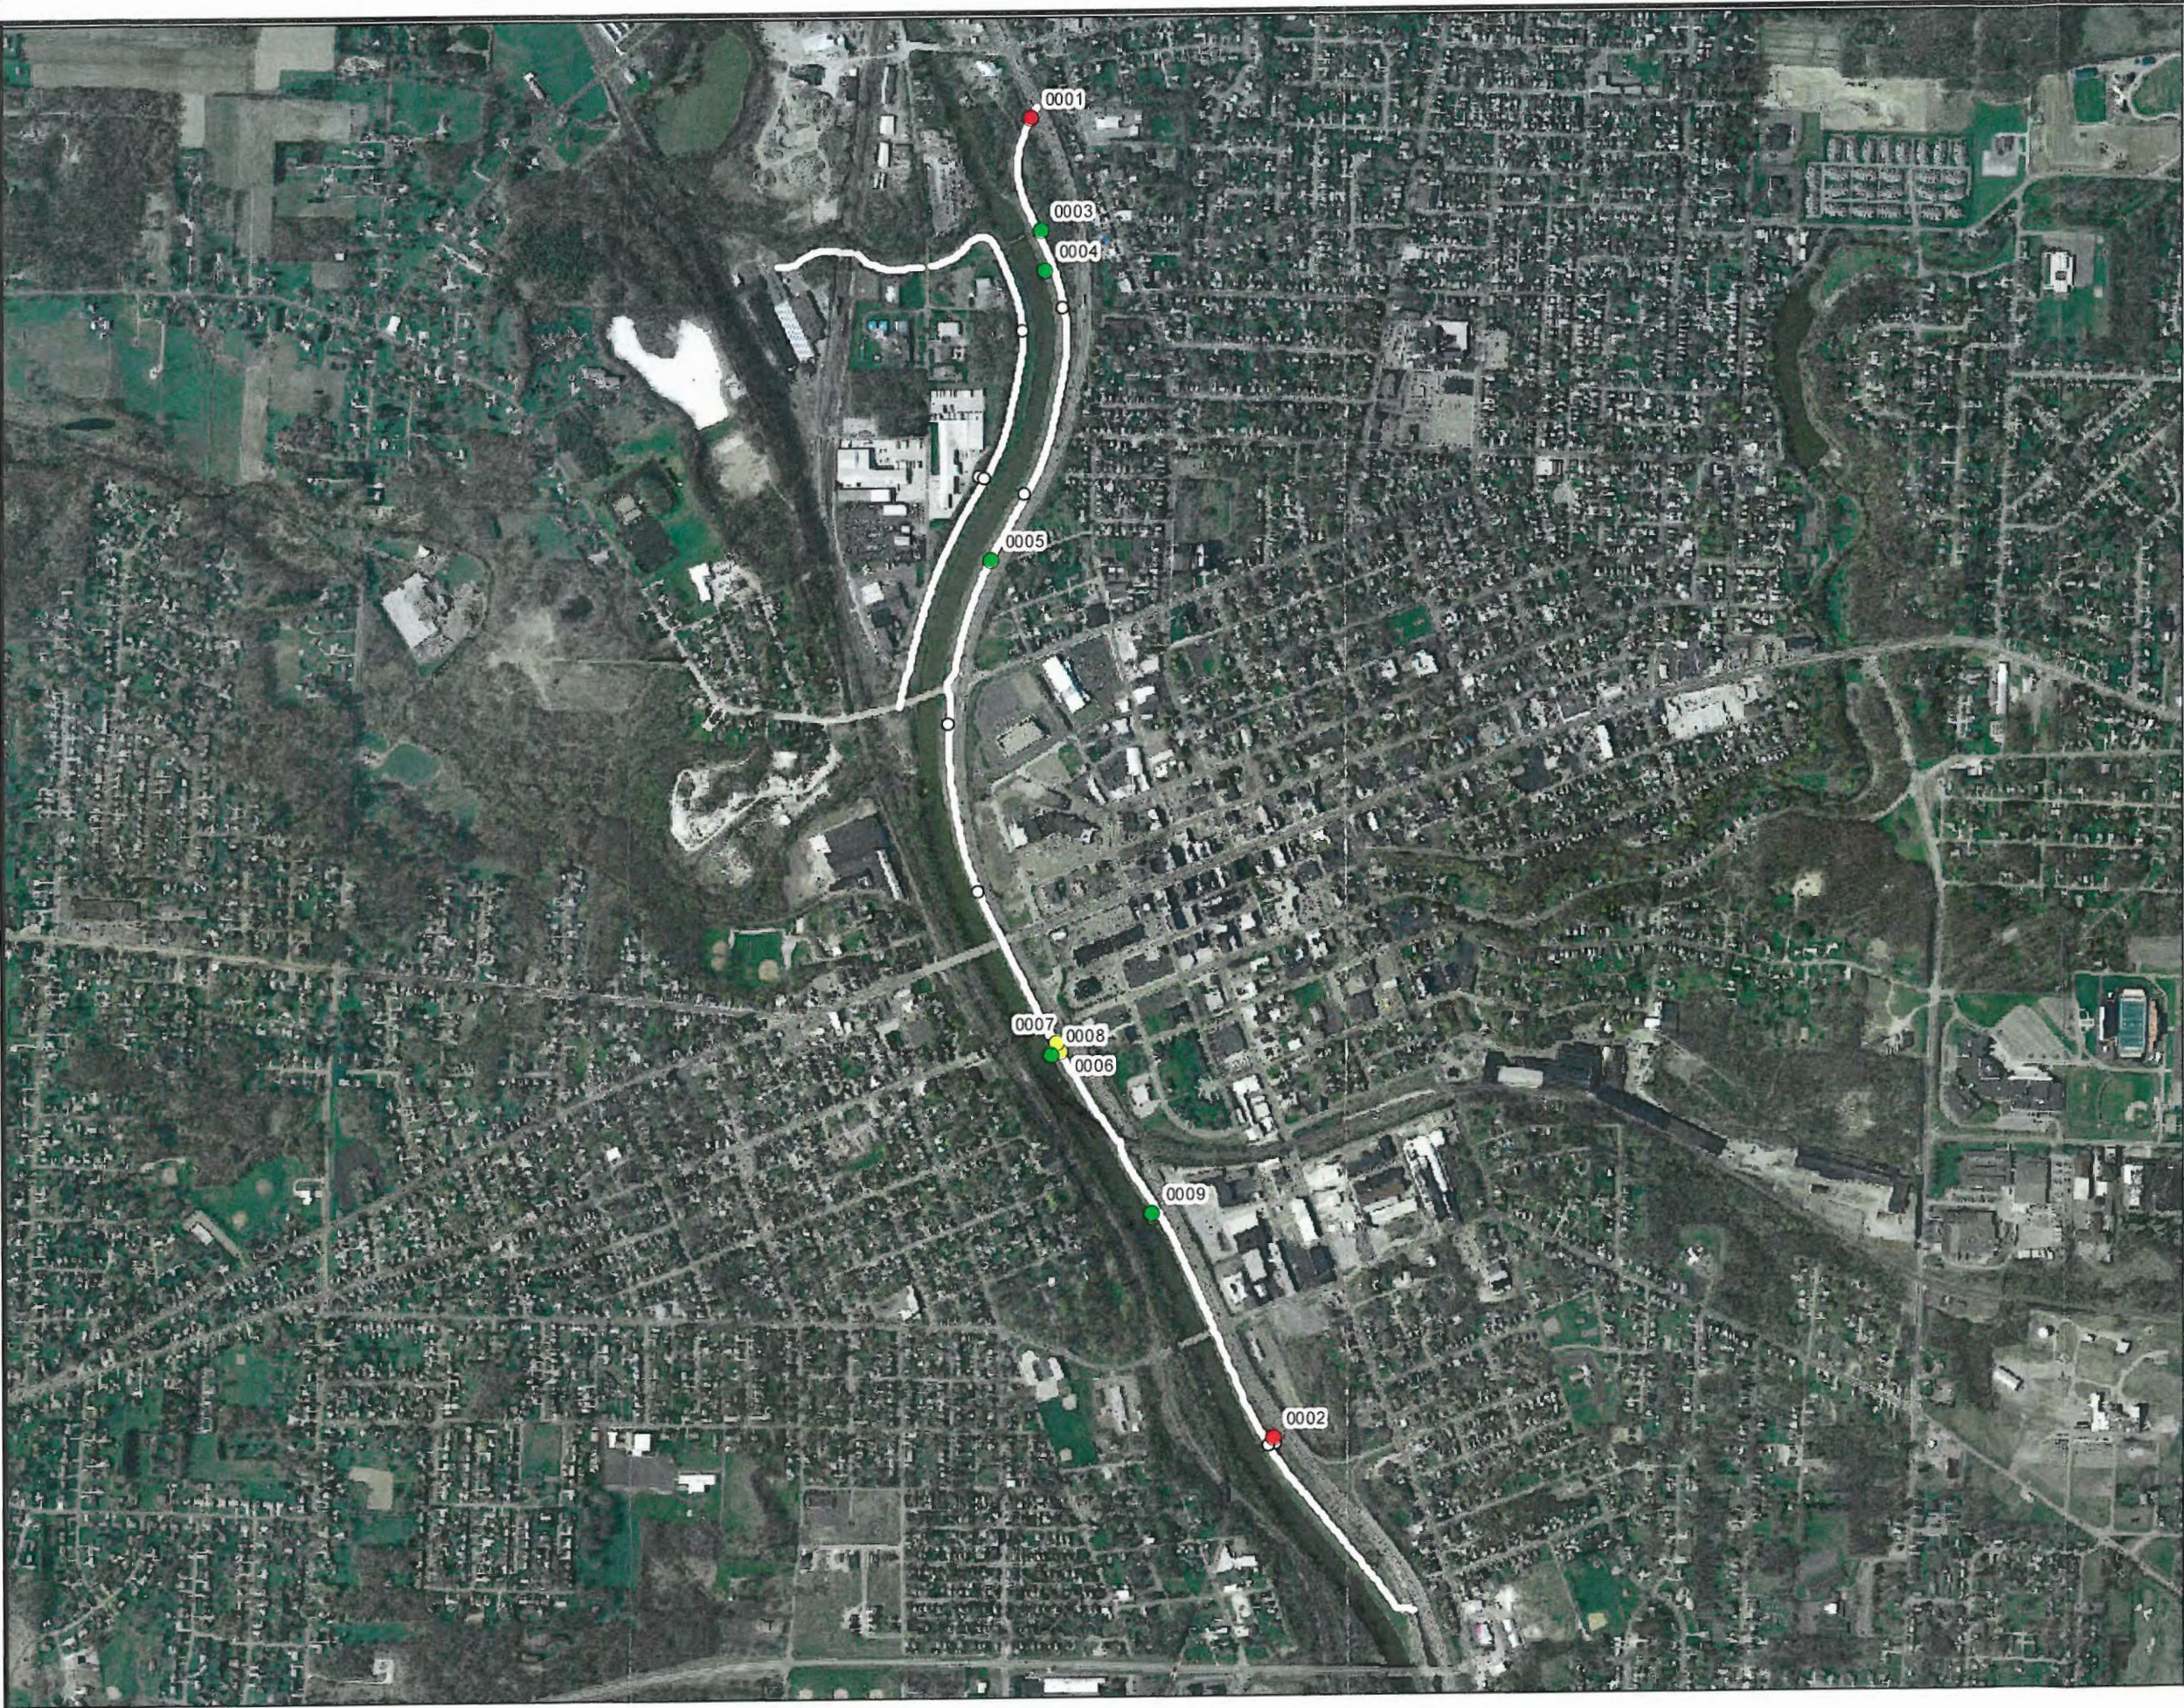
# Levee Inspection Map

| ID | Rating | Item | Remarks |
|---|---|---|---|
| 008 | A | 11. Culverts/ Discharge Pipes (This item includes both concrete and corrugated metal pipes.) | Sippo Pressure conduit inspected by city staff using visual methods in August 2015. |
| 009 | A | 11. Culverts/ Discharge Pipes (This item includes both concrete and corrugated metal pipes.) | Whetmore Avenue Pressure conduit inspected by city staff using visual methods in August 2015. |

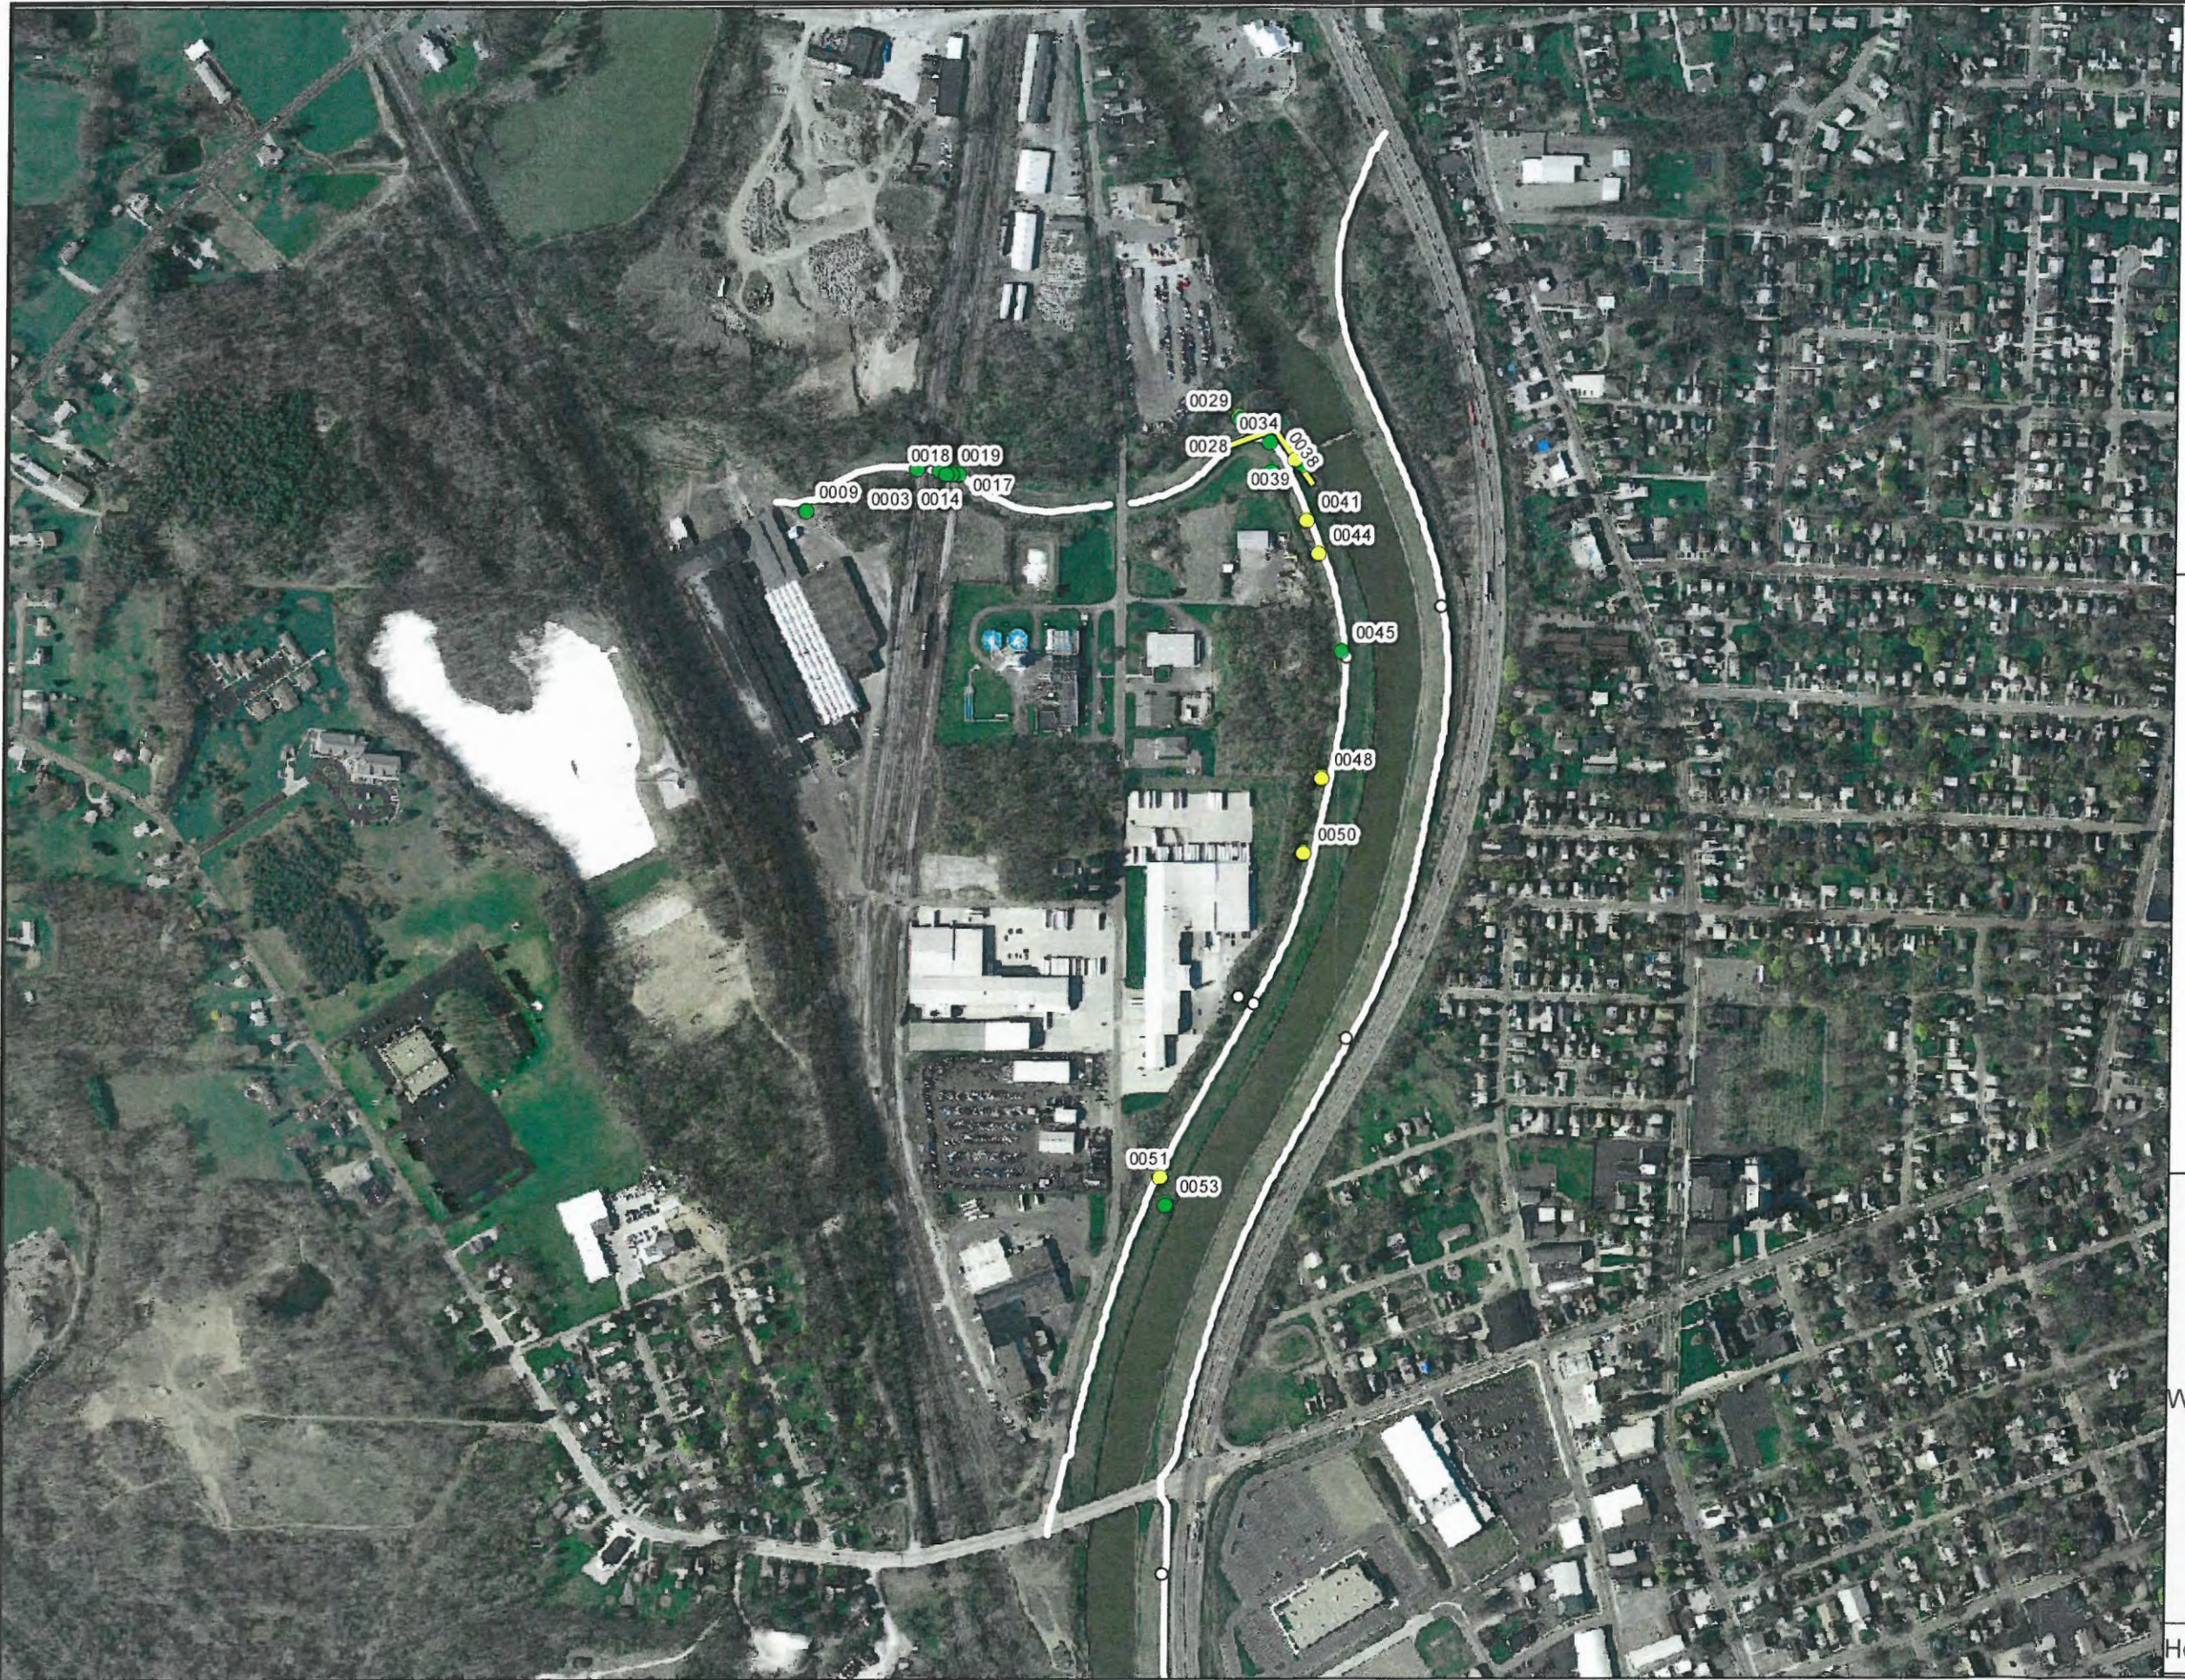
# Levee Inspection Map

| 051 | M | 1. Unwanted Vegetation Growth | Vegetation should be removed within 15' of the toe of the levee. |
| 053 | A | 5. Concrete Surfaces (Such as gate wells, outfalls, intakes, or culverts) | Gatewell Structure in good condition. |
