## GUIDANCE FOR CCTV AND SONAR INSPECTION PIPES PENETRATING LEVEES

11 November 2010

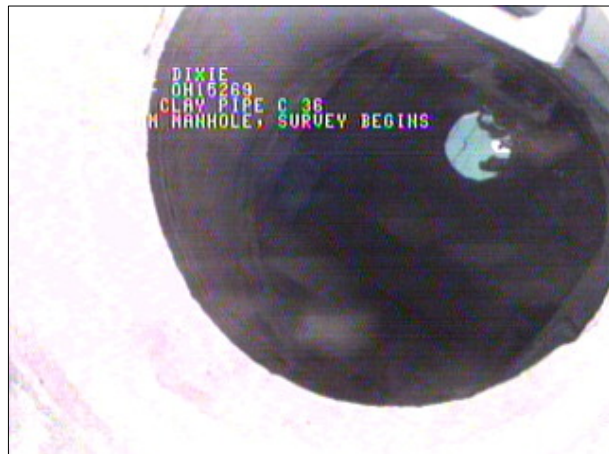
Photo: OH15269\_OH15266123825\_05112009\_A.JPG, VCR  
No.: FLOOD WALL#2, 01:42:22  
0FT, Downstream Manhole, Survey Begins

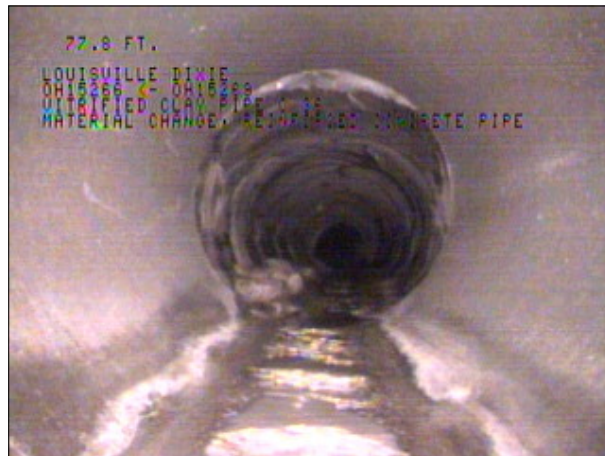
Photo: OH15269\_OH15266124720\_05112009\_A.JPG, VCR  
No.: FLOOD WALL#2, 01:45:49  
77.8FT, Material Change, Reinforced concrete pipe

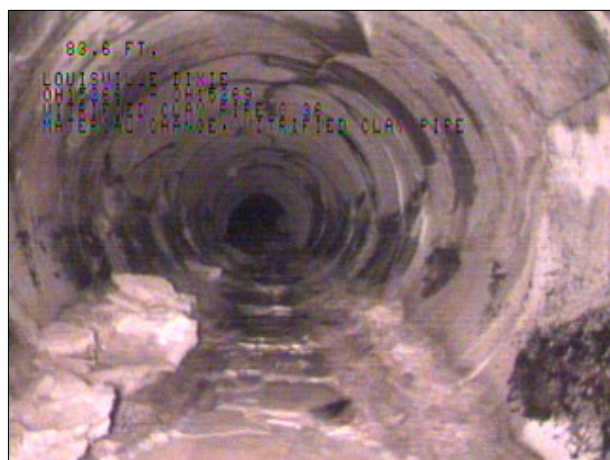
Photo: OH15269\_OH15266124748\_05112009\_A.JPG, VCR  
No.: FLOOD WALL#2, 01:46:07  
83.6FT, Material Change, Vitrified clay pipe

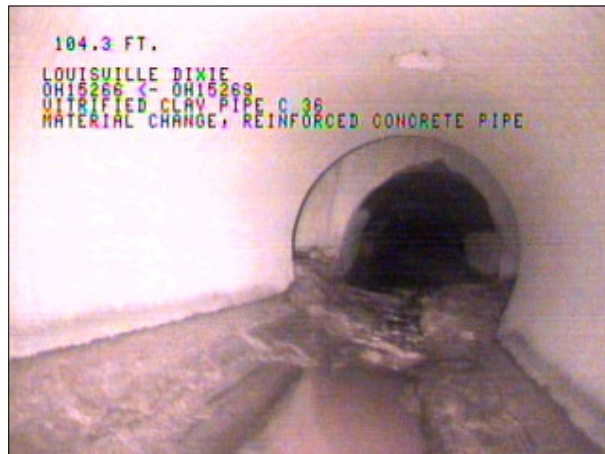
Photo: OH15269\_OH15266124907\_05112009\_A.JPG, VCR  
No.: FLOOD WALL#2, 01:46:54  
104.3FT, Material Change, Reinforced concrete pipe

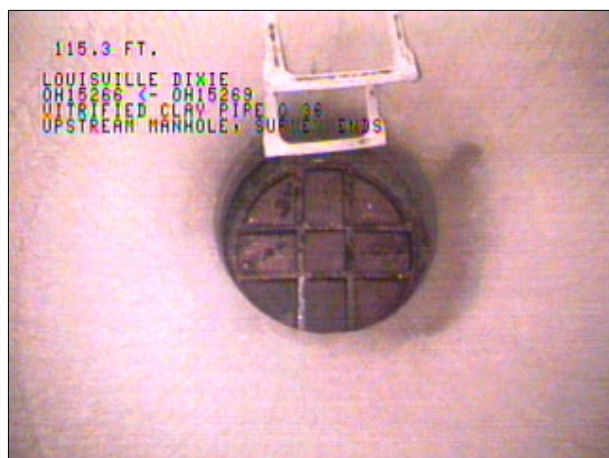
Photo: OH15269\_OH15266124956\_05112009\_A.JPG, VCR  
No.: FLOOD WALL#2, 01:47:25  
115.3FT, Upstream Manhole, Survey Ends
