DAM SAFETY INSPECTION REPORT

Sippo Creek Reservoir Dam
Class I

File Number: 0614-012

Inspection Date: April 26, 2001

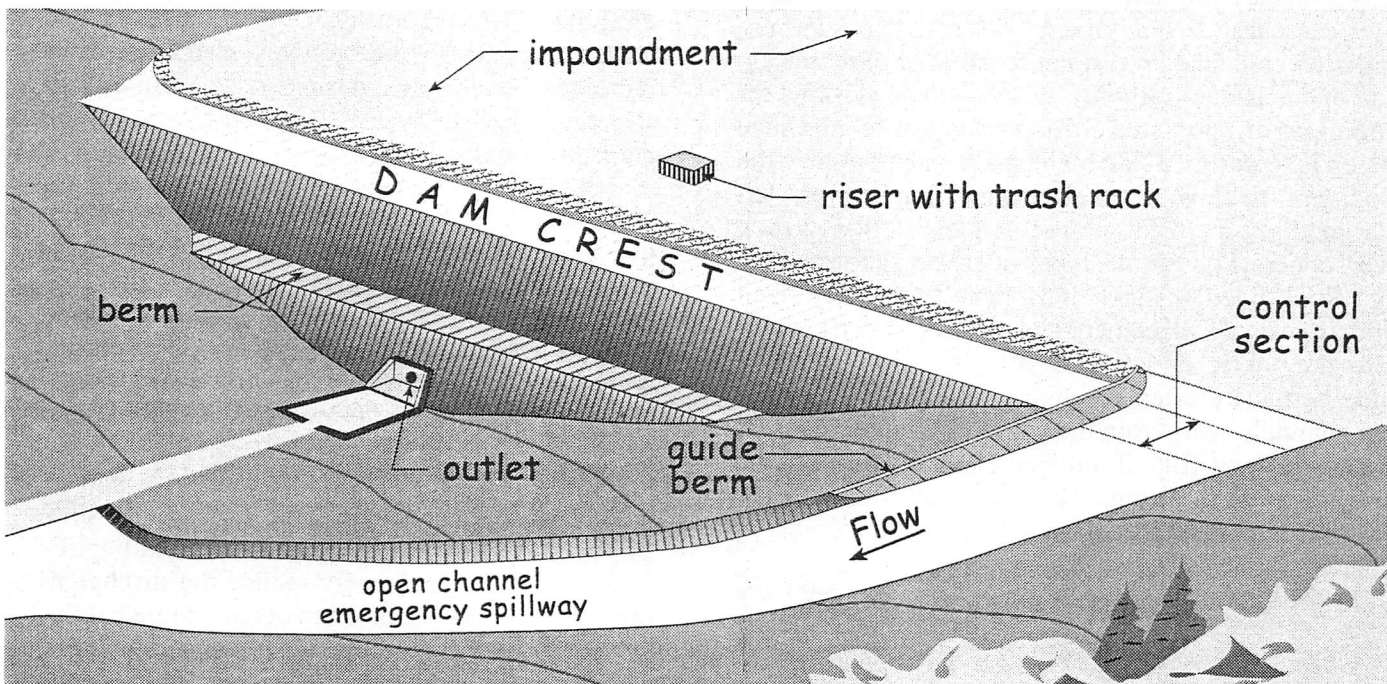
Downstream View of Open Channel Spillway

2. Replace the missing stones and the deteriorated mortar between many of the stones of the entire principal spillway. See the “Open Channel Spillways (Earth and Rock)” fact sheet included in this section for additional information.
