# DAM SAFETY INSPECTION REPORT

Sippo Creek Reservoir Dam  
Class I  
Stark County, Perry Township  
File Number: 0614-012  
February 21, 2006

**SIPPO CREEK RESERVOIR DAM  
FEBRUARY 21, 2006  
FILE NUMBER: 0614-012**

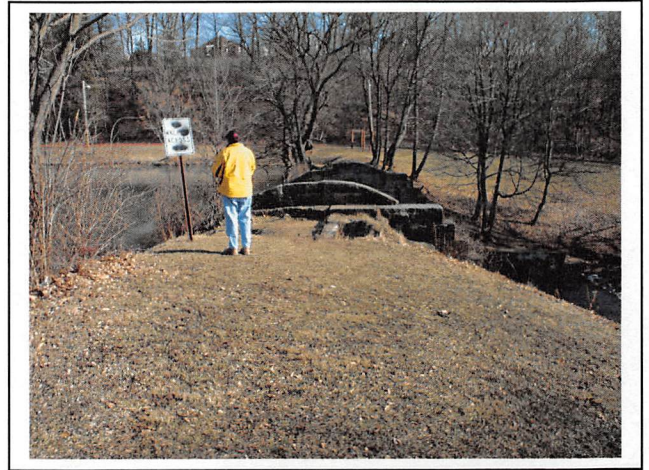
View of the right crest.

2. The erosion on the upstream slope and crest of the embankment must be repaired and the upstream slope and crest must be protected from erosion. Prepare plans and specifications for repairing the erosion and installing erosion protection. See the "Upstream Slope Protection" and "Ground Cover" fact sheet included in this section for additional information.

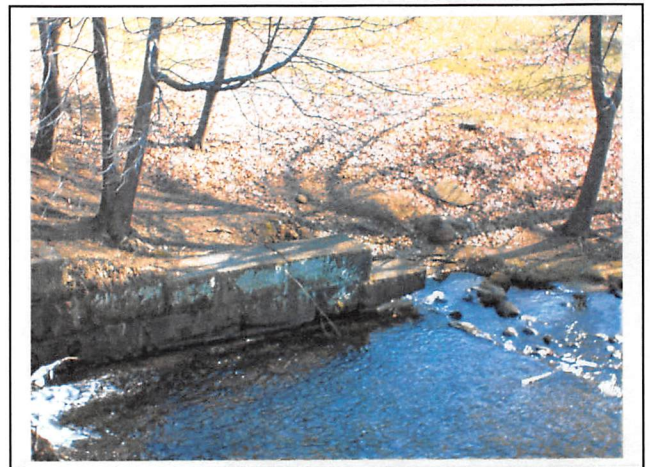
Other views of the undermining and erosion at the downstream end of the left side wall.

3. The entire spillway system must be repaired. Prepare plans and specifications for repair of the seepage through the sidewalls, the undermining of the upstream and downstream end of each sidewall, the loose and missing stones that comprise the spillway, the erosion around the sides of the apron of the spillway, and proper outlet erosion protection. The condition of the spillway system must be monitored for further deterioration. See the "Open Channel Spillways (Concrete Chutes and Weirs)", the "Outlet Erosion Control Structures (Stilling Basins)", and the "Seepage Through Earthen Dams" fact sheets included in this section for additional information.
