DAM SAFETY INSPECTION REPORT

Sippo Creek Reservoir Dam

Stark County, Perry Township

Inspection Date: June 16, 2015

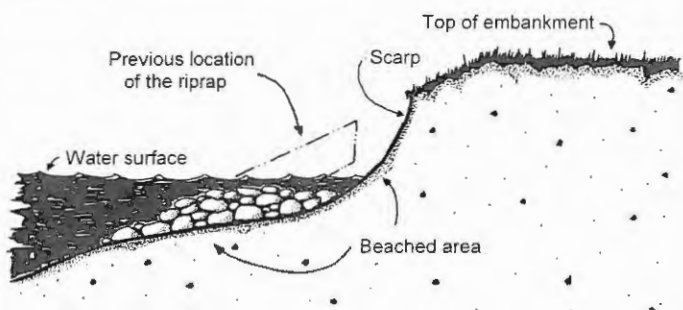
Figure 1 - Beaching

The repeated action of waves striking the embankment surface erodes fill material and displaces it farther down the slope, creating a “beach.” The amount of erosion depends on the predominant wind direction, the orientation of the dam, the steepness of the slope, water level fluctuations, boating activities, and other factors. Further erosion can lead to cracking and sloughing of the slope which can extend into the crest, reducing its width. When erosion occurs and beaching develops on the upstream slope of a dam, repairs should be made as soon as possible. However, an erosion scarp less than 1 foot high may be stable and not require repair.

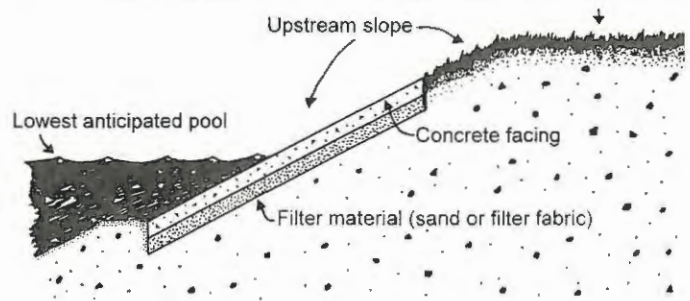
Figure 4 - Concrete facing

As with any type of slope protection, problems will develop if the concrete facing has not been properly designed or installed. Concrete facing often fails because the wave action washes soil particles from beneath the slabs through joints and cracks. This process is known as undermining, which will continue until large voids are created. Detection of voids is difficult because the voids are hidden. Failure of the concrete facing may be sudden and extensive. Concrete facing should be monitored for cracks and open joints. Open joints should be sealed with plastic fillers and cracks should be grouted and sealed. For additional information, see the "Problems with Concrete Materials" fact sheet.

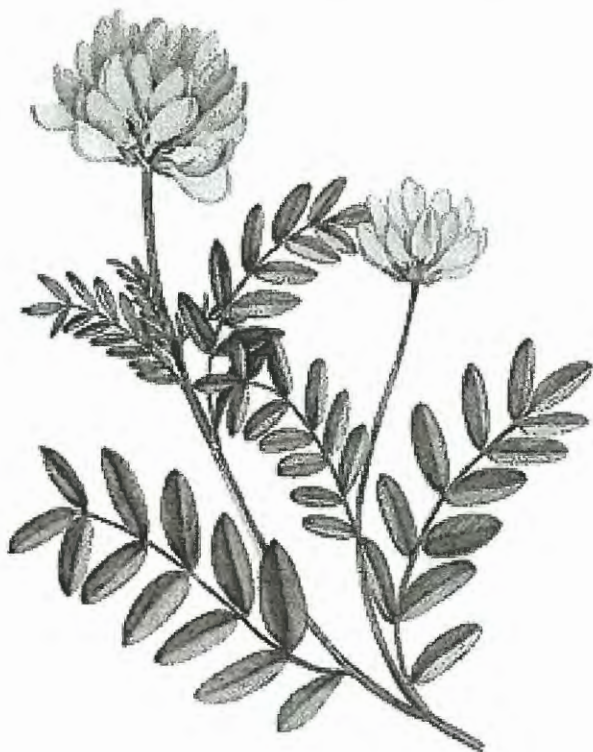
Figure 1: Crown Vetch
(Source: <http://www.vg.com>)

Crown vetch, a perennial plant with small pink flowers, has been used on some dams in Ohio but is not recommended (see Figure 1). It hides the embankment surface, preventing early detection of cracks and erosion. It is not effective in preventing erosion.

Vines and woody vegetation such as trees and brush also hide the embankment surface preventing early detection of cracks and erosion. Tall vegetation also provides a habitat for burrowing animals. All improper vegetation must be removed from the entire embankment surface. Any residual roots that are larger than 3 inches in diameter must be removed. All roots should be removed down to a depth of at least 6 inches and replaced with a compacted clay material; then 4 inches of topsoil should be placed on the disturbed areas of the slope. Finally, these areas must be seeded and mulched to establish a proper grass cover.
