# Dam Classification Checklist

Name of Dam: Sippo Creek Reservoir Dam File Number: 0614-012  
 County: Stark Date: May 25, 2010 Engineer: TMG

Name of Dam: Sippo Creek Reservoir Dam

Date of Inspection: MAY 25, 2010

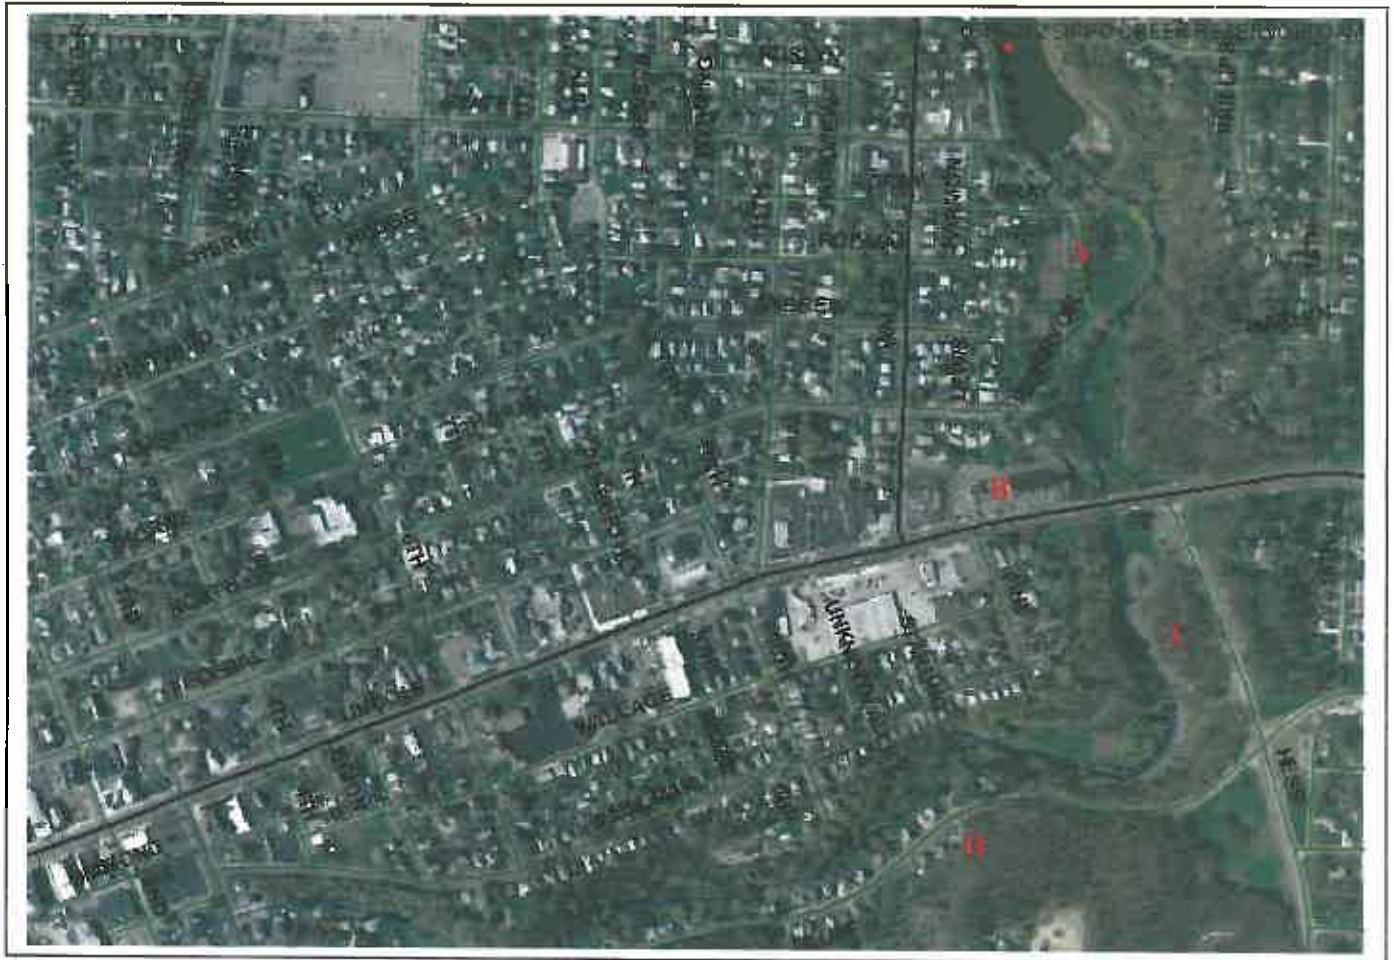
### Sketch of Developments Downstream of Dam

I	II			III		IV	-	-						
Probable loss of human life	Loss of public water supply or wastewater treatment facility, release of health hazardous waste	Flooding of structure or high-value property	Damage to high-value or Class I, II, III dam or levee	Damage to major road (US or state route), disruption of only access to residential or critical facility area	Damage to railroad or public utility	Damage to rural building, not otherwise high-valued property, or Class IV dam or levee	Damage to local road (county and township)	Loss restricted mainly to the dam or agricultural /rural land	No hazard to structure noted	No hazard assessment; further investigation needed	Distance downstream of dam to affected structure (feet)	Vertical distance from streambed to base of affected structure (feet)	Horizontal distance from stream to affected structure (feet)	
				B		A					200	3	0	Upper Park
						C					1500	26	0	SR 241
