May 6, 2003

Re: Color Television Inspection Services (for A. R. Lockhart Development Co.)  
Kenyon Creek Development - 8" and 12" Sanitary Sewers

for A. R. Lockhart Development Company  
Kenyon Creek Development  
Sanitary Sewers  
Tape No. 03012

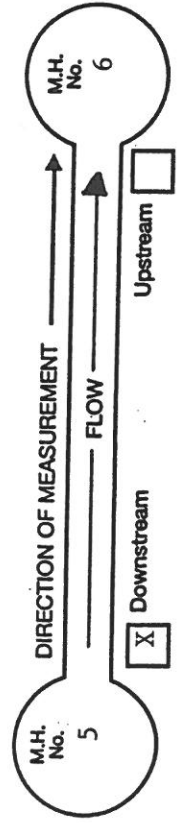
| Distance Reading | DESCRIPTION |
|---|---|
| MANHOLES ARE PRECAST AND HAVE VENTED COVERS. THE STEPS ARE GOOD. ALIGNMENT AND GRADE ARE GOOD AND ALL JOINTS APPEAR TIGHT AND EVEN. | |

Line and Grade: GOOD  
Cleanliness of Line: GOOD  
Manhole Conditions: GOOD  
Manhole Depth:

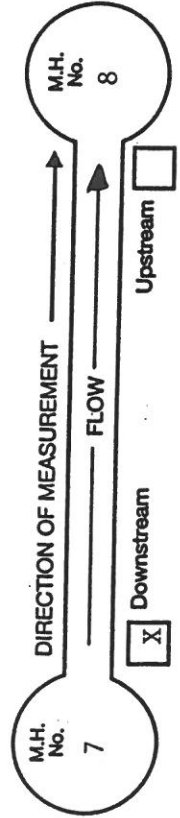
| Distance Reading | DESCRIPTION |
|---|---|
| MANHOLES ARE PRECAST AND HAVE VENTED COVERS. THE STEPS ARE GOOD. ALIGNMENT AND GRADE ARE GOOD AND ALL JOINTS APPEAR TIGHT AND EVEN. | |

Line and Grade: GOOD  
Cleanliness of Line: GOOD  
Manhole Conditions: GOOD  
Manhole Depth:

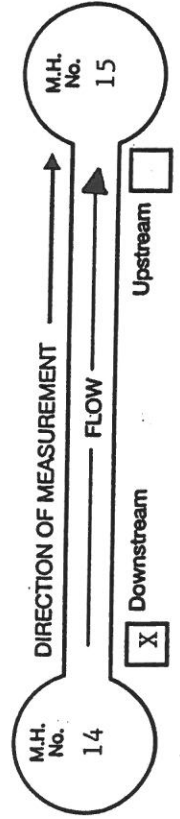
| Distance Reading | DESCRIPTION |
|---|---|
| | MANHOLES ARE PRECAST AND HAVE VENTED COVERS. THE STEPS ARE GOOD. ALIGNMENT AND GRADE ARE GOOD AND ALL JOINTS APPEAR TIGHT AND EVEN. |

Line and Grade: GOOD  
Cleanliness of Line: GOOD  
Manhole Conditions: GOOD  
Manhole Depth:

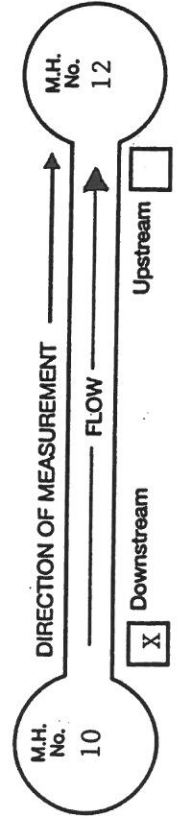
| Distance Reading | DESCRIPTION |
|---|---|
| | MANHOLES ARE PRECAST AND HAVE VENTED COVERS. THE STEPS ARE GOOD. ALIGNMENT AND GRADE ARE GOOD AND ALL JOINTS APPEAR TIGHT AND EVEN. |

Line and Grade: GOOD  
Cleanliness of Line: GOOD  
Manhole Conditions: GOOD  
Manhole Depth:

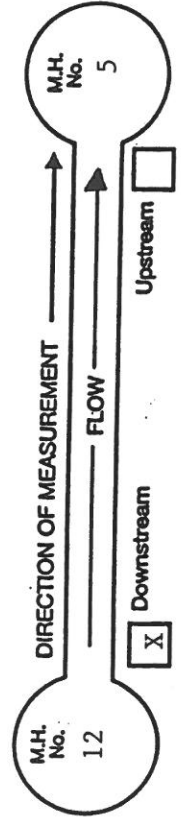
| Distance Reading | DESCRIPTION |
|---|---|
| MANHOLES ARE PRECAST AND HAVE VENTED COVERS. THE STEPS ARE GOOD. ALIGNMENT AND GRADE ARE GOOD AND ALL JOINTS APPEAR TIGHT AND EVEN. | |

Line and Grade: GOOD  
Cleanliness of Line: GOOD  
Manhole Conditions: GOOD  
Manhole Depth:
