**RE: Sippo Creek Reservoir Dam
City of Massillon, Stark County
Hydrologic and Hydraulic Report
File Number 0614-012**

URS Corporation (URS) is pleased to submit this Hydrologic and Hydraulic Report for the Sippo Creek Reservoir Dam for the City of Massillon. This submittal reflects the City of Massillon's request that URS provide services to develop a design discharge for the dam and to bring the dam into compliance with ODNR regulations.

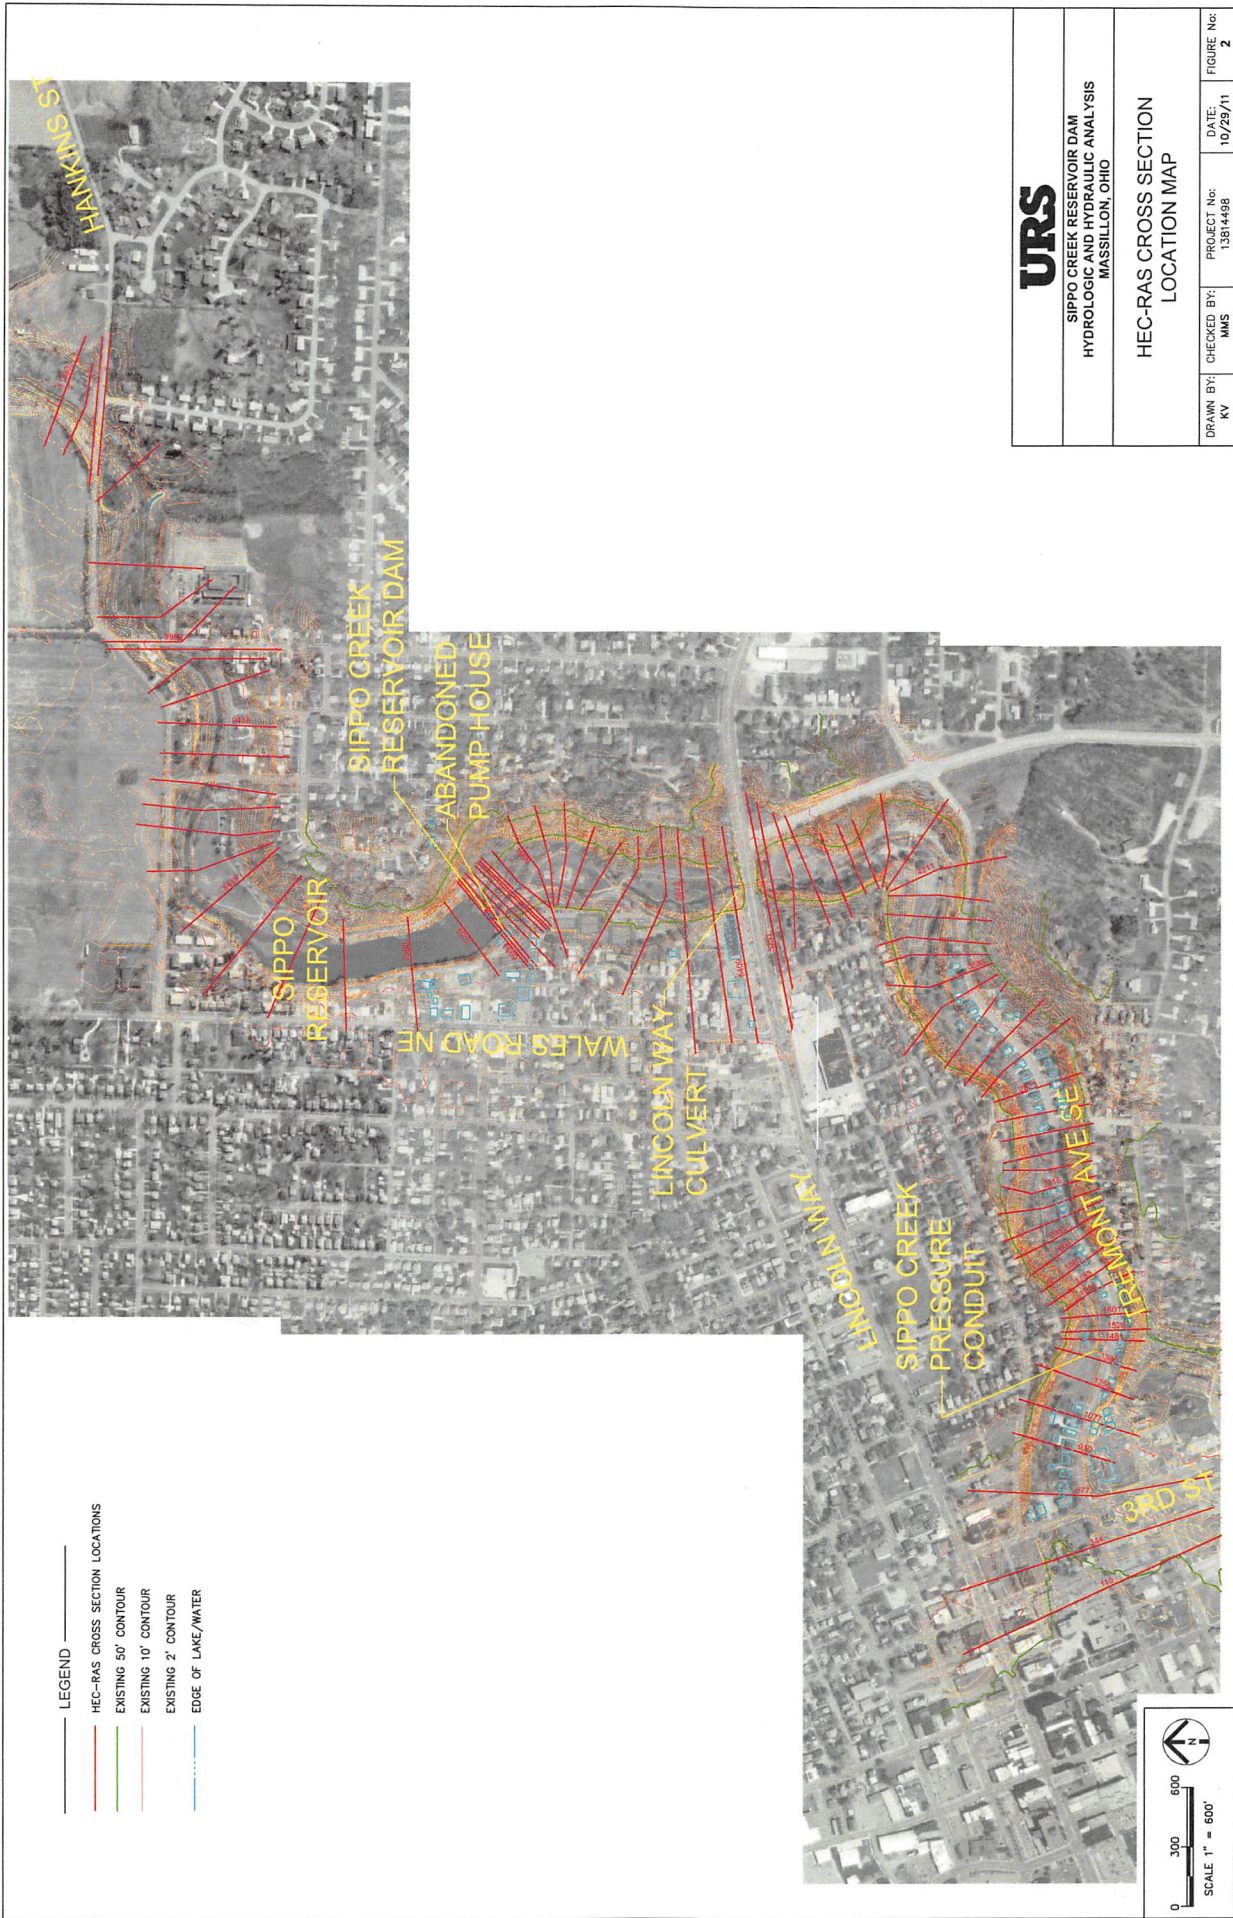
URS			
SIPPO CREEK RESERVOIR DAM HYDROLOGIC AND HYDRAULIC ANALYSIS MASSILLON, OHIO			
HEC-RAS CROSS SECTION LOCATION MAP			
DRAWN BY: KV	CHECKED BY: MMS	PROJECT No: 13814498	DATE: 10/29/11
			FIGURE No: 2

Ineffective flow areas are areas that are not used in the conveyance calculations in HEC-RAS, but are used to calculate storage between cross sections. The most significant areas that are considered ineffective in the HEC-RAS model are the areas just outside of the opening of the modeled culverts. It is recommended by the Hydrologic Engineering Center that these areas be designated ineffective to ensure that head losses through the culvert are calculated correctly.

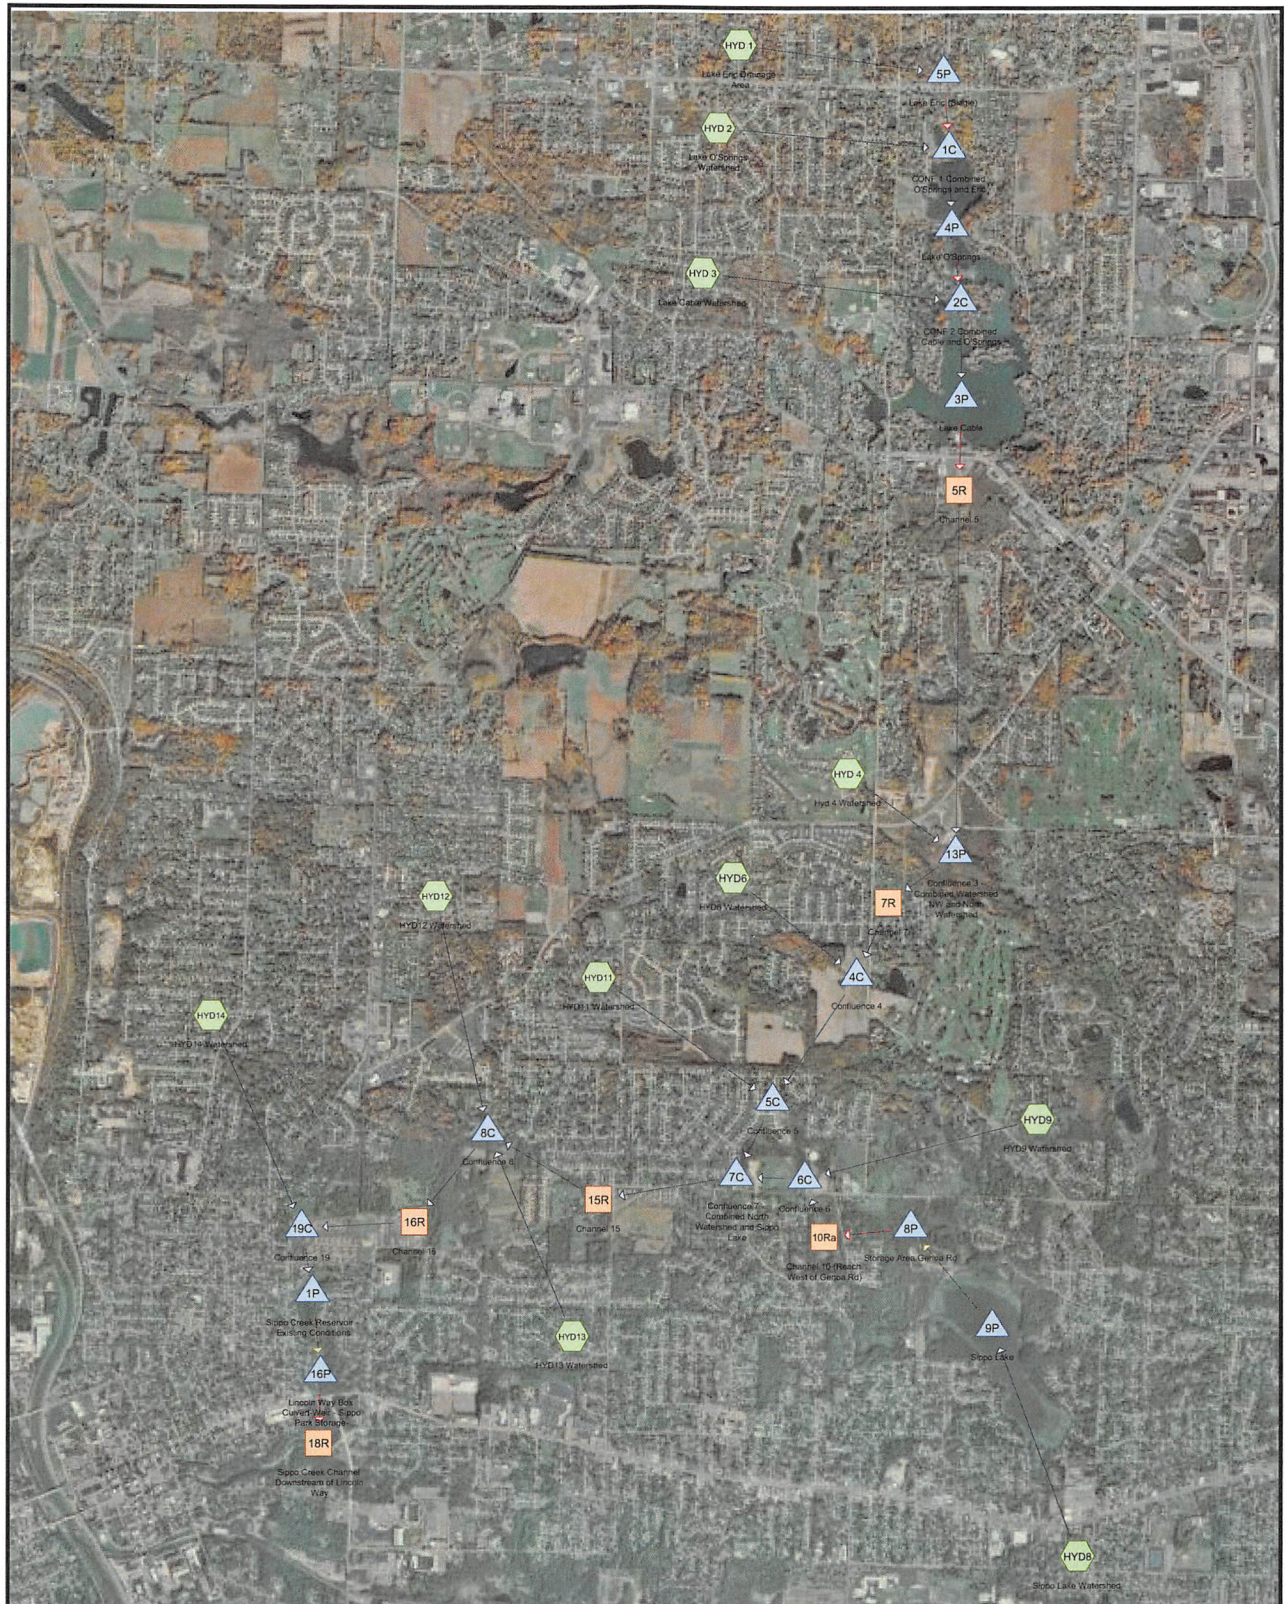
CHART 1

Drainage Diagram for Existing Conditions Sippo Reservoir-URS-Final
 Prepared by URS Corporation, Printed 10/21/2011
 HydroCAD® 9.10 s/n 04378 © 2010 HydroCAD Software Solutions LLC

The URS dam failure analysis estimates that that a Critical Flood exists for the Sippo Creek Reservoir Dam due to the submergence of the Dam and the overtopping of the Lincoln Way embankment as shown on Chart 1.
