FIRST NATIONAL BANK

- MASSILLON - OHIO -

OF PROPERTY ON THE SOUTH SIDE MAIN ST. BETWEEN ERIE & EXCHANGE STS.  
DIMENSIONS IN FEET AND INCHES. ELEVATIONS BASED ON CITY OF MASSILLON DATUM.  
MADE AT ORDER OF WALKER & WEEKS ARCHITECTS -  
1900 EVCLID BLDG - CLEVELAND - OHIO -

By GEORGE M. GARRETT.

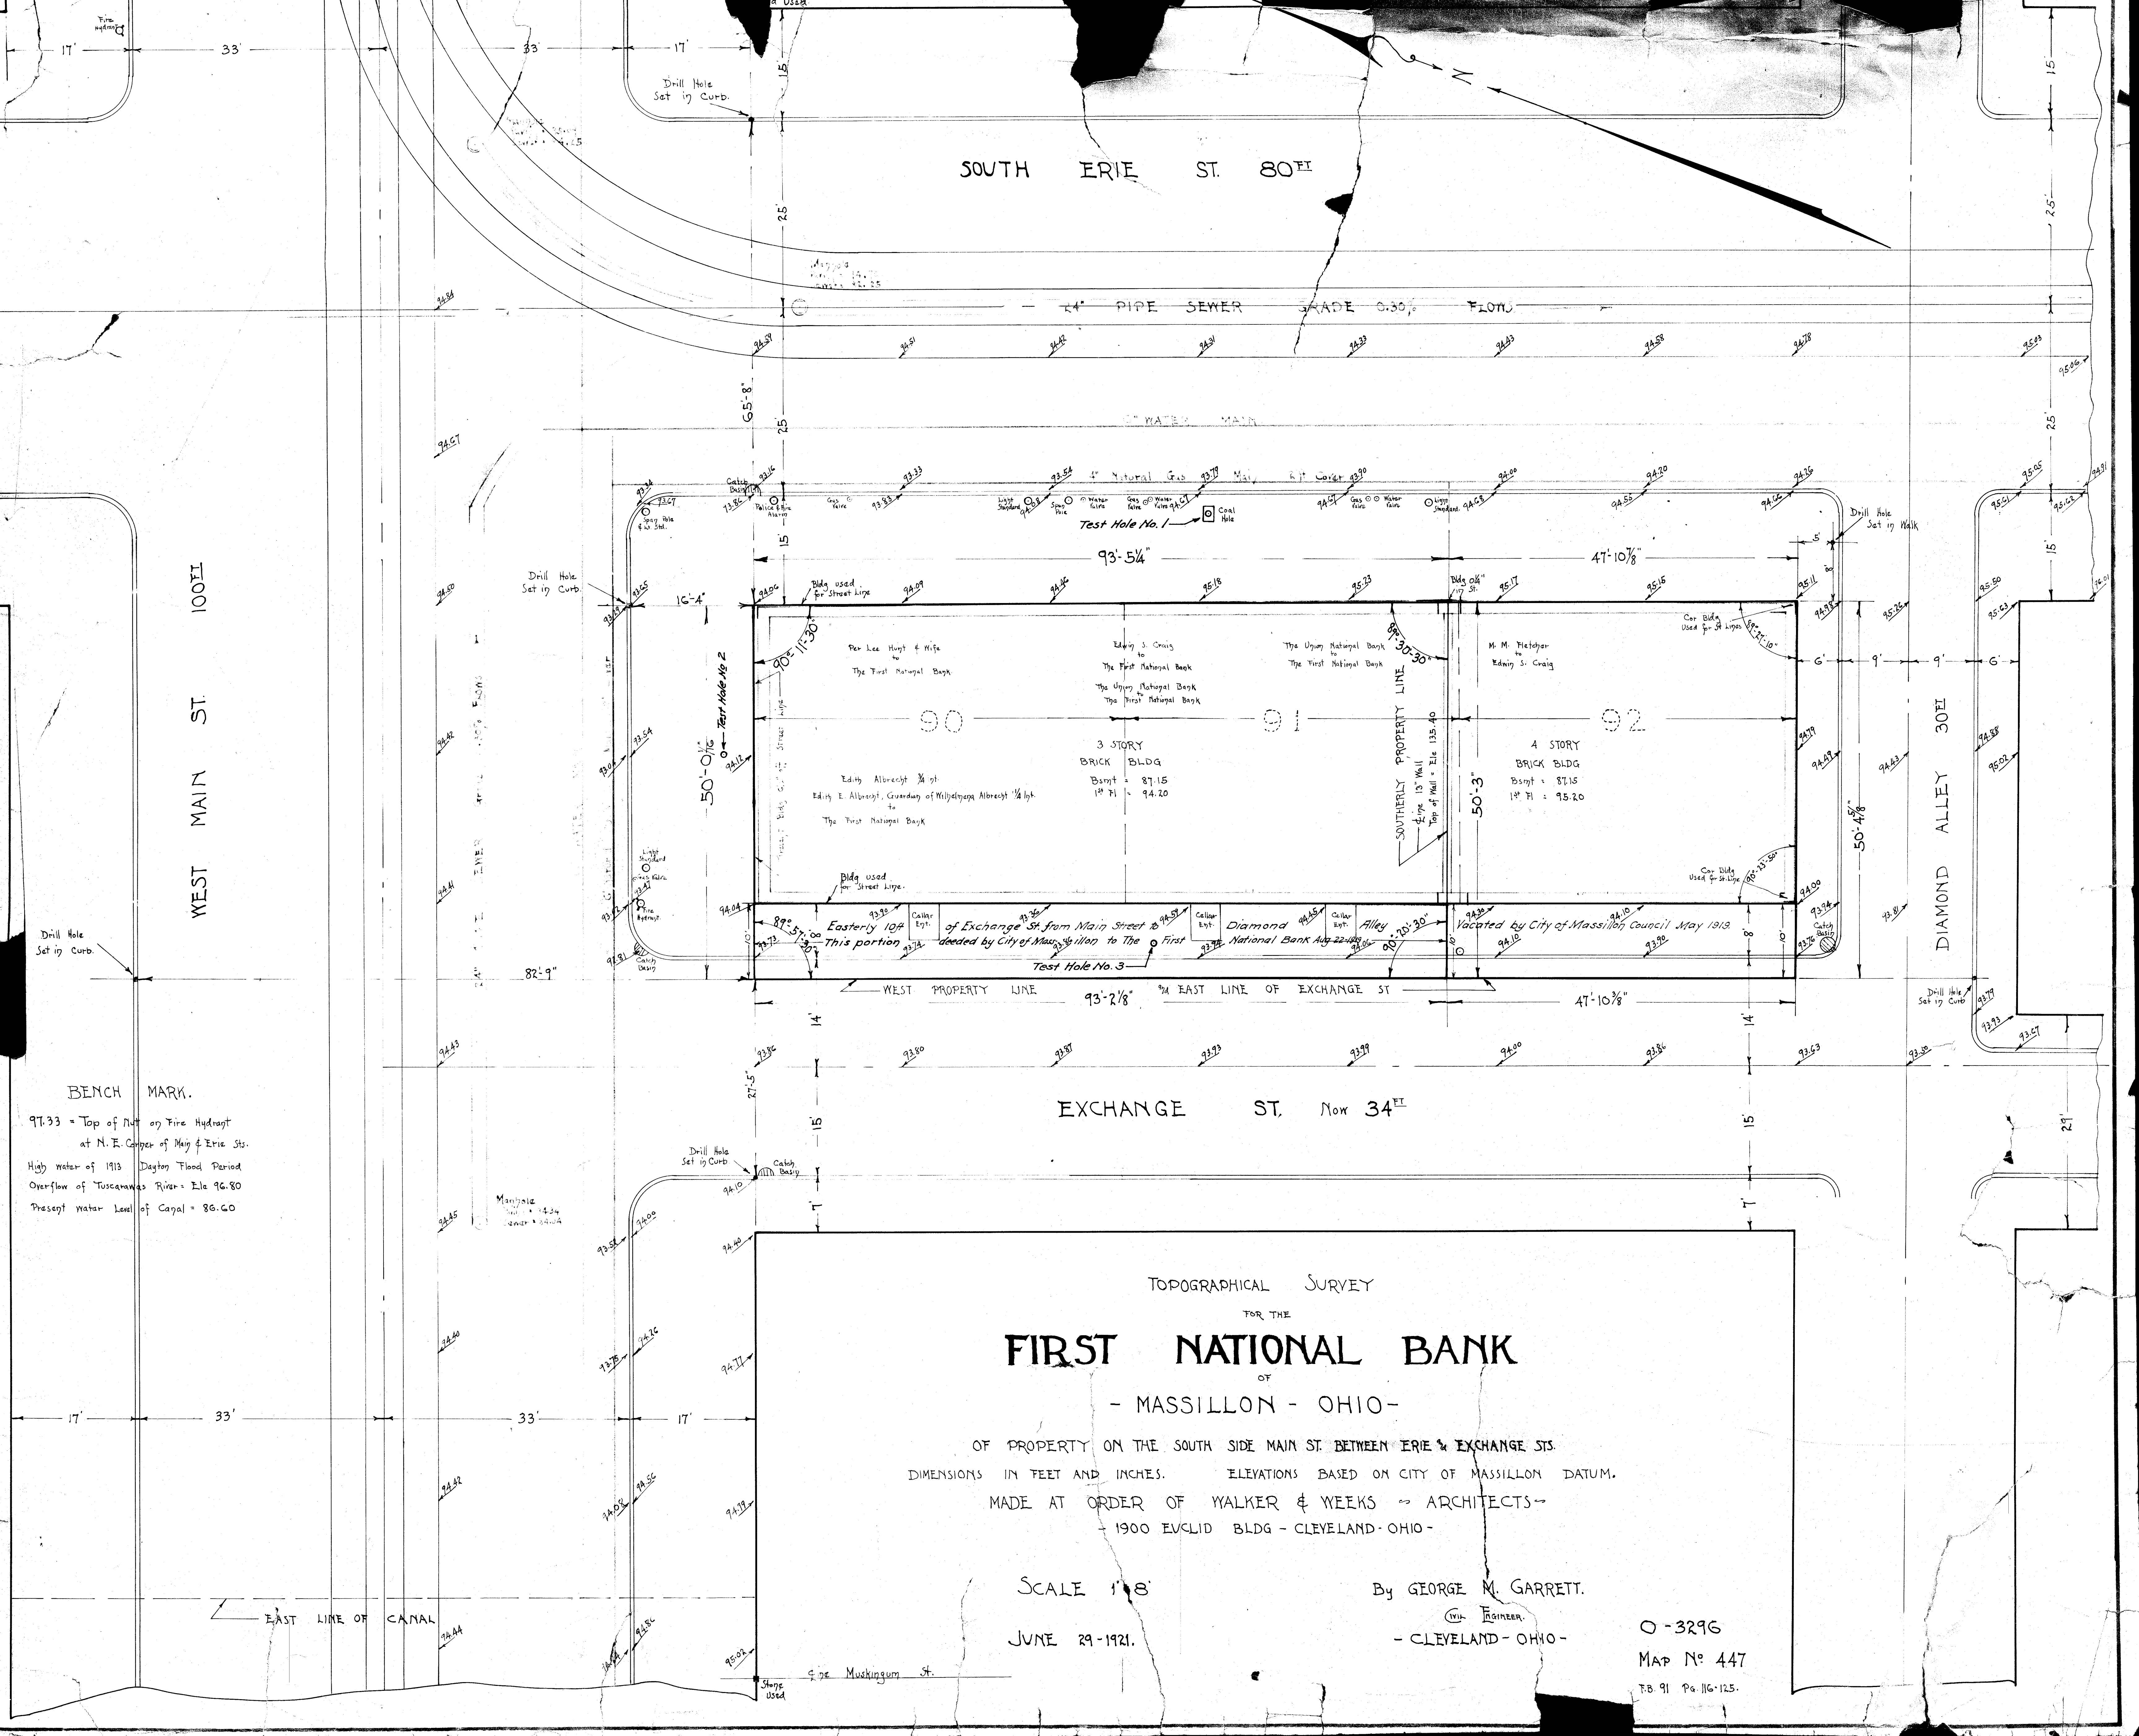
MAP No 447

24" PIPE SEWER GRADE 0.30% FLOW

WATER MAIN

Test Hole No. 1

Test Hole No. 2

SCALE 1" = 8'

97.33 = Top of Nut on Fire Hydrant  
at N.E. Corner of Main & Erie Sts.  
High water of 1913 Dayton Flood Period  
Overflow of Tuscarawas River = Ele 96.80  
Present water level of Canal = 86.60
