LAKE AVE FROM FIRST TO ANHERST RD. NE.

LAKE ST. SANITARY SEWER  
MILL ST TO AKRON ST

DRAWN BY F.C.D. DATE SEP. 9 '24 SHEET NO 2

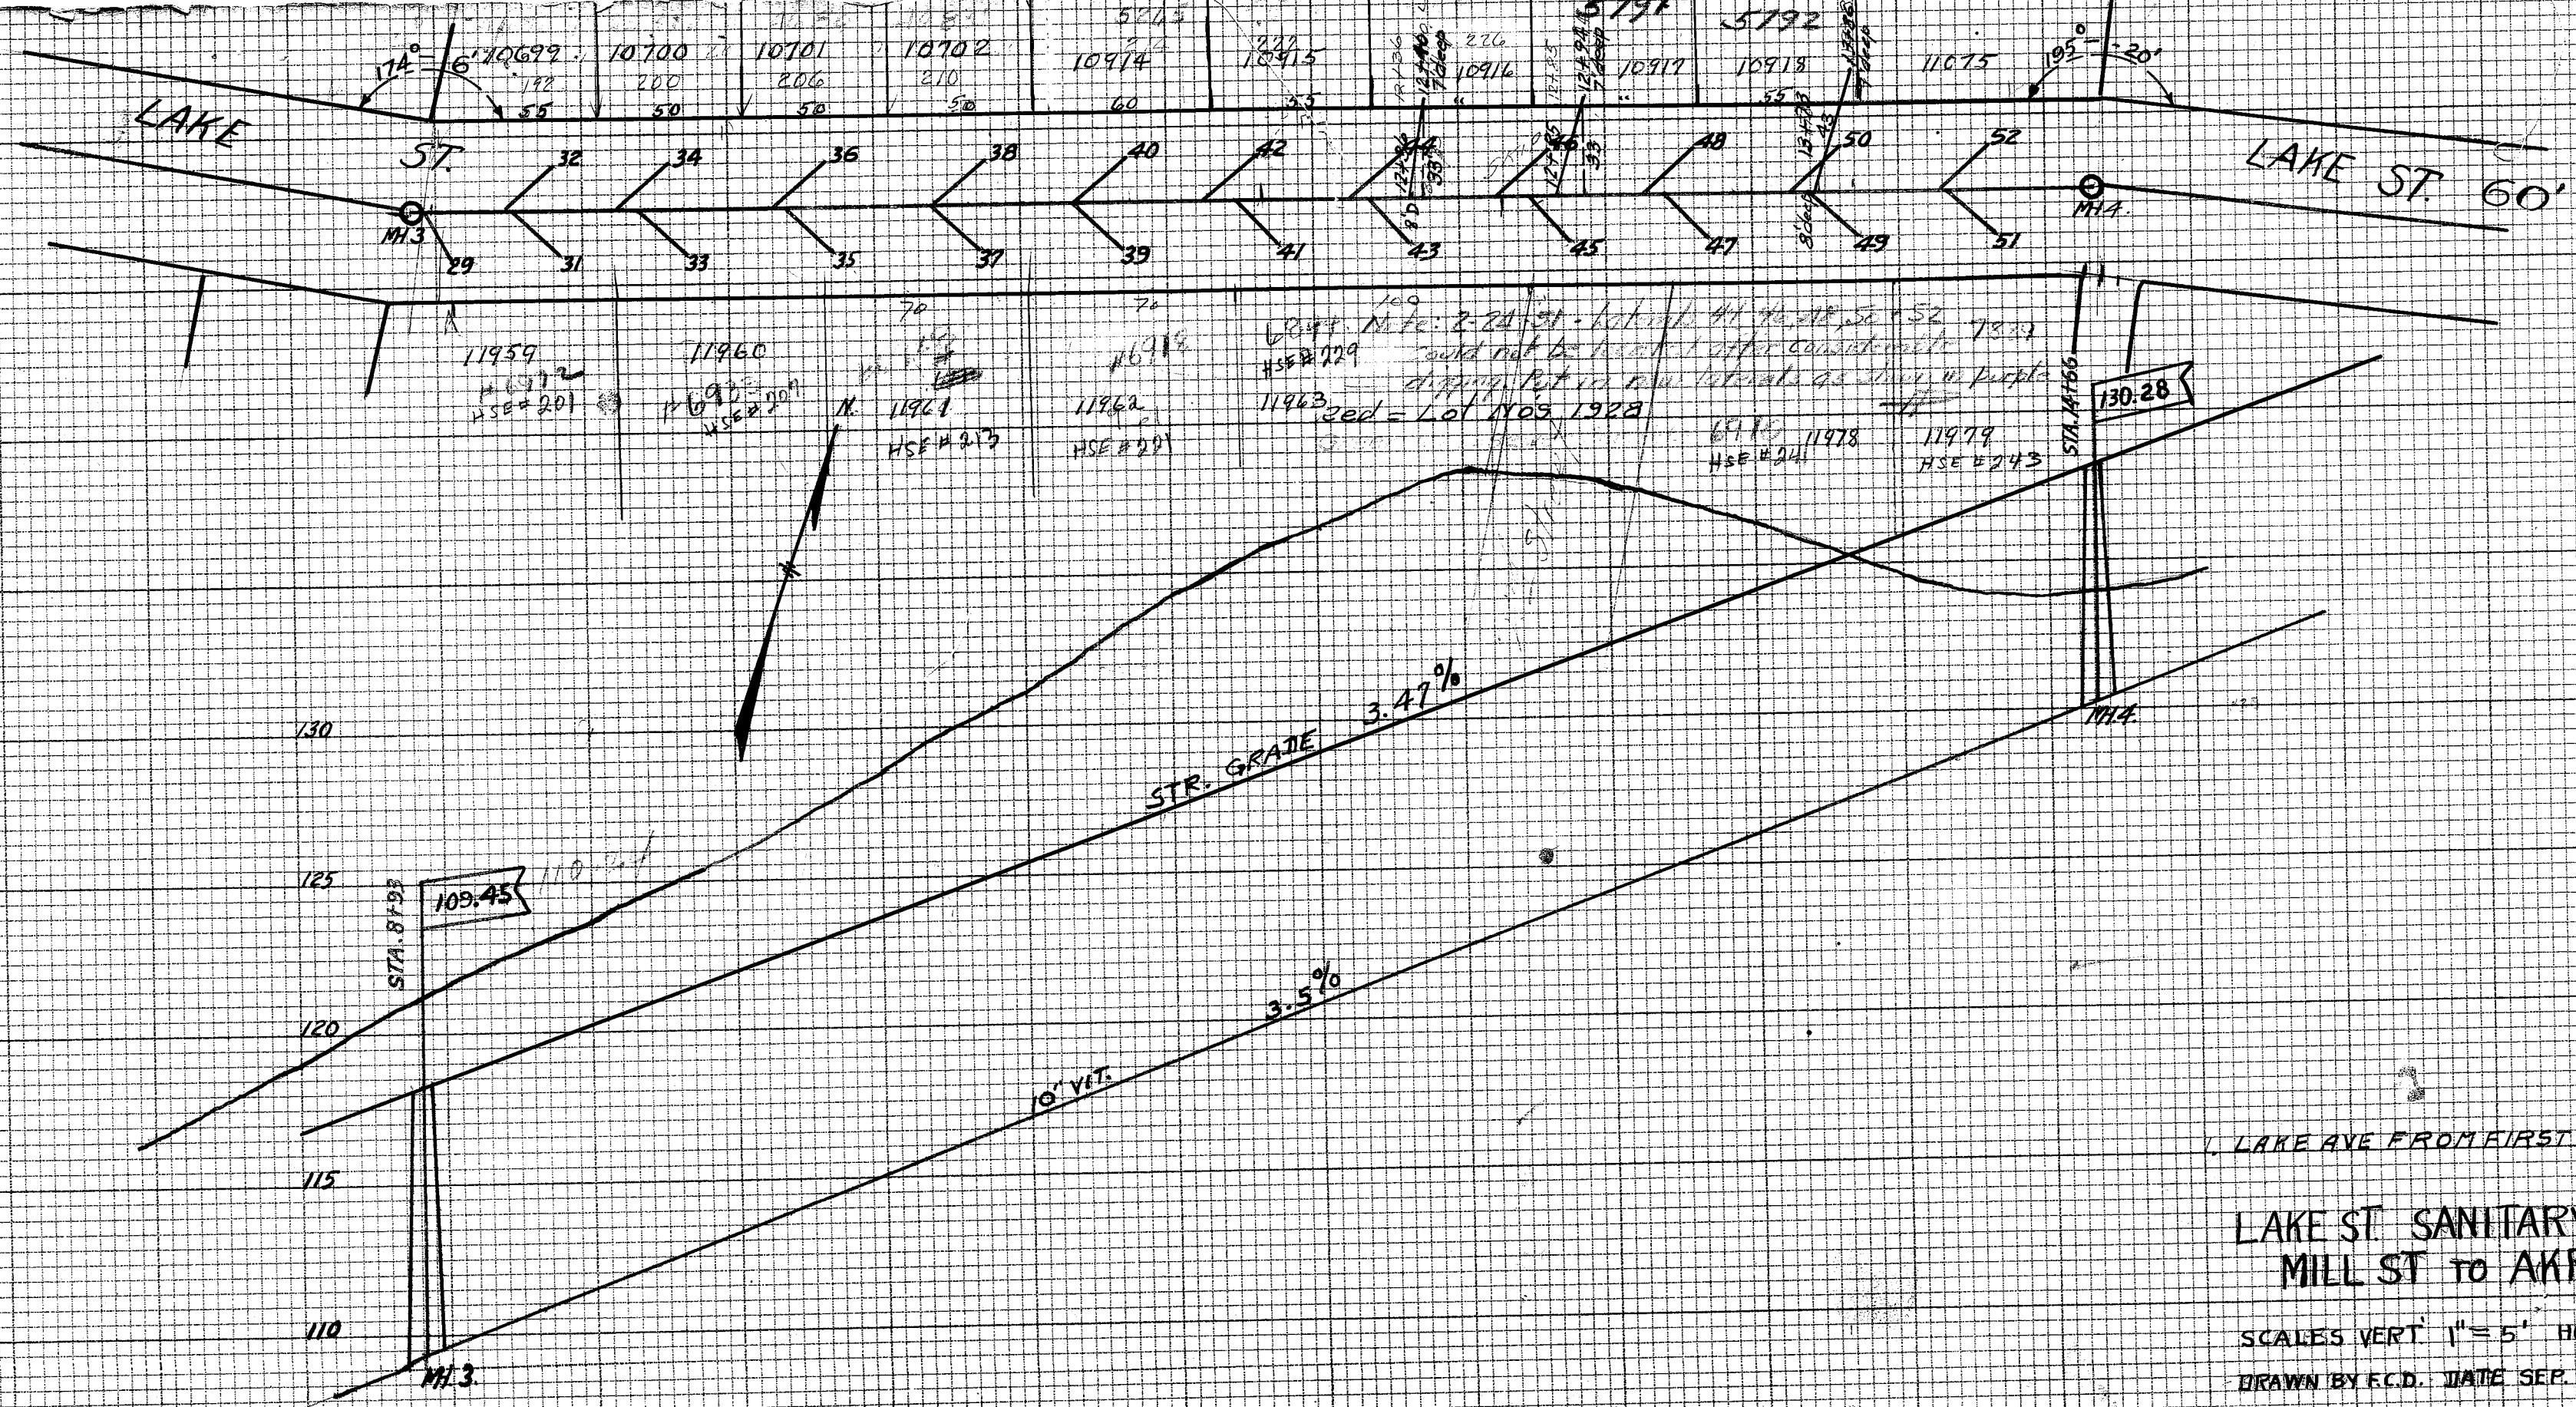
NOTE: 2-24-51 - lateral 41 to 48, 50 to 52  
could not be located after construction  
digging pit in rear lateral as shown in purple  
red = Lot 1109 1928
