CITY OF MASSILLON, OHIO  
WWTP UPGRADE 2000  
TR "D", LIGHTING PNL & AIR HANDLING UNIT  
LAB BLDG SOUTH WALL, MAIN FLOOR

| SHEET<br>EP358-D |

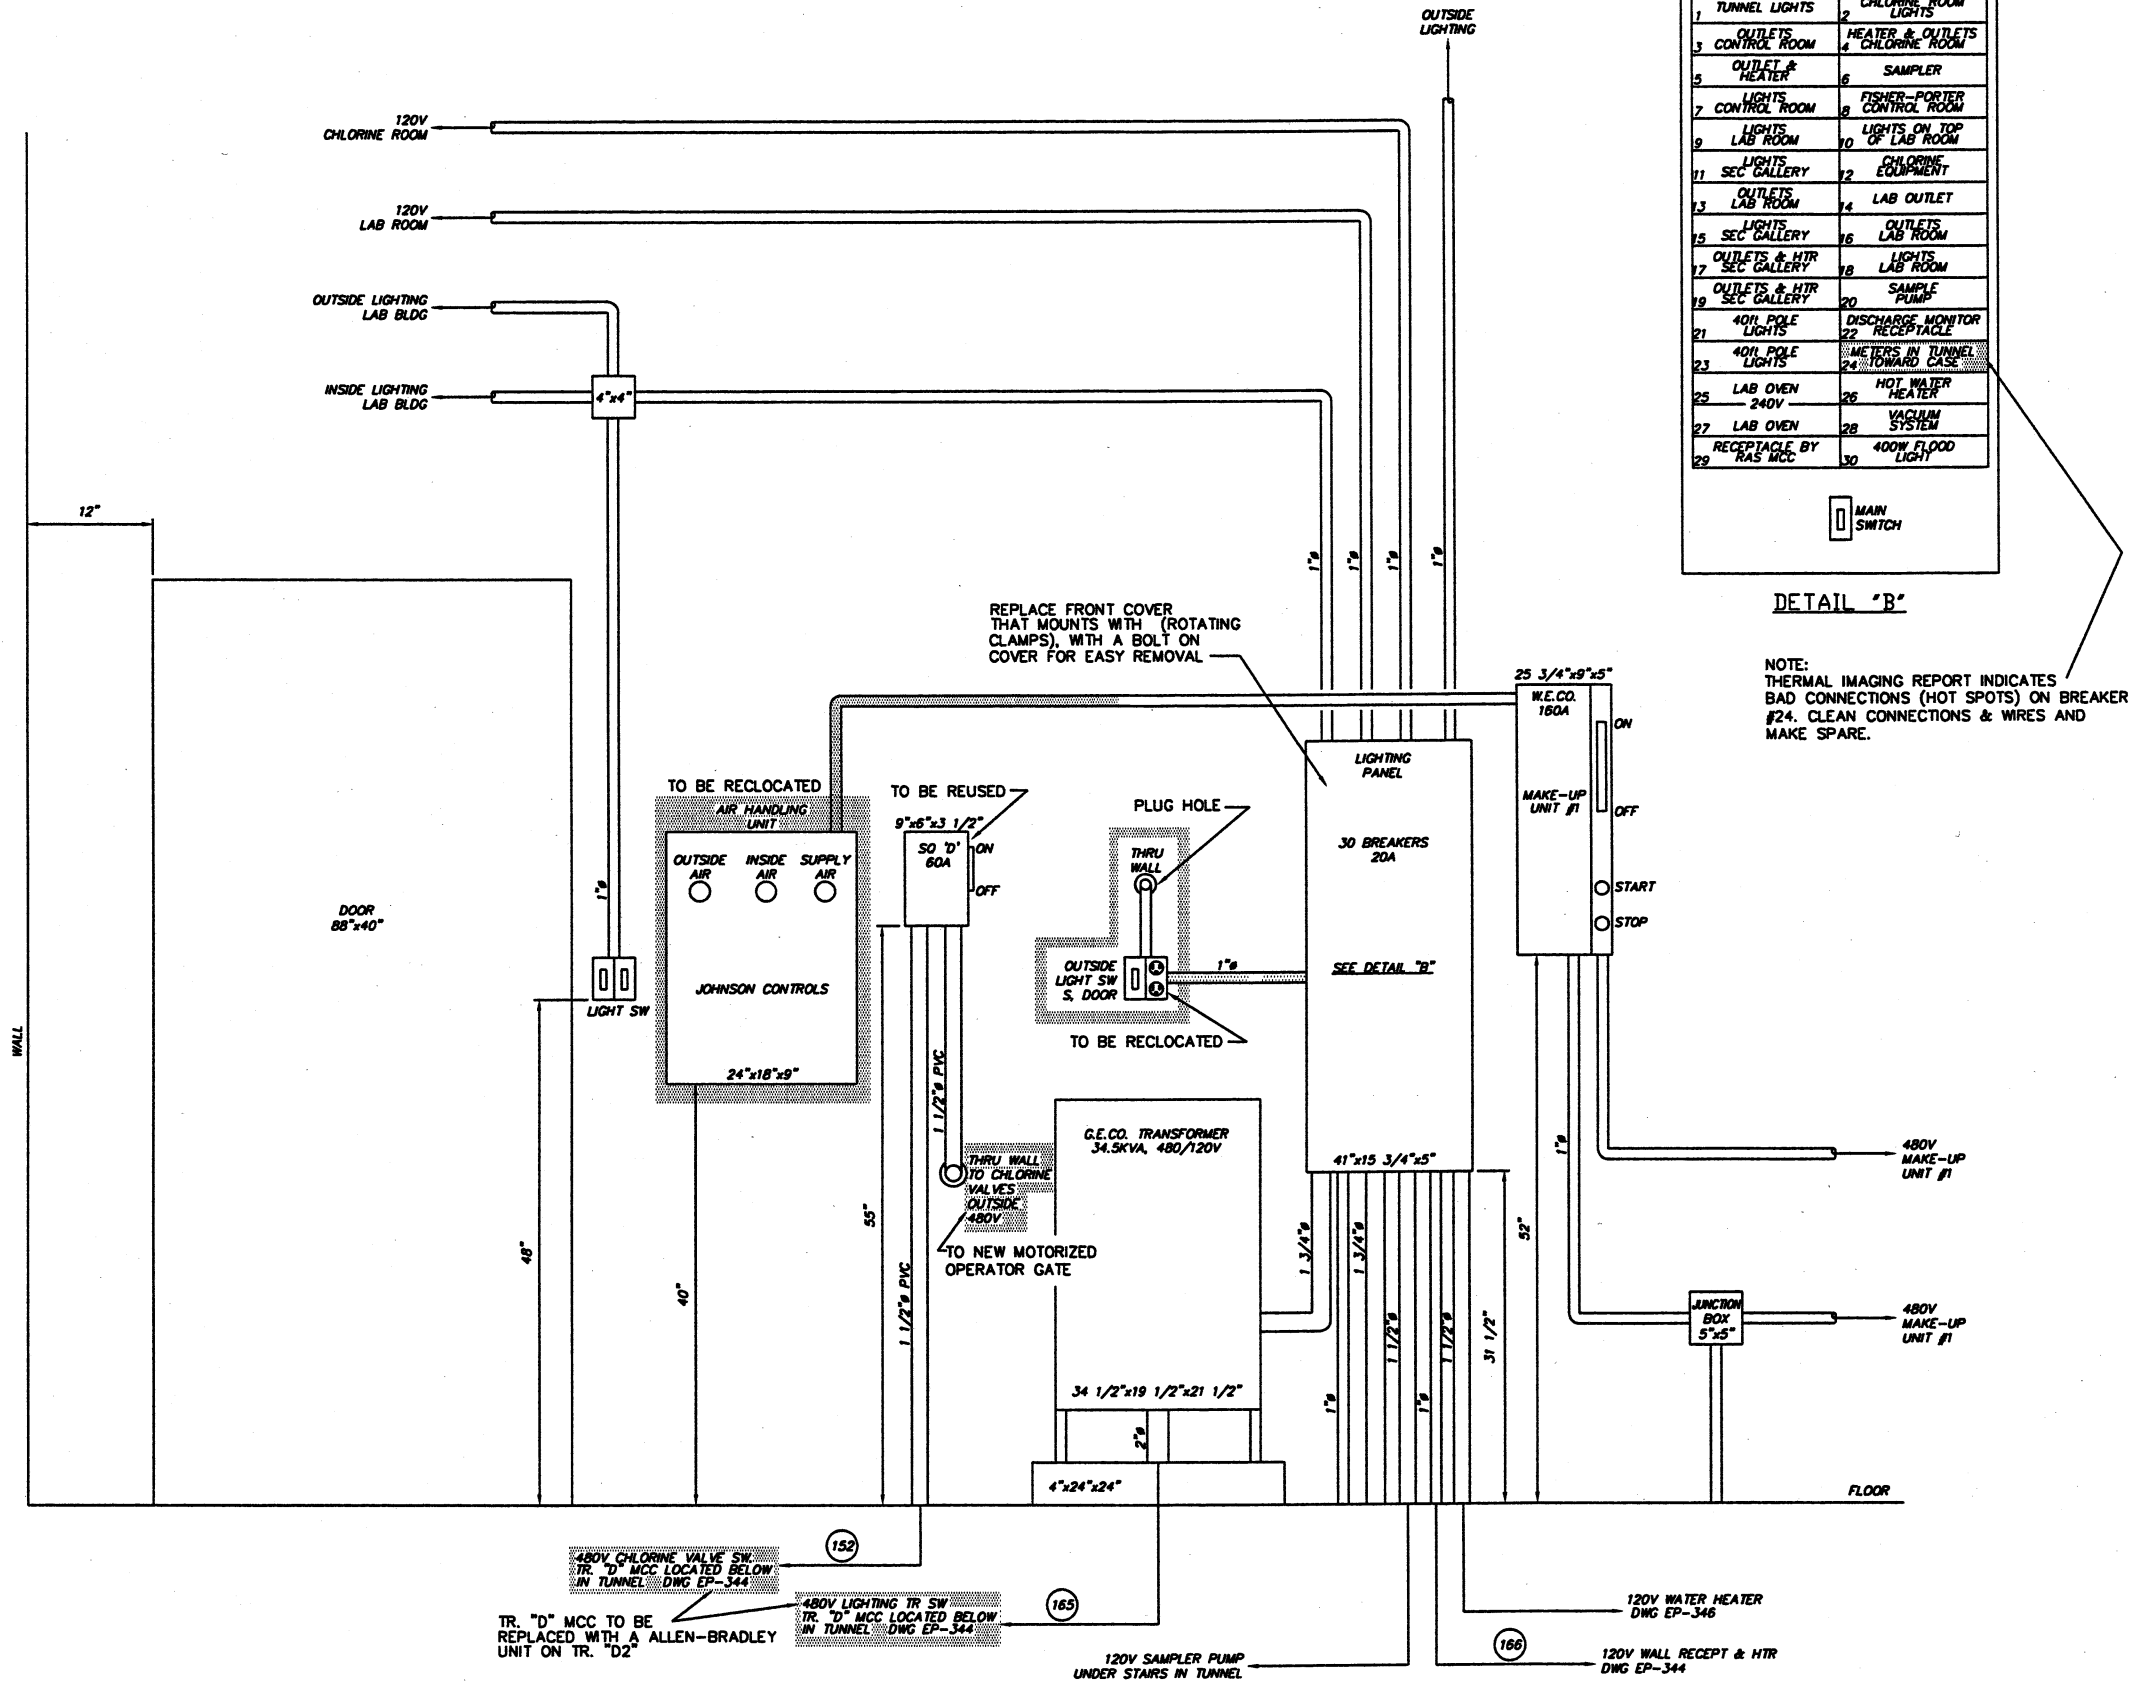
DETAIL "A"

| 1 MAIN CONTROL PANEL | 2 WAS TO THICKENER |
| 3 PLANT EFFLUENT TO THICKENER | 4 BAS WITHDRAWAL #1 |
| 5 BAS WITHDRAWAL #2 | 6 BAS WITHDRAWAL #3 |
| 7 BAS TO AERATION & BAS WITHDRAWAL SUMMERS | 8 EFFLUENT CEI-P-350 & SUMMER |
| 9 BAS SLUDGE TO AERATION | 10 ANNUNCIATOR |
| 11 BUBLER | 12 EFFLUENT CEI-P-360 |
| 13 ABB TOTALIZING METERS | 14 UNKNOWN |
| 15 SLMT DISPLAY UNIT | 16 100A |
| 17 SLMT DISPLAY UNIT | 18 MAIN SWITCH |

LOCATED IN BACK OF MONITORING CAB

NOTE: THERMAL IMAGING REPORT INDICATES BAD CONNECTIONS (HOT SPOTS) ON BREAKER #24. CLEAN CONNECTIONS & WIRES AND MAKE SPARE.
